HOME BUYER SURVEY

REF 3468

The format of this Mi HOME BUYER SURVEY is consistent with the guidance note requirements for a Survey Level 2 as defined by RICS Surveys of Residential Property 3rd edition May 2016

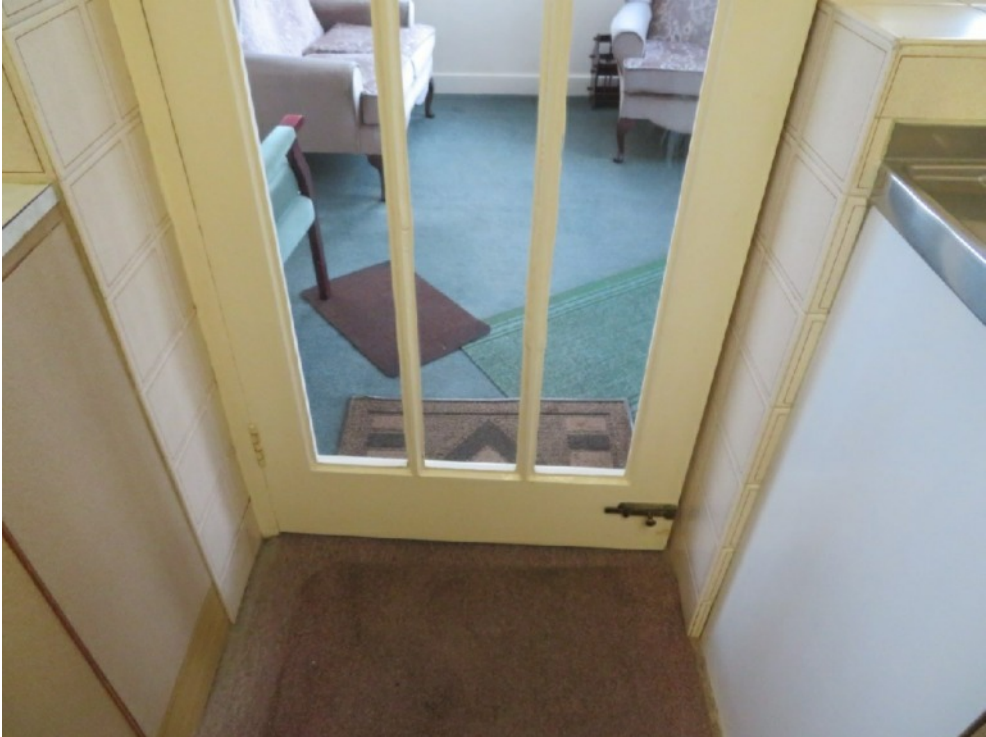
<p style="text-align: center;">Lack of safety glass</p>
<p>Safety Glass</p>	<p>Safety glass was not noted to the kitchen doors. See also section 5.7.</p>
<p>Lead Pipes</p>	<p>A visual inspection was carried out, however pipes buried within walls or beneath the ground were not inspected.</p>
<p>Risk of Falls</p>	<p>Window Sill heights: No Issue Noted Trip Hazards: No Issue Noted Slip hazards: There is a lot of moss to the paths and drive which is a slip hazard.</p>

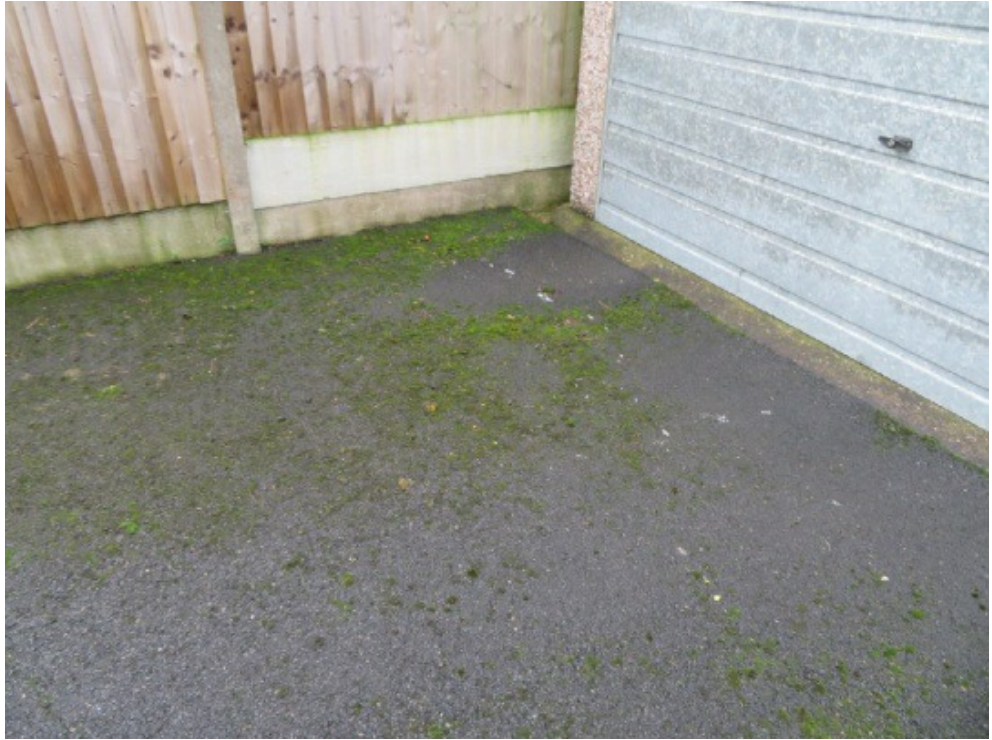
Moss to asphalt drive

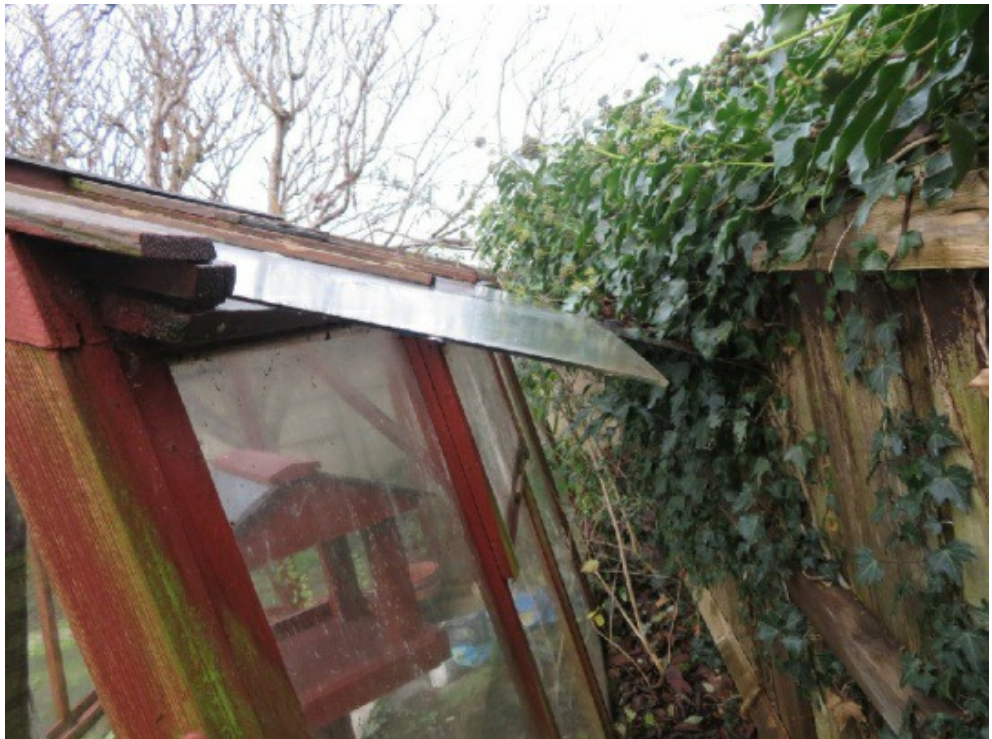
The glazing supports to the greenhouse roof are in a very poor state and the glass to the roof could fall at any time.

Loose glass to greenhouse

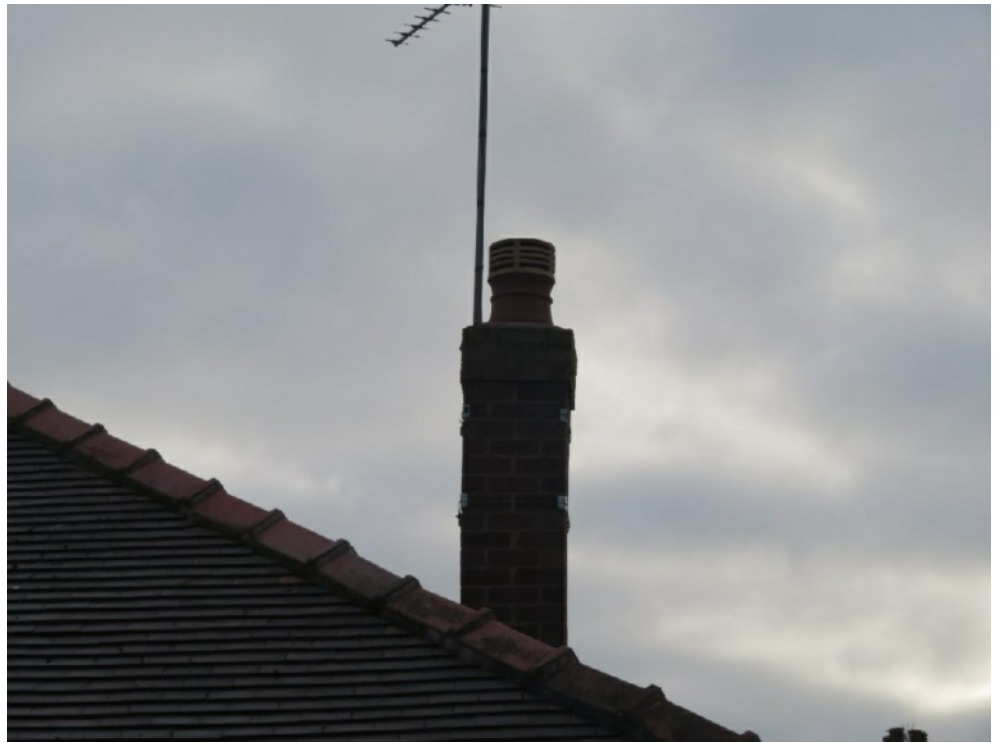
<h3 style="margin: 0;">4.1 Chimney Stacks</h3>	Condition rating	1
Construction & Type and Limitations	<p>The chimney stacks are brick built. The left hand stack has one pot which provides a flue to the gas fire and back boiler in the reception. The flashing at the base of the stacks at the junction with the roof slopes is of lead. The right hand stack has been reduced in height and is capped.</p> <p>The chimneys were examined from ground level with the aid of binoculars for possible defects including undue movement, distortion, chemical or weather related damage, brickwork and pointing damage and other evidence of failure.</p> <p>Due to limited viewing angles it is not possible to see all faces of the chimney stacks from ground level, and it is assumed that the condition of those faces not visible is similar to that of the visible faces.</p>		
Condition	<p>All flashings, brickwork and pointing seen were in a fair condition.</p> <p>The pot has a rain cowl fitted to allow flue gases to escape but prevent vertical rain entering the flue line.</p> <p>When moss builds up on chimney stacks it can eventually damage the bricks, render or pointing with obvious consequences. Therefore stacks will always benefit if the moss is cleaned off.</p> <p>Chimney stacks very often bulge and distort as a result of natural weathering caused by wind-driven rain, sulphate attack and also attacks by condensation and the products of combustion (soot and salts etc). Such problems are very often accentuated by lack of a proper flue lining system. There is a slight lean to the left hand stack. This is not considered to be of concern currently but you should check it for further movement periodically.</p> <p>No significant defects are noted.</p>

Slight lean to chimney stack

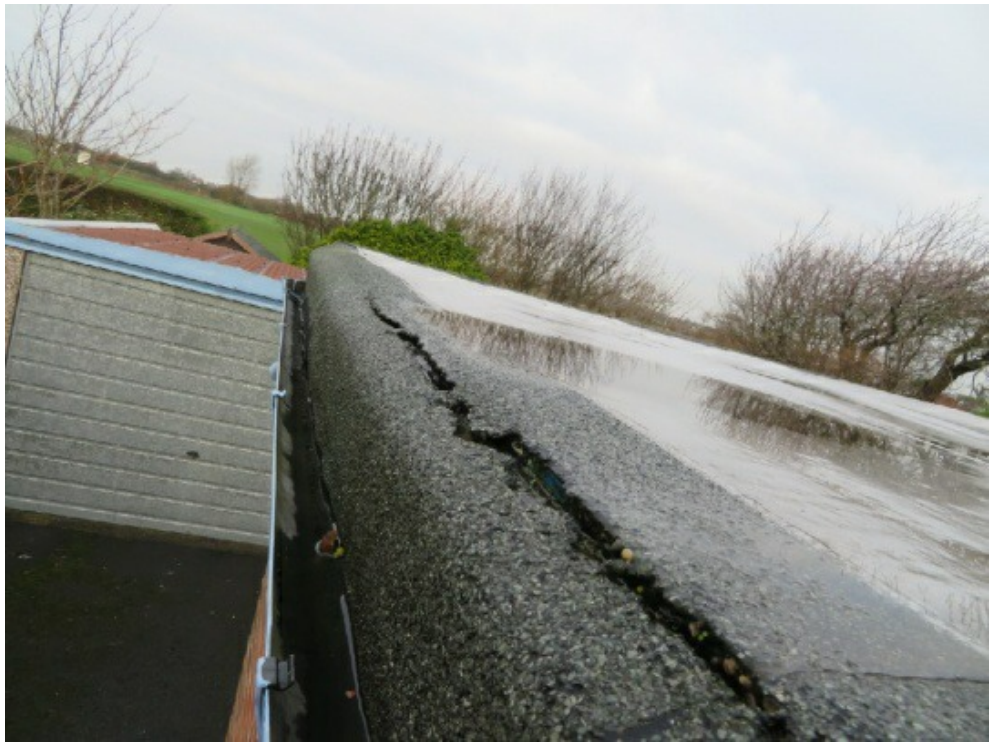
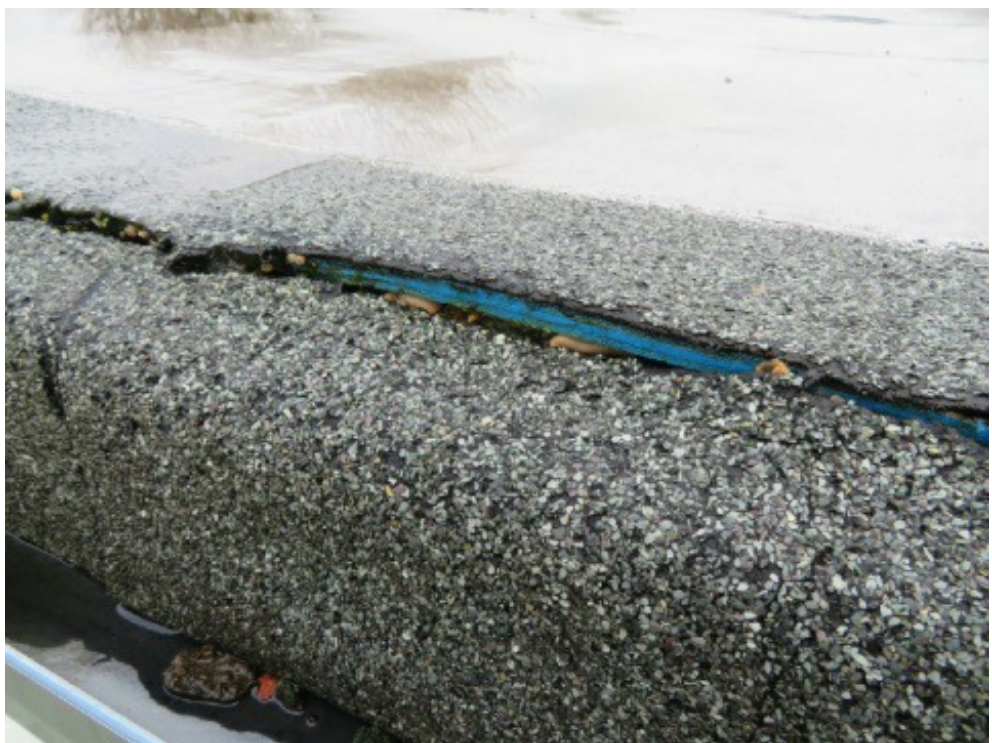
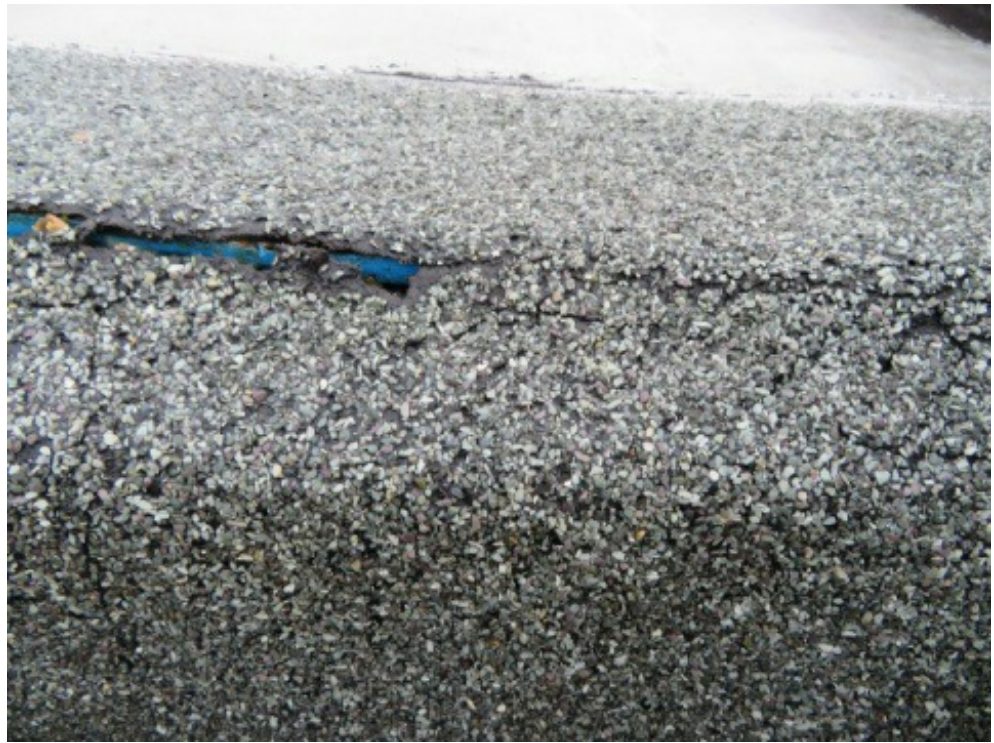
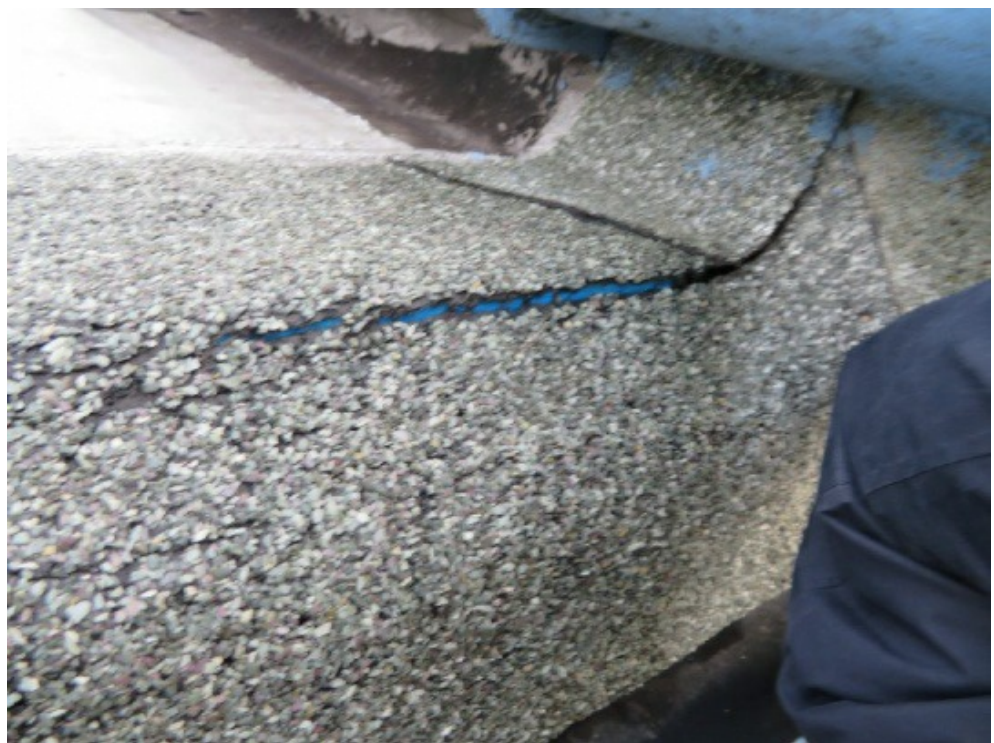
<p>Condition</p>	<p>Pitched Sections All tiles seen were in a fair condition with no evidence of any major failures or defects. The mortar beneath the hip tiles is complete and intact with no evidence of any major weathering. The top line of ridge tiles is even with no evidence of any undue levels of flexing or bowing. If ridge or hip tiles are not bedded in well with mortar they are prone to being lost in high winds. At least one hip tile to this property has an incomplete mortar bed which would benefit from repair.</p> <p>When moss builds up on roofs it can eventually damage the tiles with obvious consequences. Therefore roofs will always benefit if the moss is cleaned off. There is moss to the main roof.</p> <p>Flat Sections The flat roof appeared to be in a poor condition. Ponding was visible and damp was located on the underside. Levels of tears were noted to the felt on the left hand edge, immediately above all the damp found in the sun room, see sections 5.2 and 5.3. We would estimate that the roof covering is past its expected lifespan of 15/20 years. This roof requires a full recover and probably replacement of most of the timbers which appear to have mould growth.</p>

Collapsing flat roof

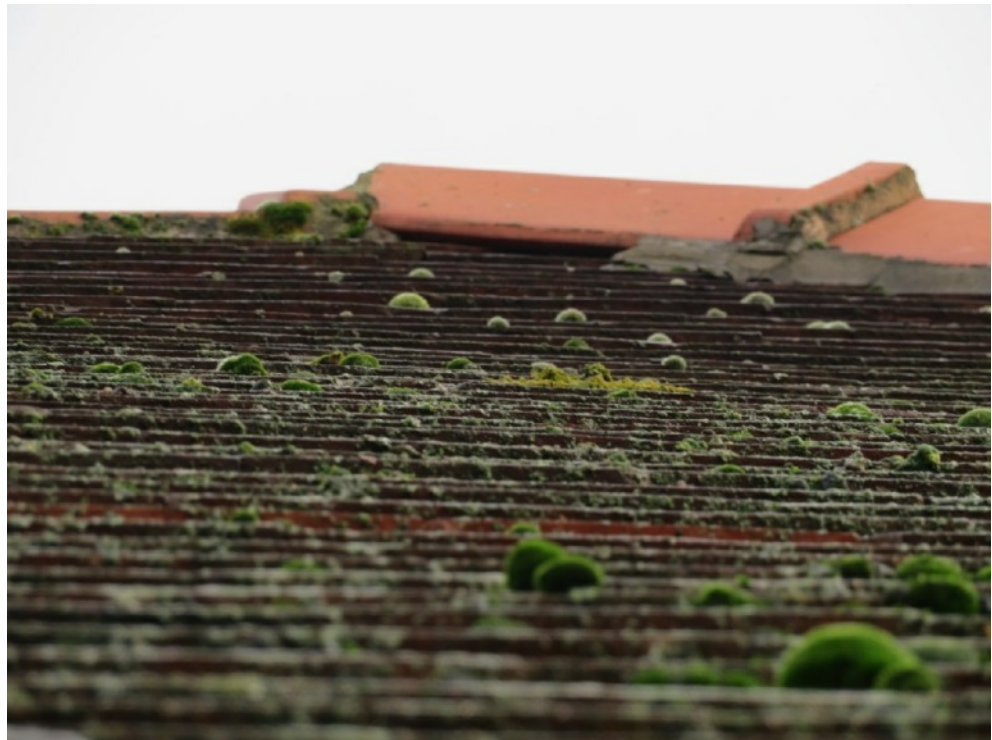
Moss to main roof

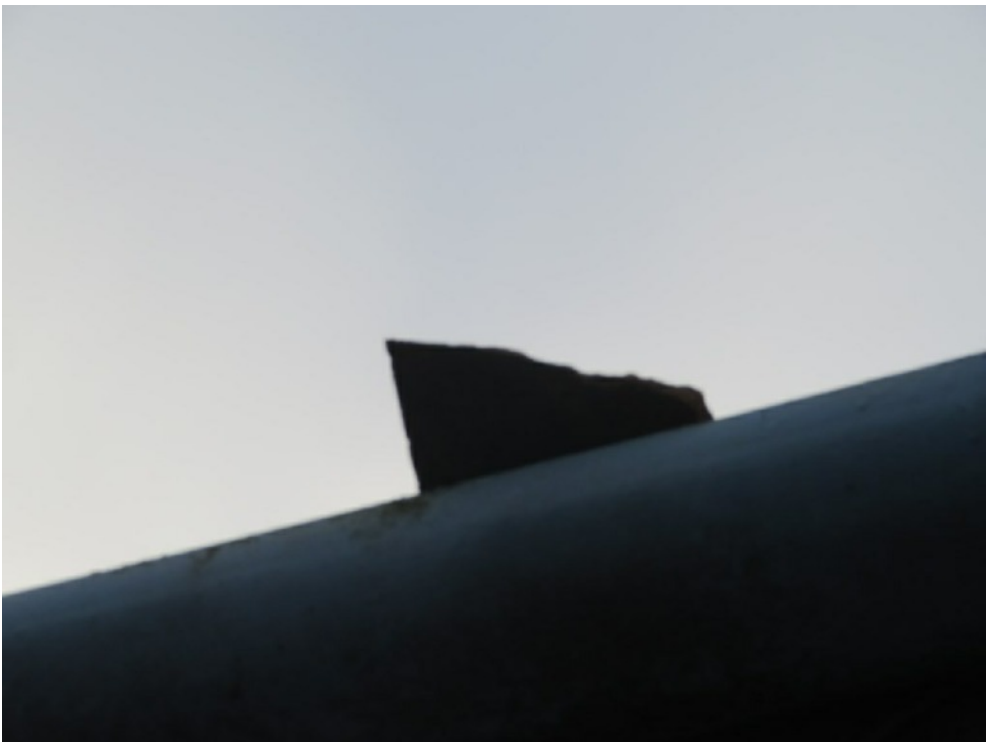
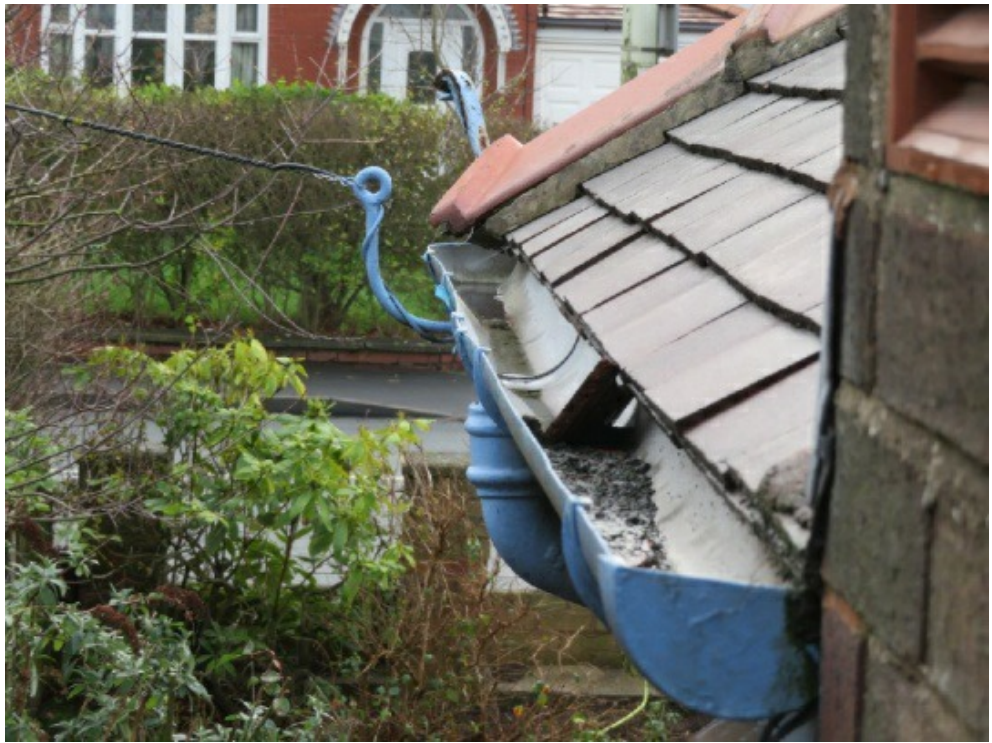
<p>Condition</p>	<p>The gutters are currently in fair condition and alignment, although there is a kink in the gutter at the back of the roof where it meets the flat roof. There were no significant leaks noted but all gutters require examining periodically and clearing of moss, leaves and silt which will inevitably accumulate. There was debris, moss and silt noted to the gutters and cleaning should be undertaken at your earliest convenience.</p> <p>All gulleys were not clear at the time of the survey but with no evidence of any flooding or other drainage problems. However all gulleys require regular clearing of any debris that will accumulate over relatively short periods of time.</p>

<p>Debris in gutter</p>

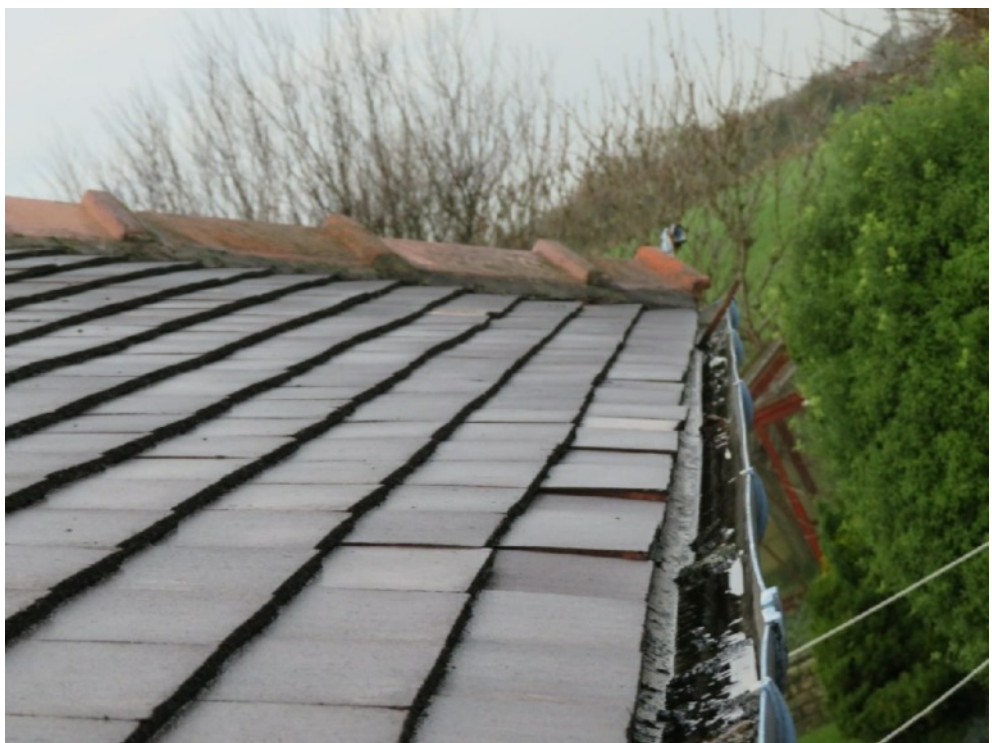
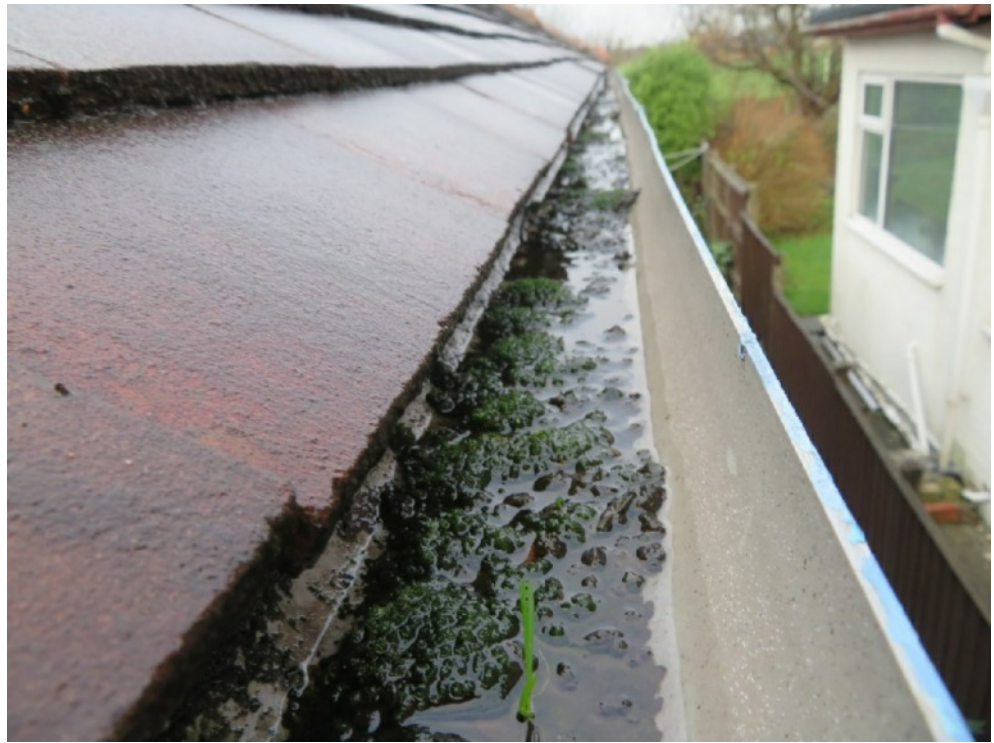
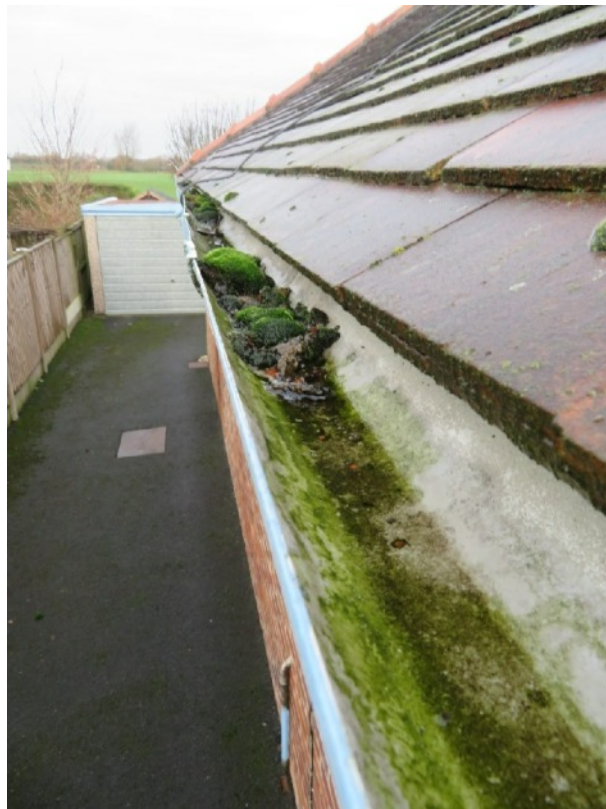
Moss and silt in gutter

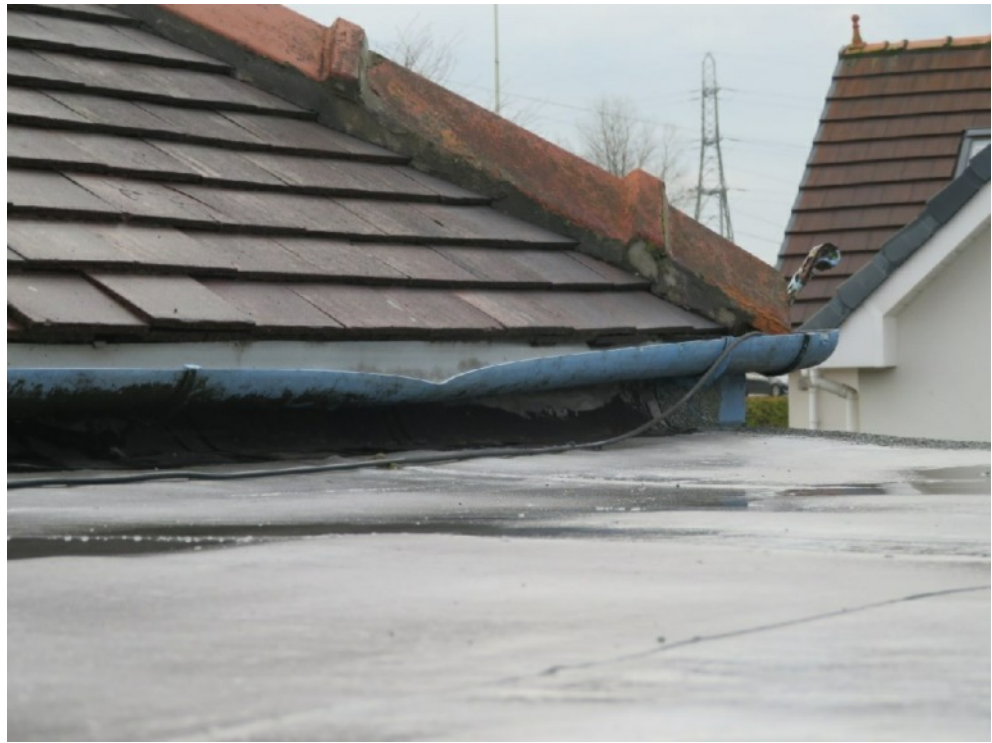
Bent gutter

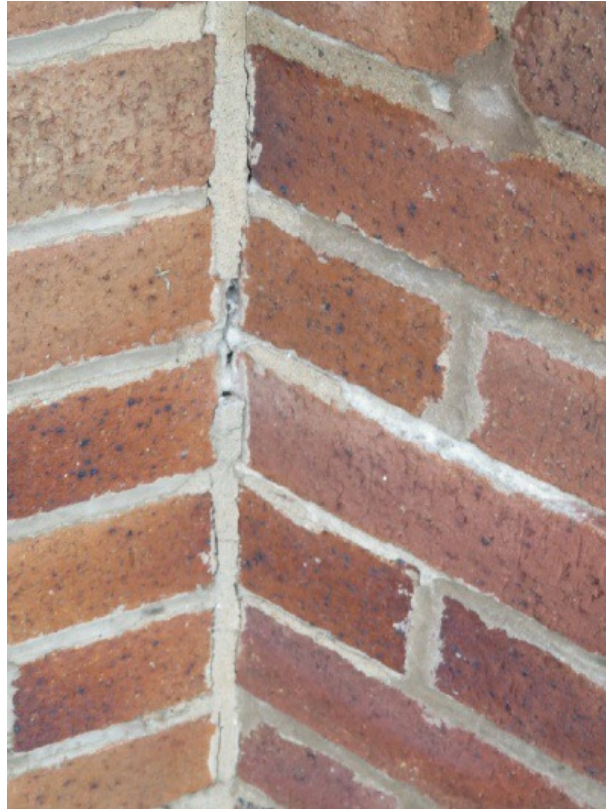
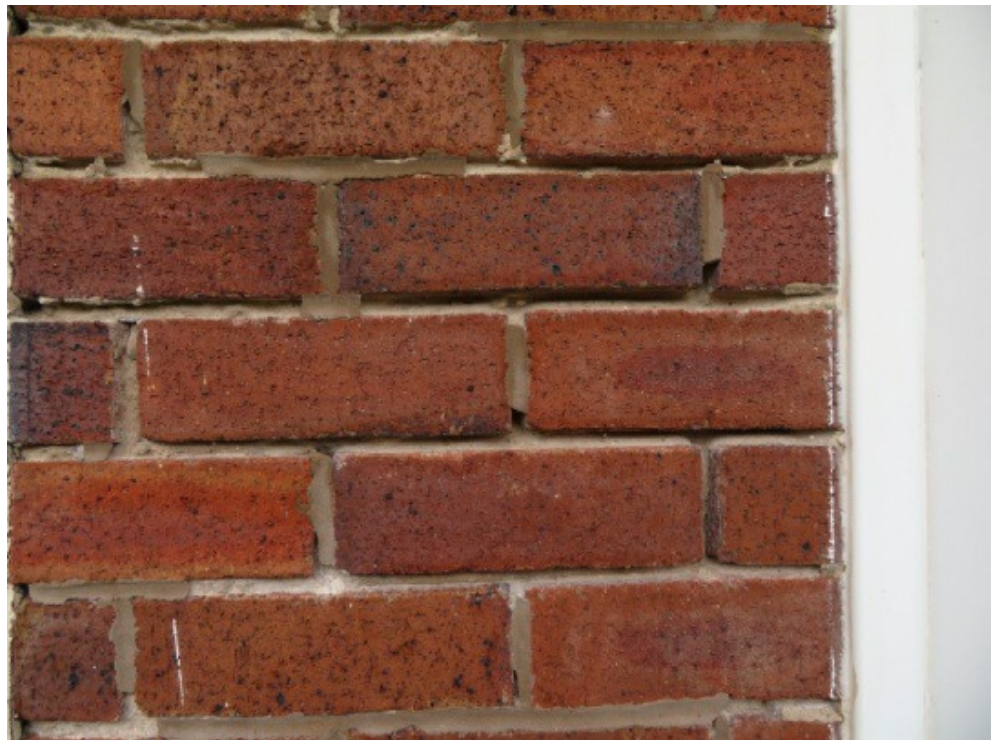
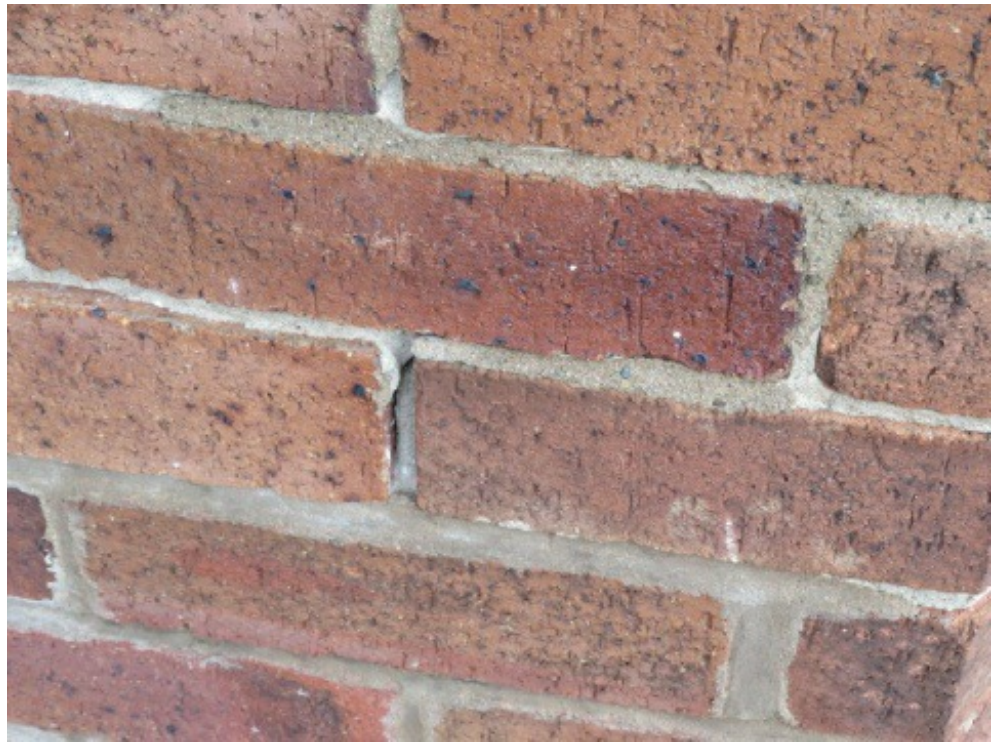
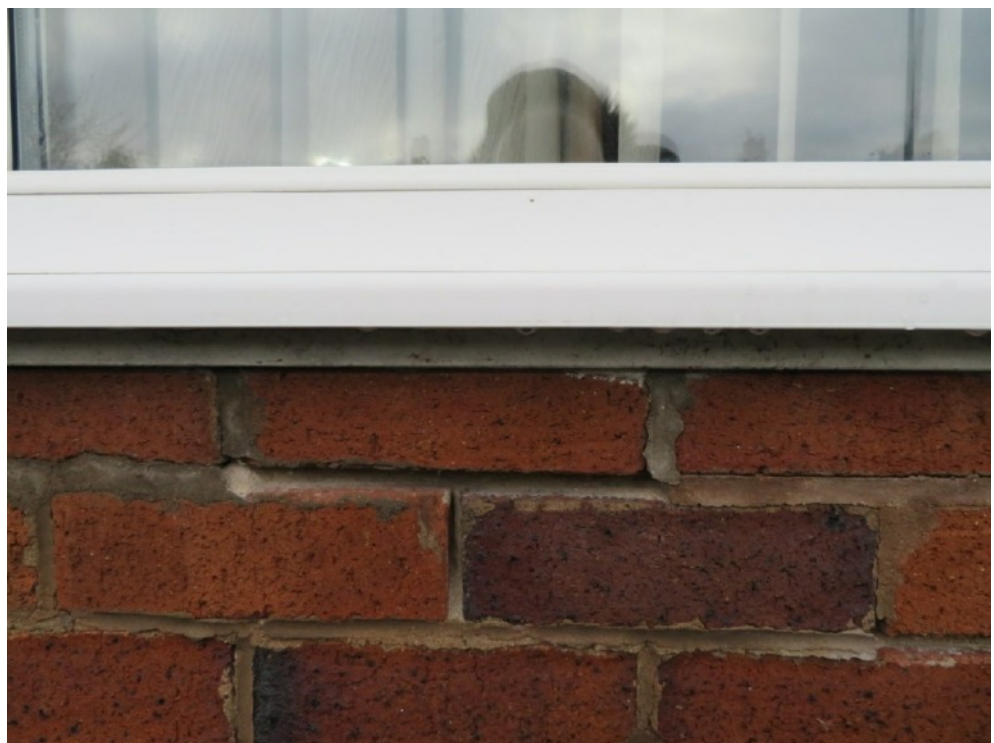
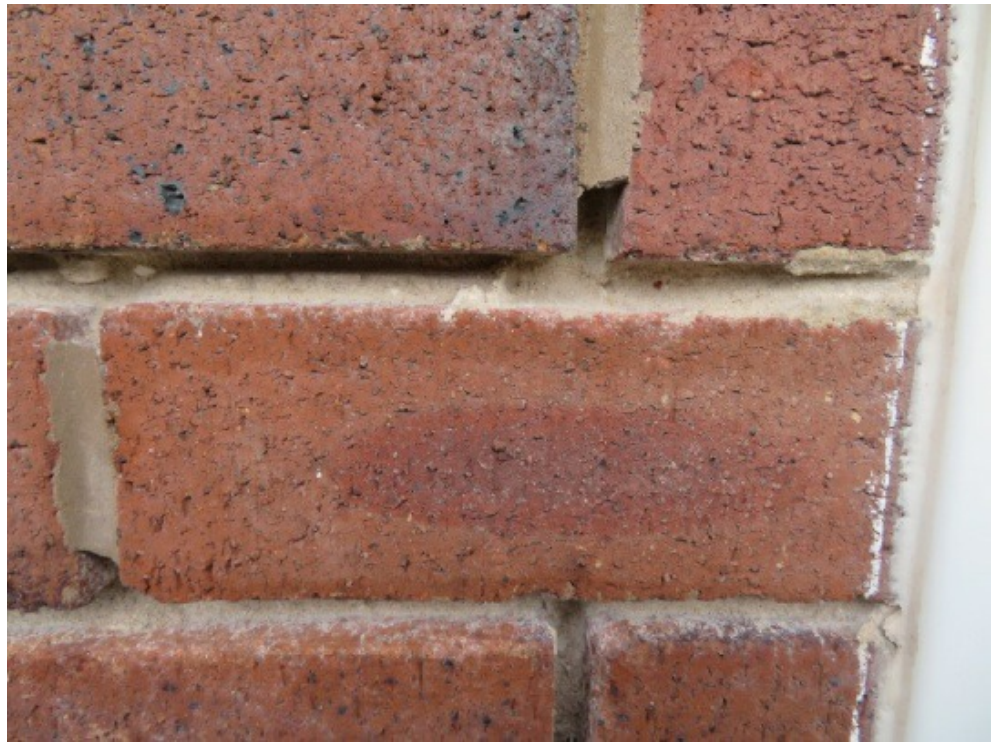
Condition	<p>Foundations I have not undertaken exposure of the foundation structures during the course of my inspection, as this generally proves impractical in a building survey of this type.</p> <p>Movement Stability and vertical alignment is generally satisfactory. Condition and alignment of the brickwork is fair. There is no evidence of any significant bulges or major structural cracks. There is no evidence of foundation cracking at ground level.</p> <p>The British Geological website indicates the ground is of mudstone which is a solid base and hence not liable to move adversely. No other evidence of movement was seen other than that which would normally be expected in any building of this age.</p> <p>Other Aspects The outside walls are brick-faced and of cavity construction (this means that it was built with an air gap between the inside and outside faces). The cavity has been insulated for which there should be an insurance backed guarantee. (Note: I have raised this in Section 3.1 for your conveyancer/solicitor to check).</p> <p>Cavity Wall Insulation can sometimes cause problems by allowing water to cross the cavity and cause damp on the inside skin of the wall. I saw possible evidence of this at the time of my inspection (though it is not within the scope of the survey to drill a hole in the wall to look inside the cavity for possible problems).</p> <p>Significant areas of the pointing (the mortar joints between the brickwork) of this front wall are incomplete and possibly allowing damp penetration to get into the insulation and across the cavity. This is considered serious and in need of urgent repair.</p> <p>Air bricks are visible in the walls. These are present to ensure adequate ventilation to the property. It is essential that a free flow of air is maintained through the air bricks. At the time of the survey most airbricks were obstructed.</p> <p>There is damp staining to the left hand wall of the extension from the collapsed flat roof, which is probably allowing water penetration into the insulation and hence internally.</p>

Eroded pointing

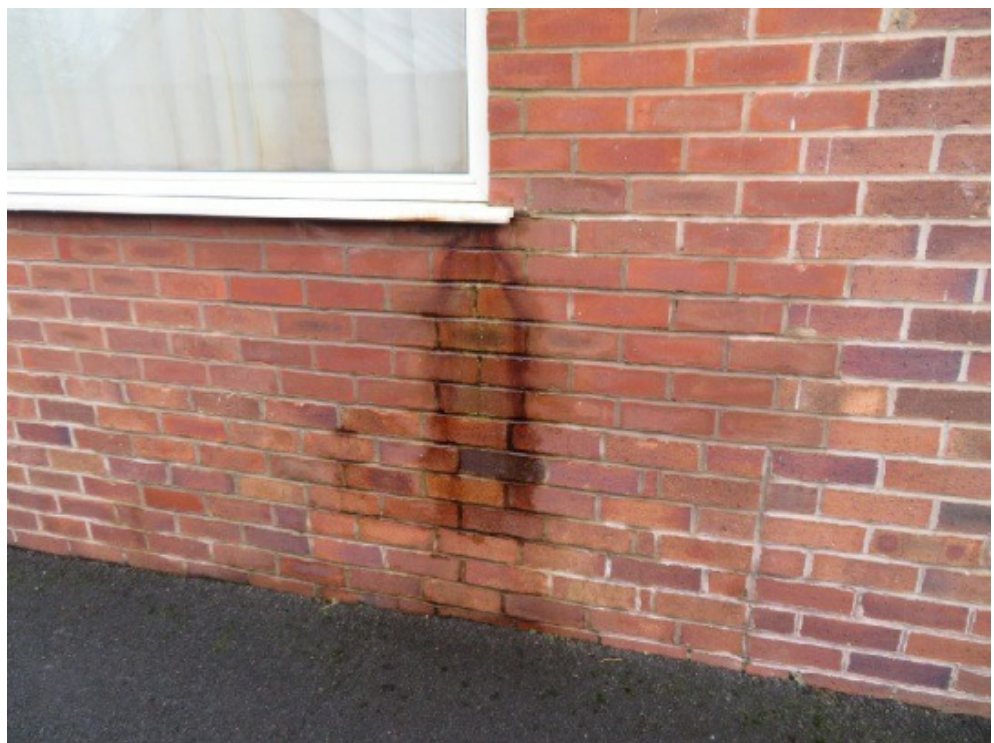
Damp staining to external wall below flat roof

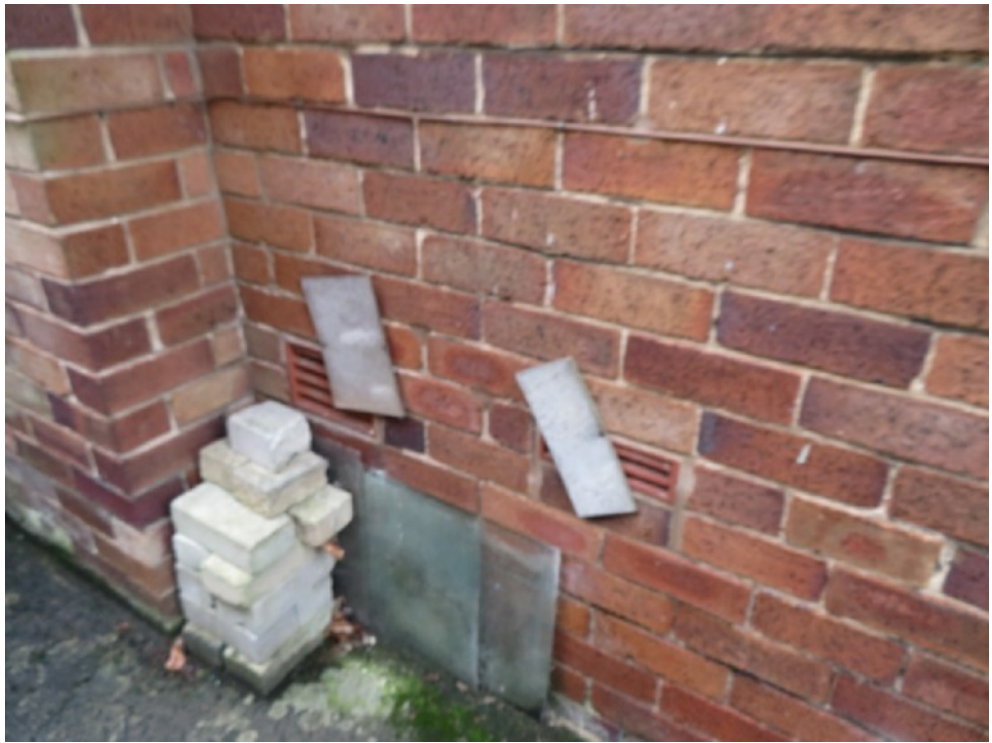
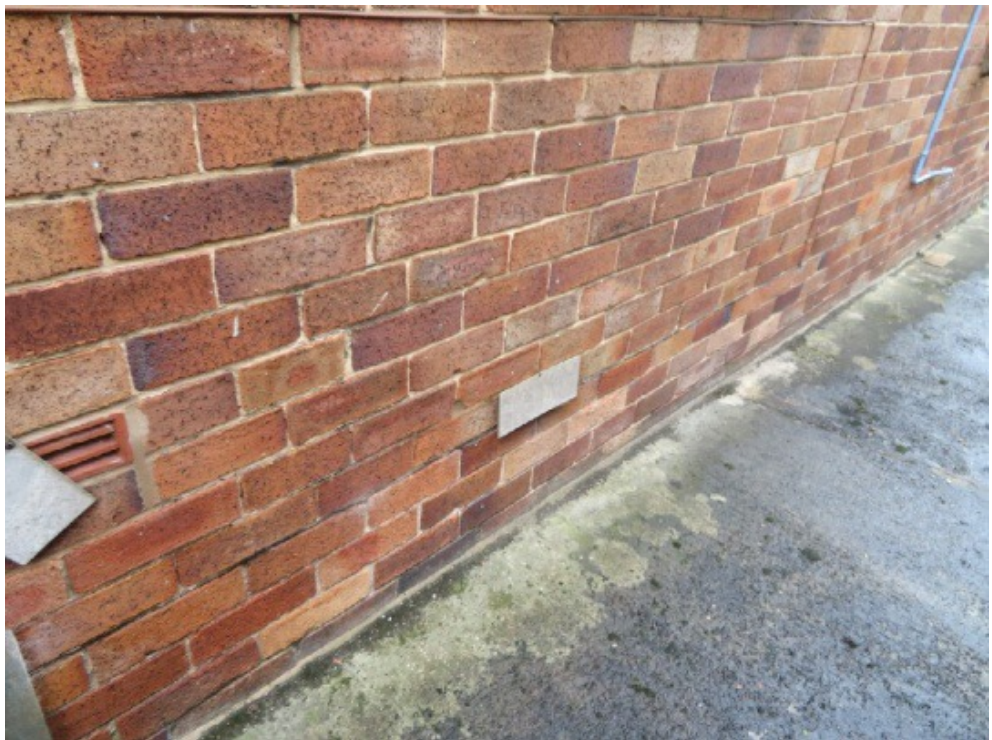
Vents blocked

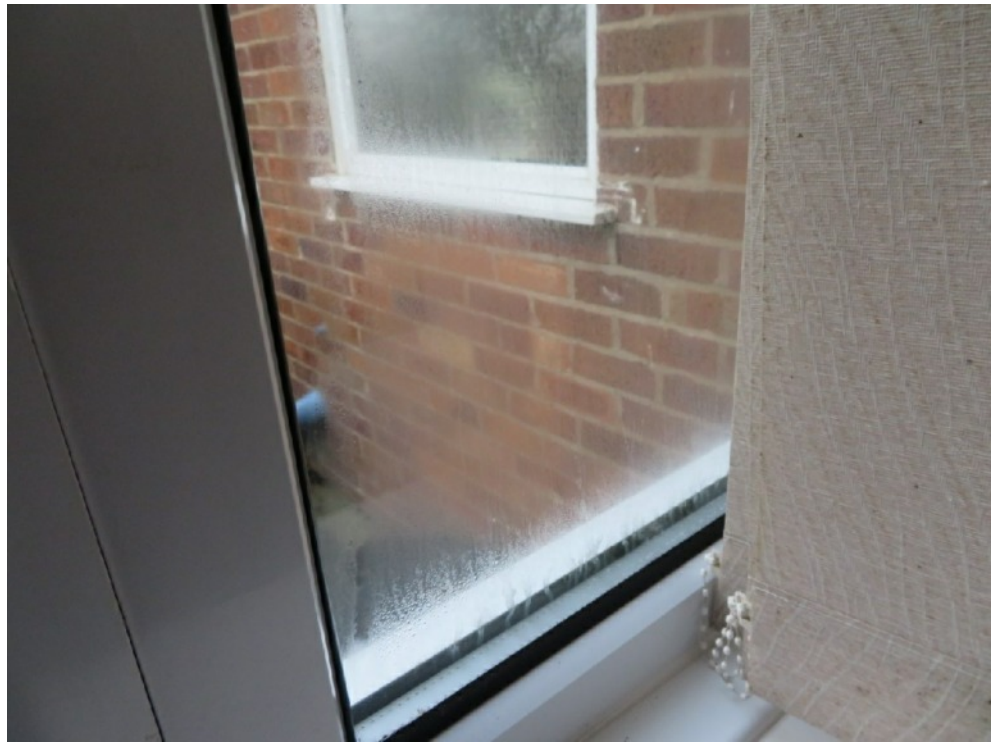
4.5 Windows and External Doors	Condition rating	2
Construction & Type and Limitations	<p>The front door is of timber construction. The door from the extension is UPVC framed with a double glazed panel.</p> <p>All of the windows are double glazed with UPVC frames.</p> <p>All external doors were checked for normal operation and signs of failure or damage.</p> <p>Windows were examined for general signs of degradation and failure including misted double glazing units and worn seals. Opening was attempted to all windows and all checked for normal operation. The condensation levels in certain weather conditions can disguise evidence of misted double glazed units.</p>		
Condition	<p>Doors No significant defects were noted, all doors operated effectively on opening and closure. All locks functioned correctly.</p> <p>Windows Internal sill heights were compliant with the current legal safety limits, all handles operated satisfactorily, except to the bathroom which was stuck and could not be opened.</p> <p>Under normal circumstances sealed double glazed units can be expected to last around 20 years before the seals begin to fail. This can occur more quickly where windows are in exposed or vulnerable situations. It is estimated that most of the windows currently fitted are over 16 years old and there is evidence of failures.</p> <p>The frames are usually fixed into the brickwork and flexible sealant or mortar is added to the perimeter as a weatherproof seal. Occasionally this may crack or shrink and allow windblown rain to penetrate. These seals therefore should be regularly checked for weather tightness. I noted at least one shrunken seal.</p>

Misted window (failed seal)

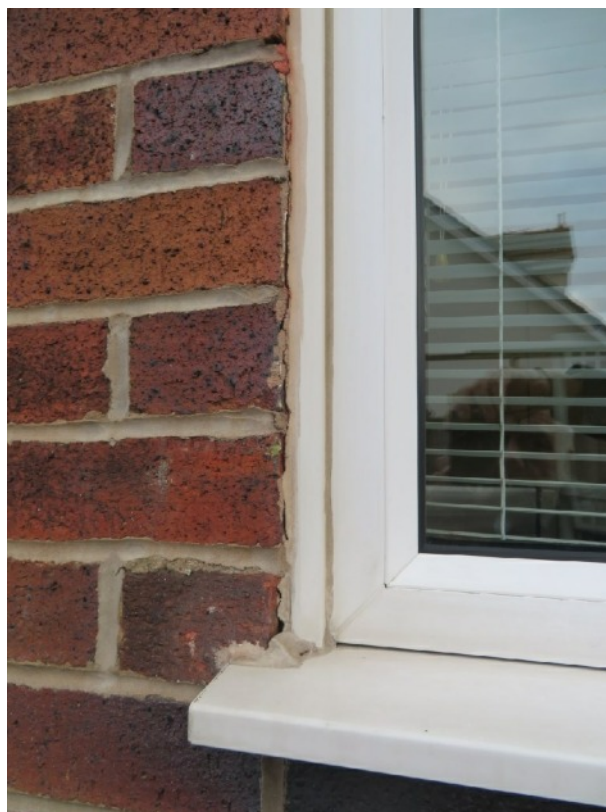
Shrunken seals around window frames

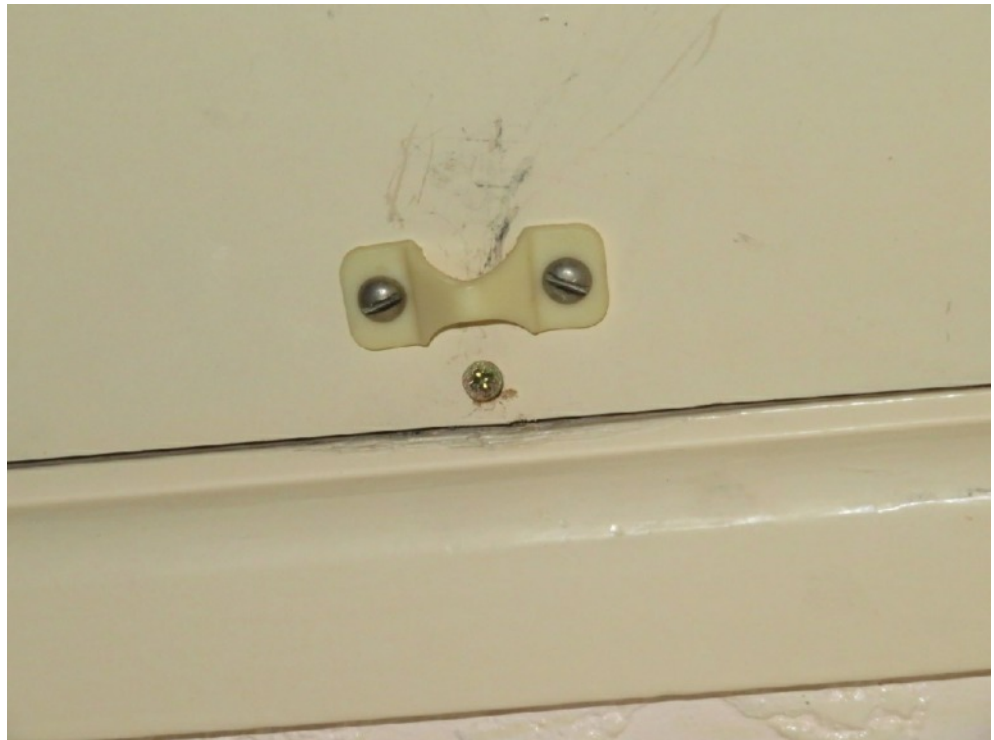
Screw holding loft hatch in place
