HOME BUYER SURVEY

REF 3468

The format of this Mi HOME BUYER SURVEY is consistent with the guidance note requirements for a Survey Level 2 as defined by RICS Surveys of Residential Property 3rd edition May 2016

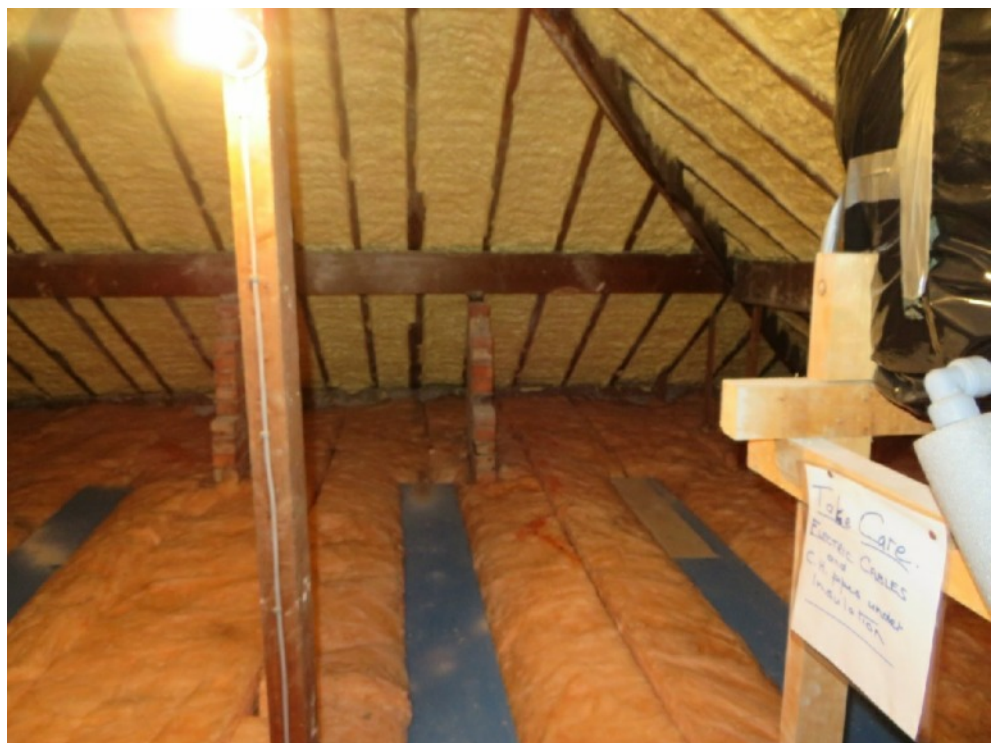
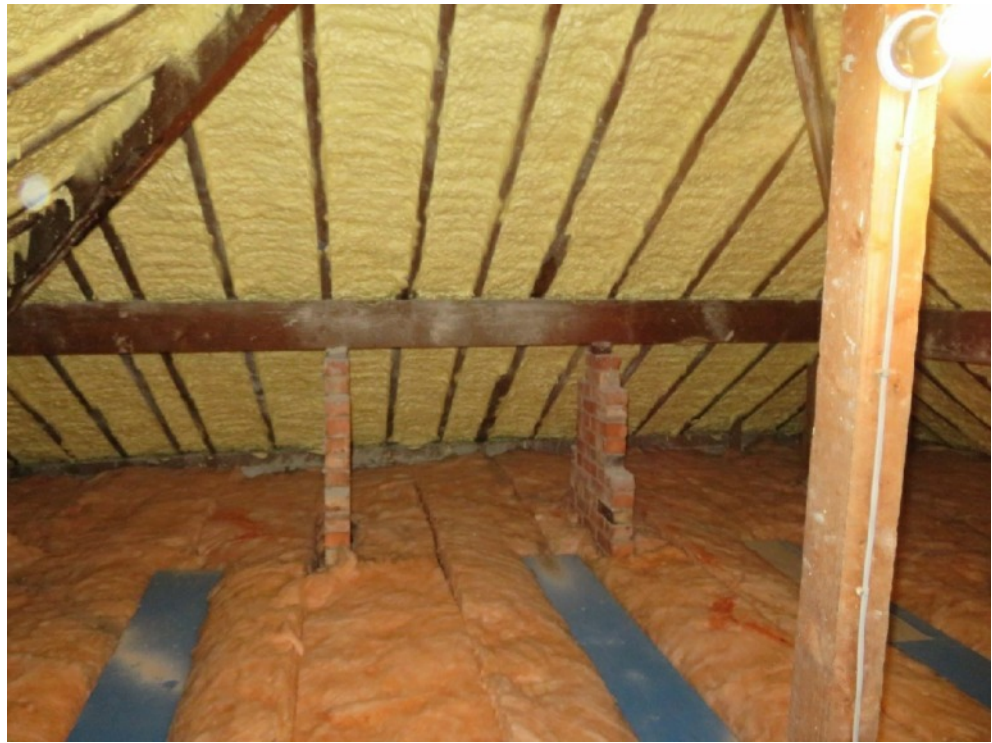
<p>Condition</p>	<p>The roof structure appeared to be in a good condition with reasonable quality timbers throughout. The rafters, purlins and strut timbers are complete with no evidence of any undue stress or cracking. The loft hatch latch is not operating correctly and it is therefore currently held in place with a screw. The bitumen undercovering (secondary waterproof covering) is hidden by the addition of spray foam.</p> <p>Sprayed-on foam roof under coatings might seem, to the uninitiated, like a good idea. However, coating the underside of a slated or tiled roof will compromise two vital attributes: the roof's ability to move and to breathe.</p> <p>Traditional pitched roofs are constructed from a timber frame, which will expand and contract in response to changes in moisture and temperature. Tiles are individually nailed to battens, and free to move relative to each other, in order to accommodate this movement. If they become bound together by the rigidity of the foam, this could set up stresses which might damage the verges, the ridges, or the individual tiles.</p> <p>The chief disadvantage, however, is the reduction in breatheability, which might lead to wood rot in the roof timbers. The insulating properties of the foam will mean that in cold weather the battens and rafters - deprived of the slight warming effect of heat escaping from below - will be nearer dew point temperature, and hence more likely to become damp from condensation. Once moisture has condensed out on the timbers, the enclosing effect of the foam means that it is likely to be trapped there for extended periods. For this reason, foam under coatings contravene the requirements of the Building Regulations, which insist on a clear ventilated air gap between roof insulation and the tile covering.</p> <p>It is also reported that although foam spraying is often promoted as a cheap solution to roof problems, it can sometimes cost more than re-roofing using traditional methods. This is compounded by the fact that when the time comes to strip the roof off and do the job properly, it will be found that the foam sticks so tightly to the tiles that they will not be re-usable, and will have to be dumped.</p> <p>The National Federation of Roofing Contractors does not endorse foam undercoating, nor does it recognise it as a discipline of the industry.</p> <p>If the valuer spots the spray foam he is likely to down value the property, which will affect any mortgage application you may undertake.</p> <p>The roof space is laid with approximately 250mm of wool type insulation at joist level. This is close to the current recommendation of 270mm for maximum energy efficiency.</p> <p>As mentioned earlier, in 4.6, the soffit boards [panels that link the gutter boards to the walls] does not have ventilation grilles to supply cross ventilation to the roof space. Without adequate ventilation condensation can form on the underside of the roof surface and hence introduce dampness to the roof space, which will be exacerbated by the spray foam.</p>

Spray foam between rafters

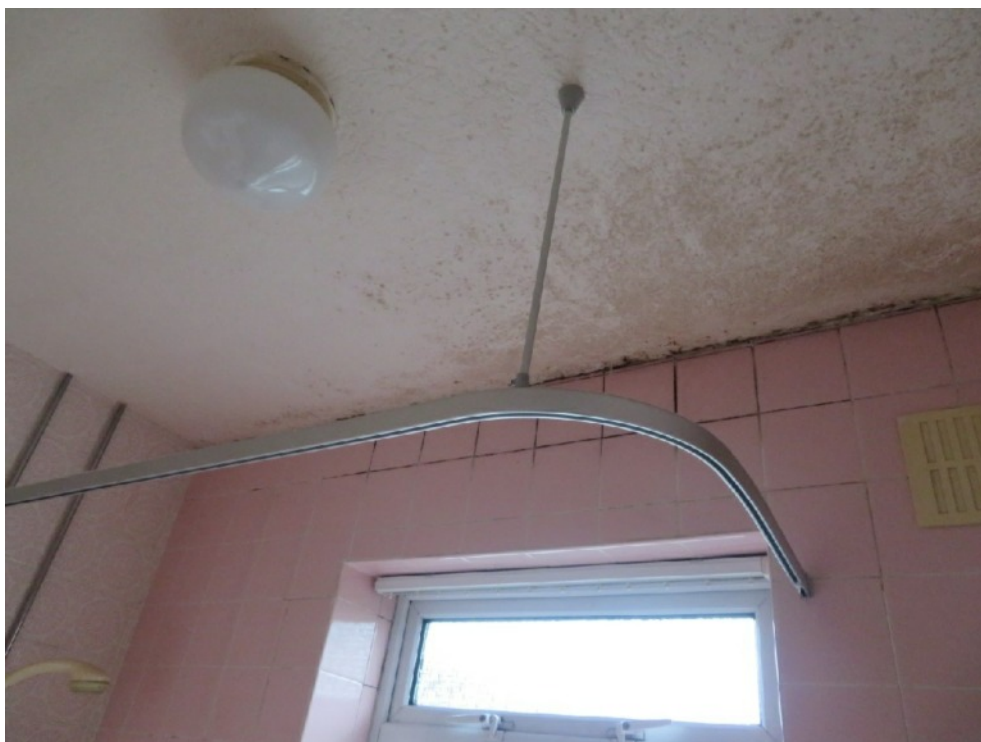
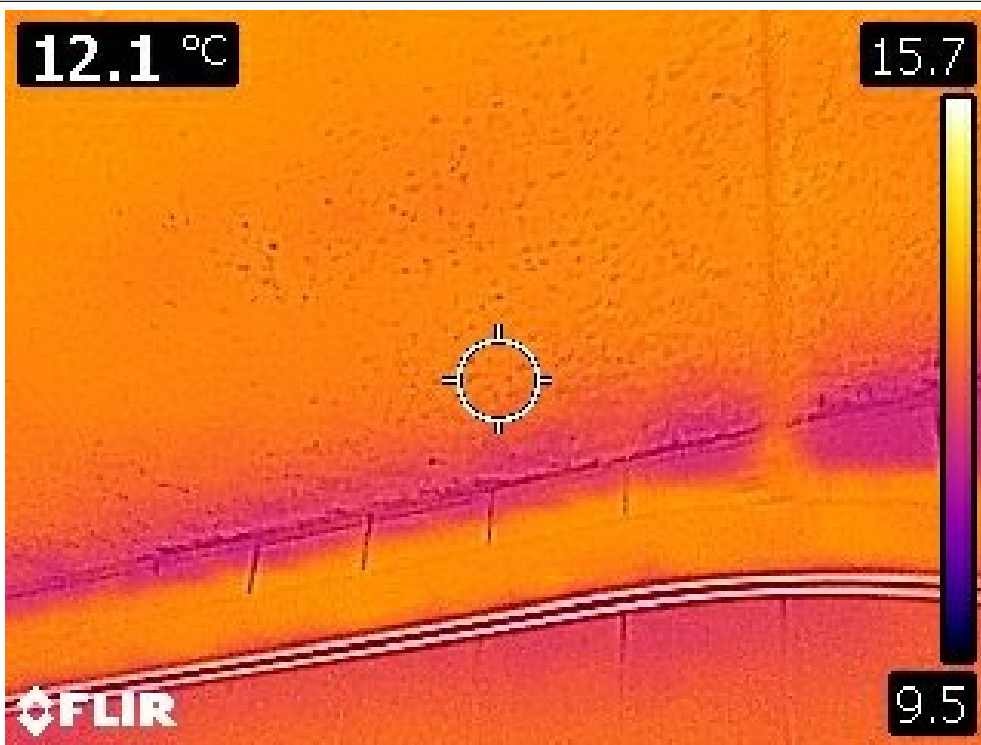
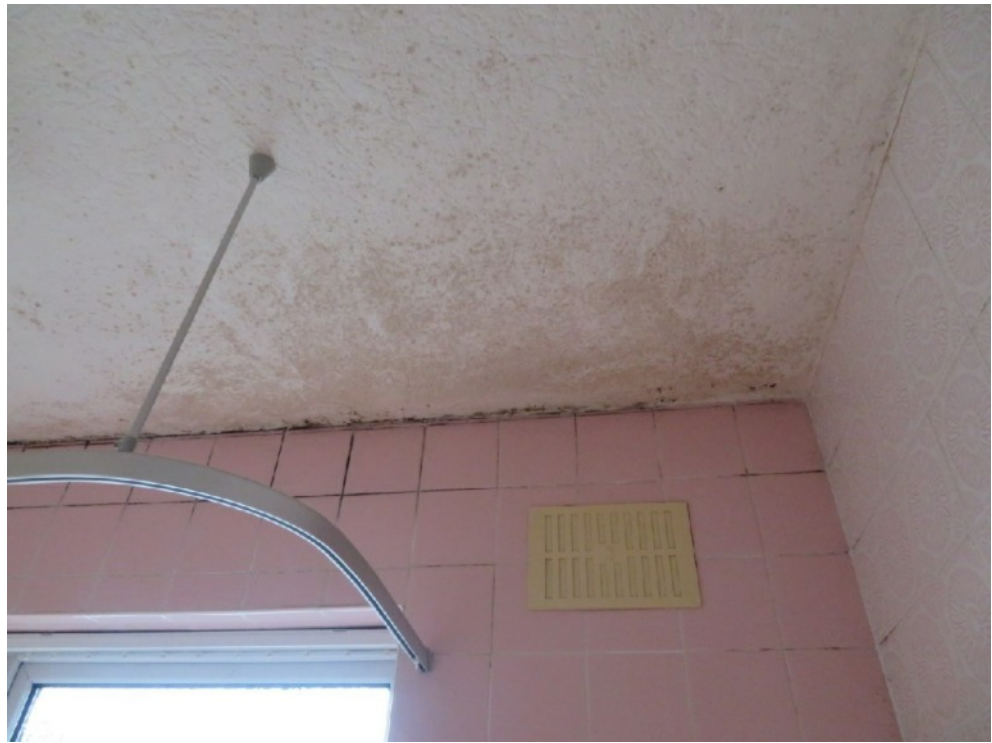
Damp stained ceiling in bathroom

Thermal image of damp stained ceiling in bathroom

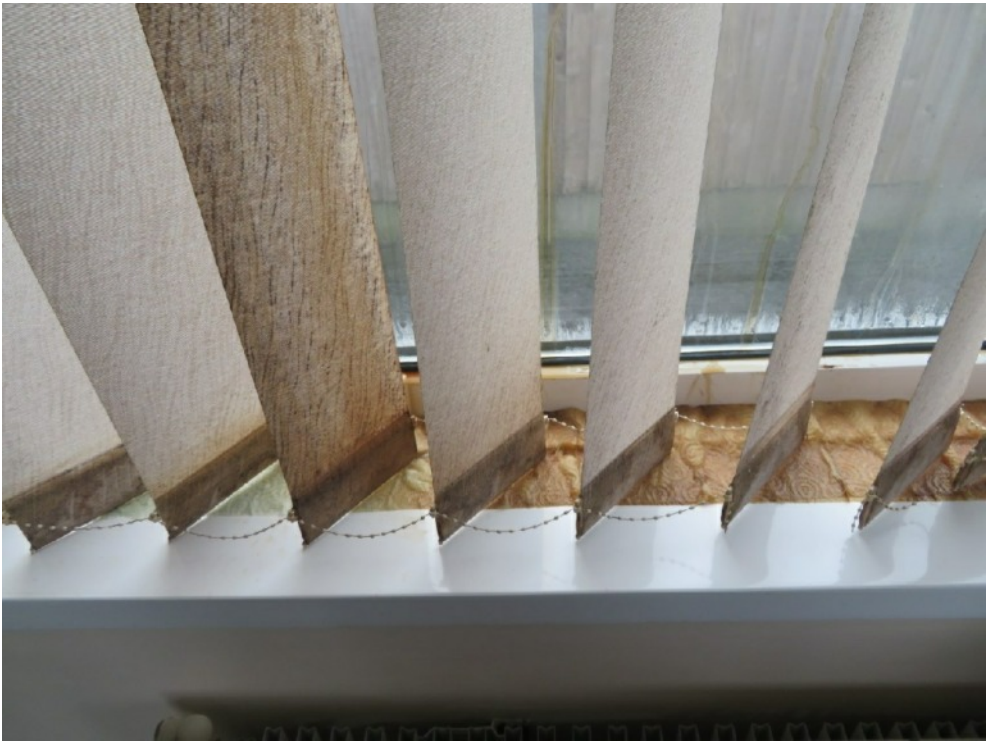
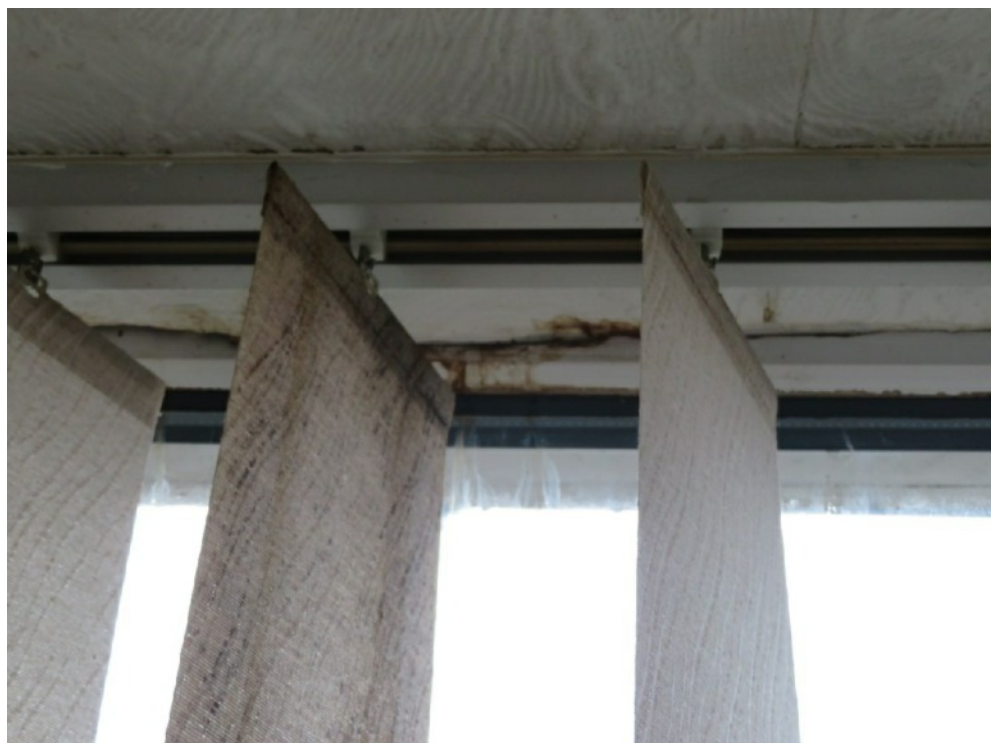
<p style="text-align: center;">Leak from flat roof</p>

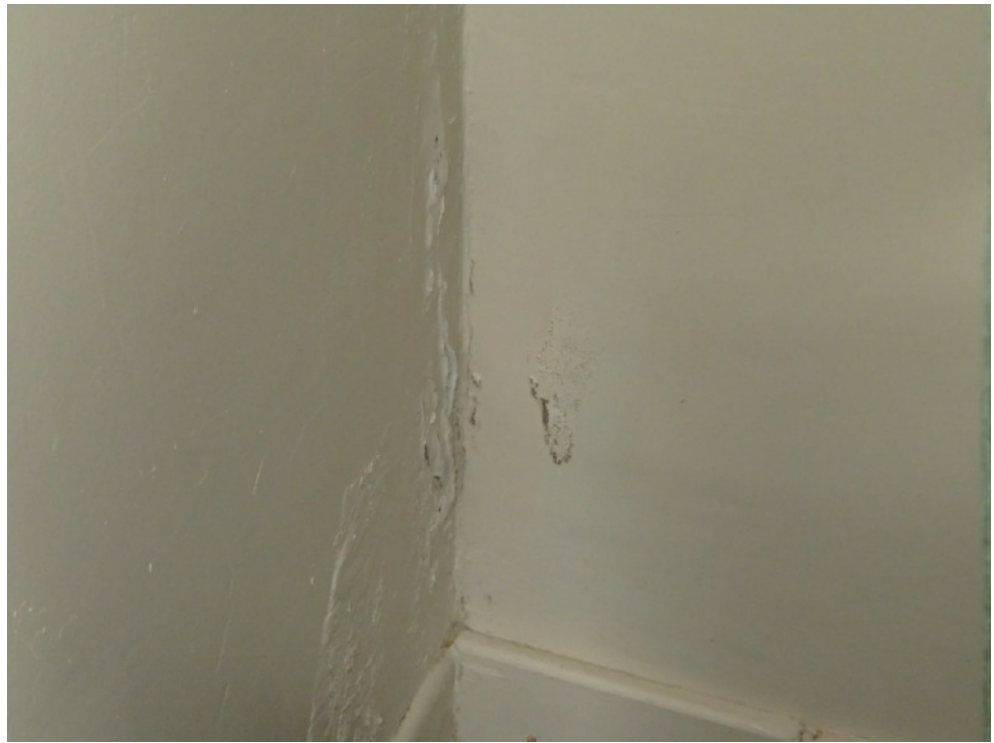
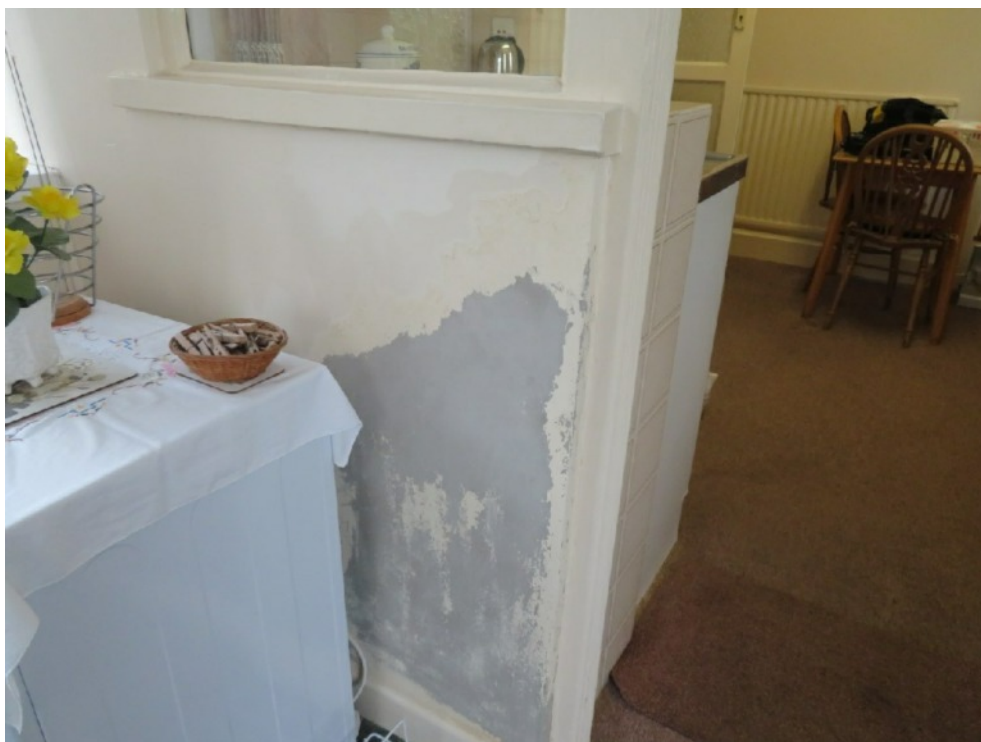
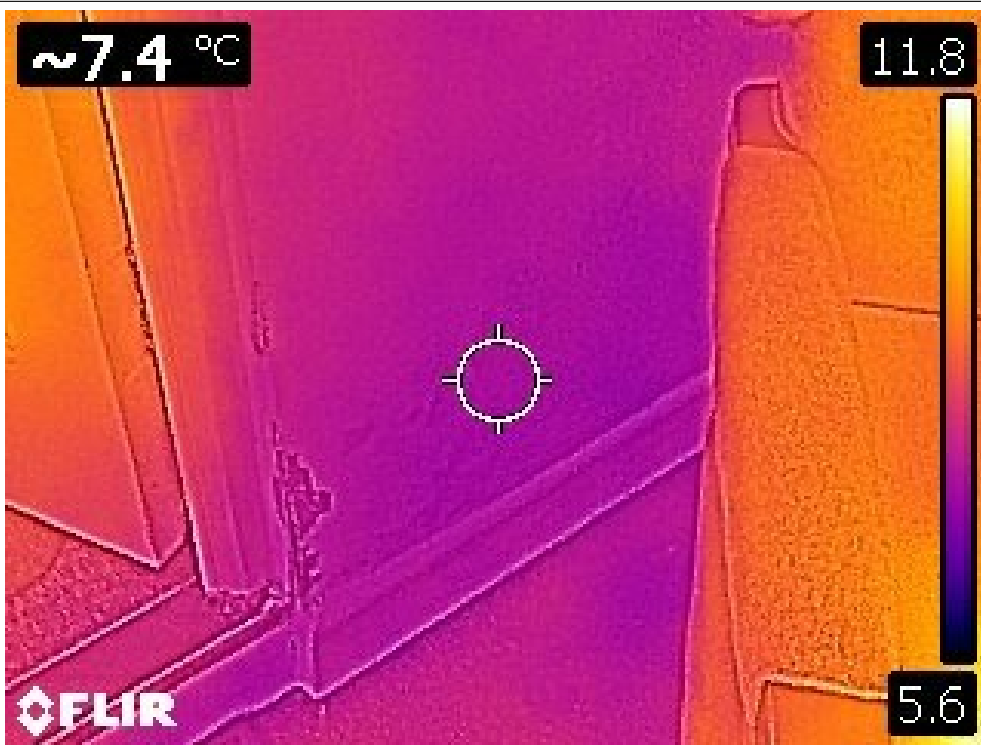
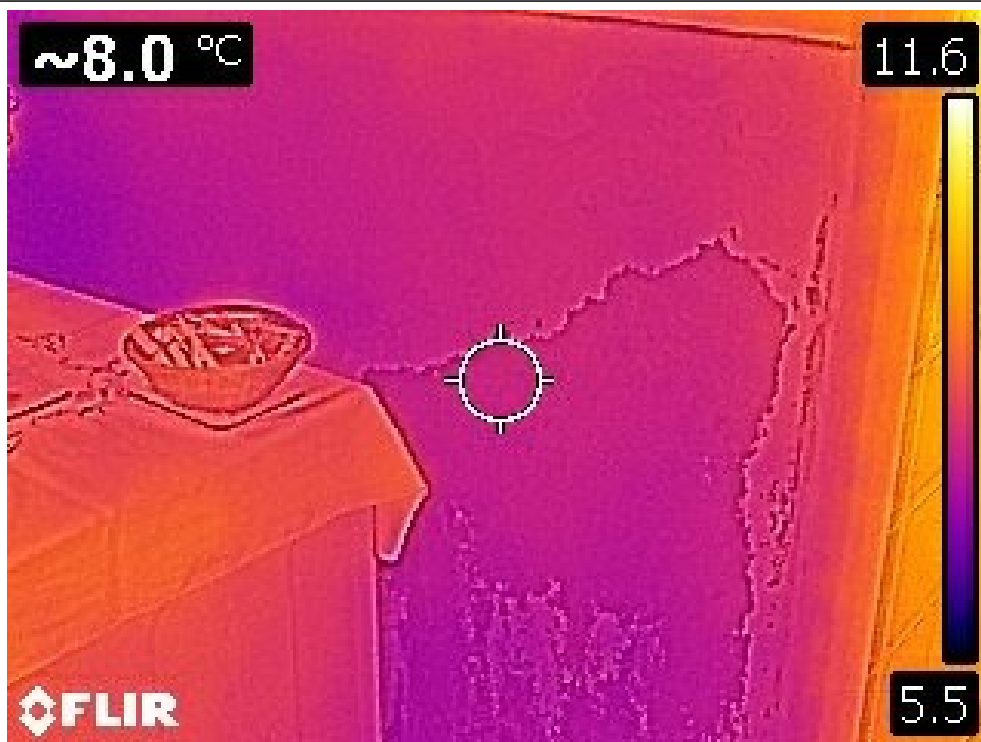
<p>Condition</p>	<p>All internal walls have been maintained and all surfaces are presented in a fair decorative order.</p> <p>There was dampness recorded to the internal walls on the day of inspection. However this does not preclude that its further presence may be hidden behind furniture or recent Decorations. The external vents should have their obstructions removed to improve ventilation and reduce condensation levels.</p> <p>Damp was found to the internal walls to the sun room which I would suggest is caused by the flat roof defects above this room as detailed in section 4.2. There is also high level evidence of damp in the kitchen adjacent to the defect in the roof.</p> <p>Damp was also noted to the bay windows in the reception and bedroom one. Some of this could be condensation, but as mentioned in section 4.4 there is eroded pointing and this is possibly allowing the cavity insulation to become wet and then transferring the damp internally. It may be that you will have to remove the cavity wall insulation to allow the walls to dry out after repointing has been carried out.</p>

Damp stained wall in sun room

Thermal image of damp stained sunroom wall

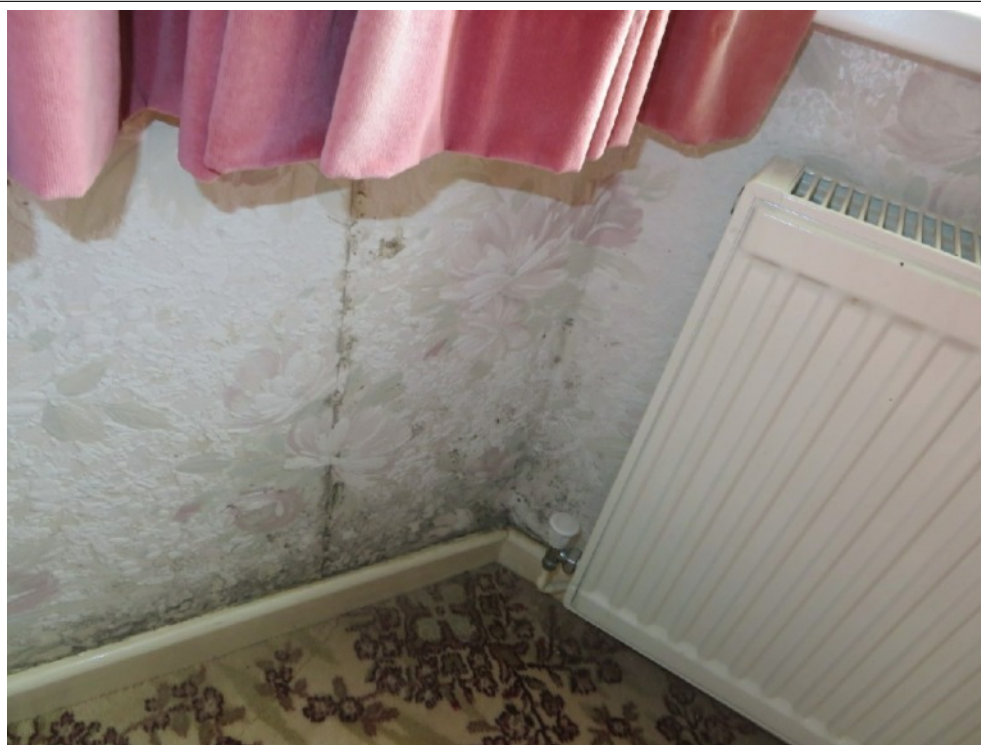
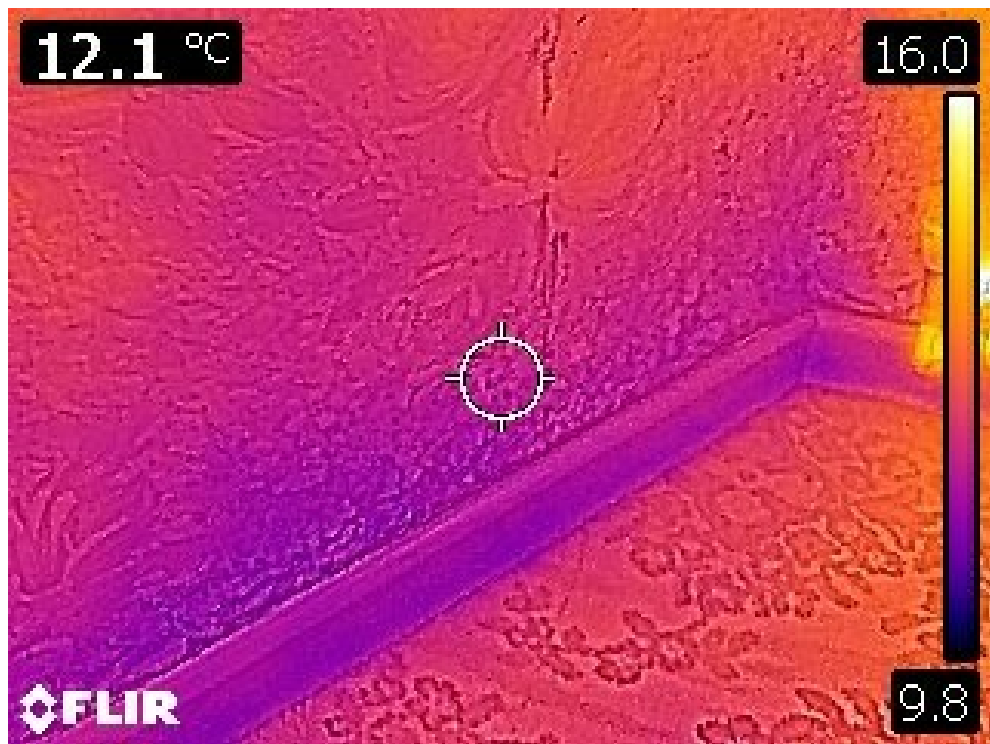
Damp stained wall in bedroom one

Thermal image of damp stained bedroom one wall

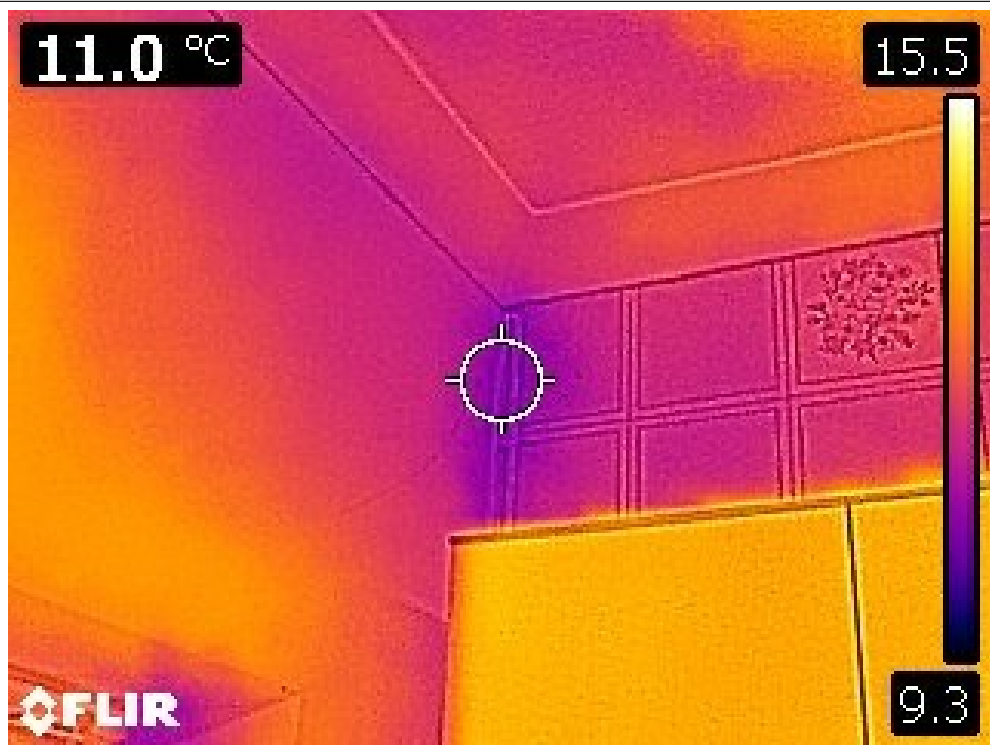
Thermal image of damp staining in kitchen

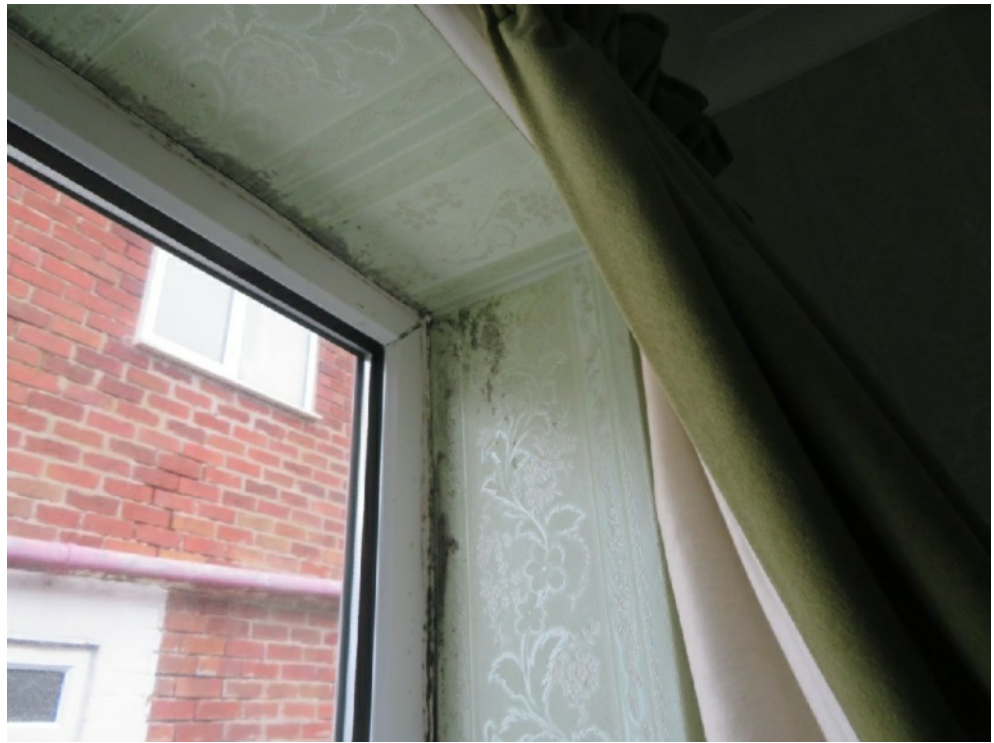
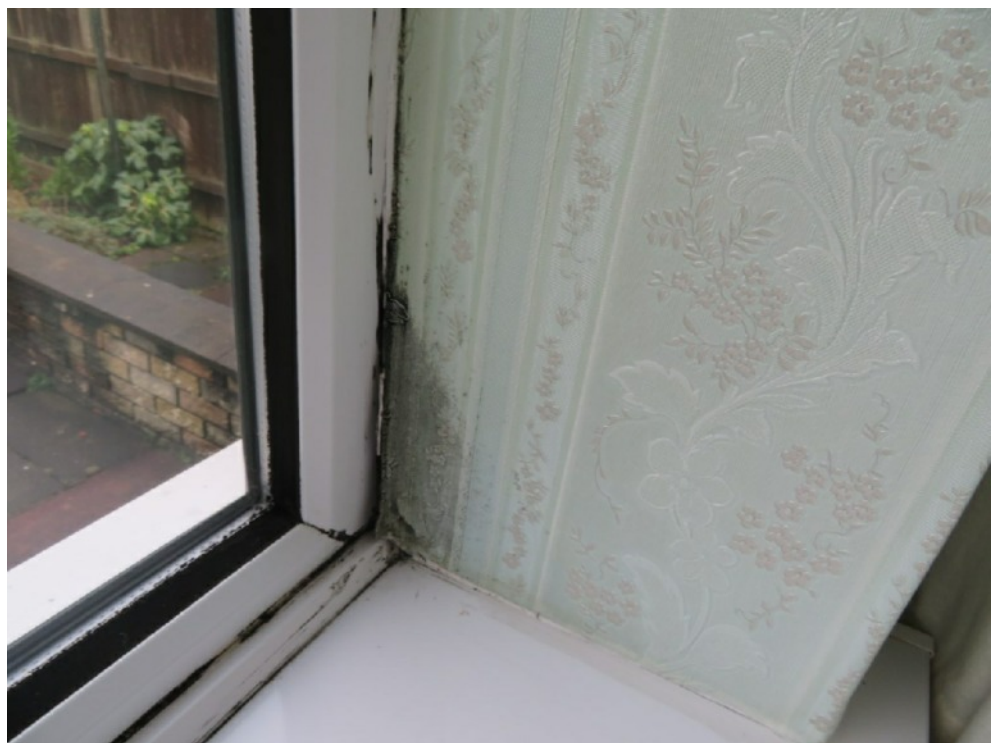
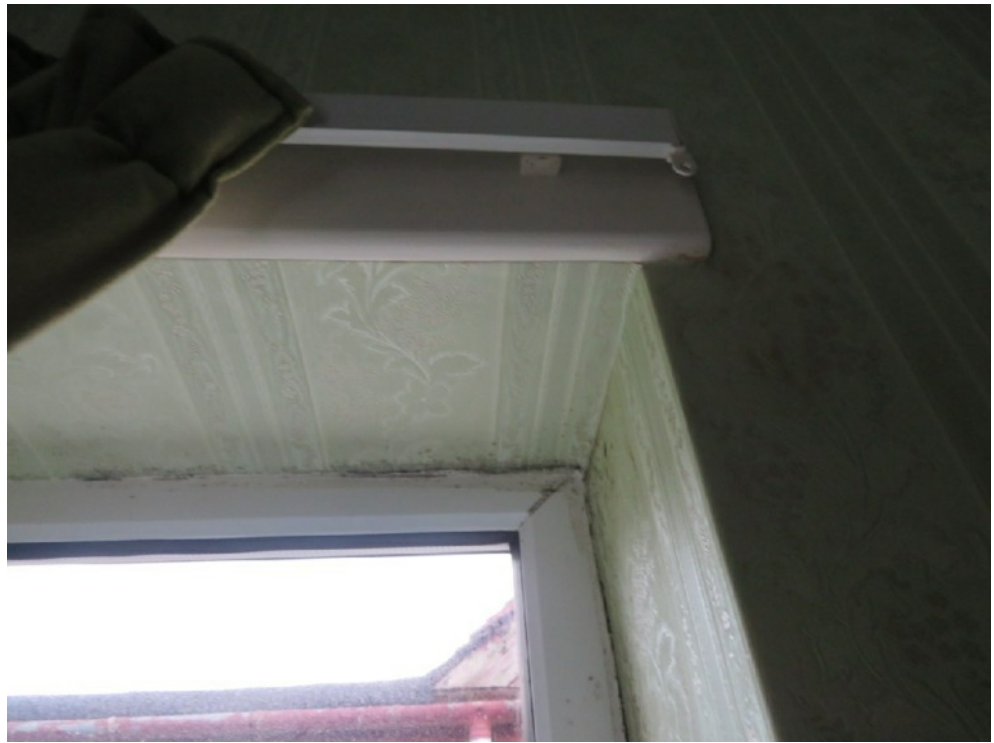
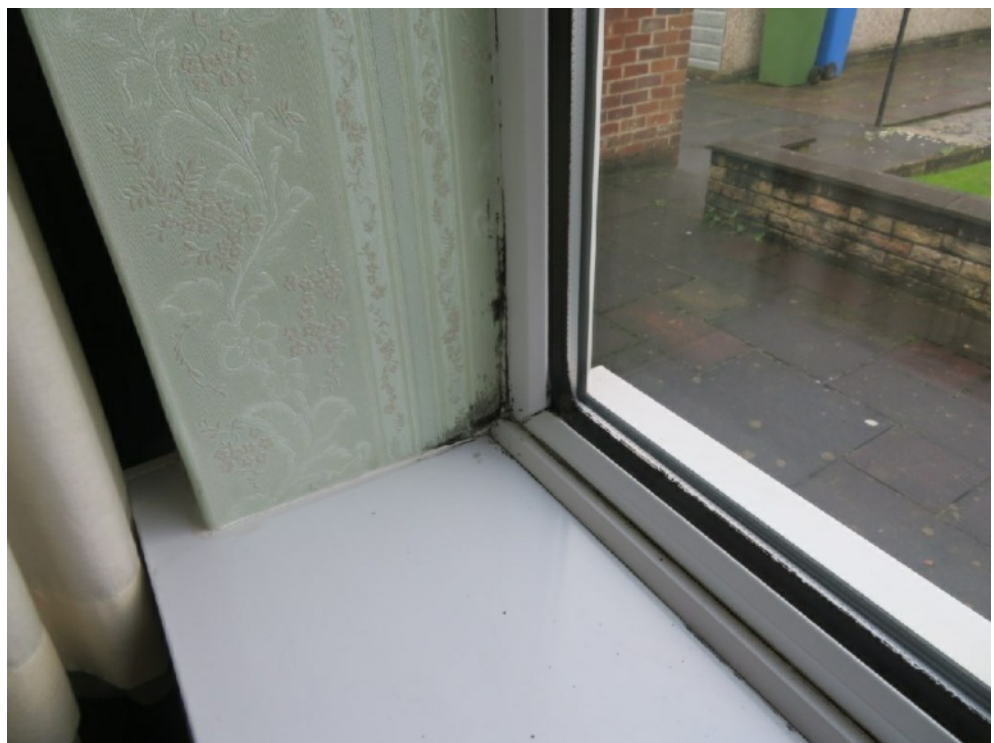
Damp stained window reveal

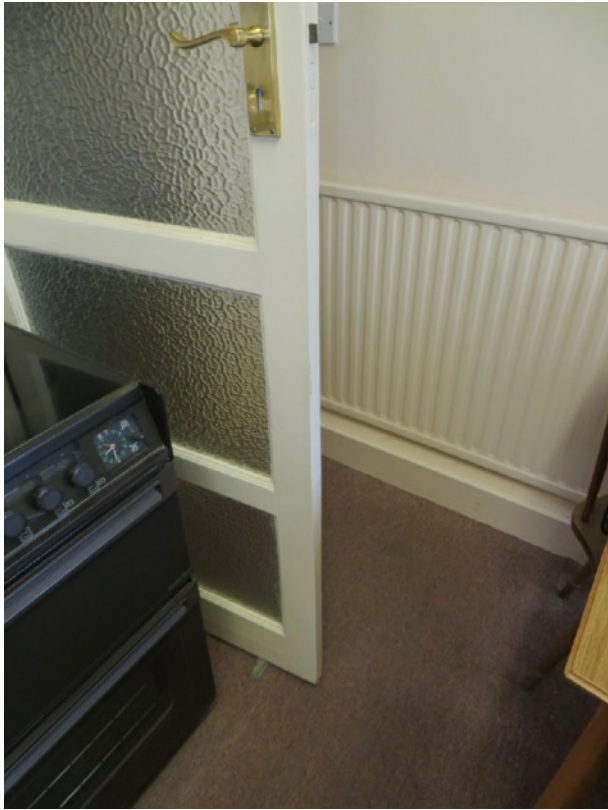
<h2 style="margin: 0;">5.7 Internal Joinery</h2>	Condition rating	1
Construction & Type and Limitations	<p>The internal woodwork includes such items as: doors, frames and skirting boards. All the internal doors are made from softwood.</p> <p>The internal doors were checked for normal operation and other woodwork examined for a range of defects.</p> <p>Woodwork was also examined for evidence associated with movement of the structure of the property, woodworm and other infestations, and general condition. Moisture meter readings were taken at regular intervals.</p>		
Condition	<p>All internal doors were in fair alignment with no undue movement noticed to the frames. All doors operated effectively.</p> <p>No significant defects or damage was noted, but no safety glass was noted to the two kitchen doors which are part glazed, see section 3.2.</p>

<p data-bbox="815 1630 1034 1662">Lack of safety glass</p>

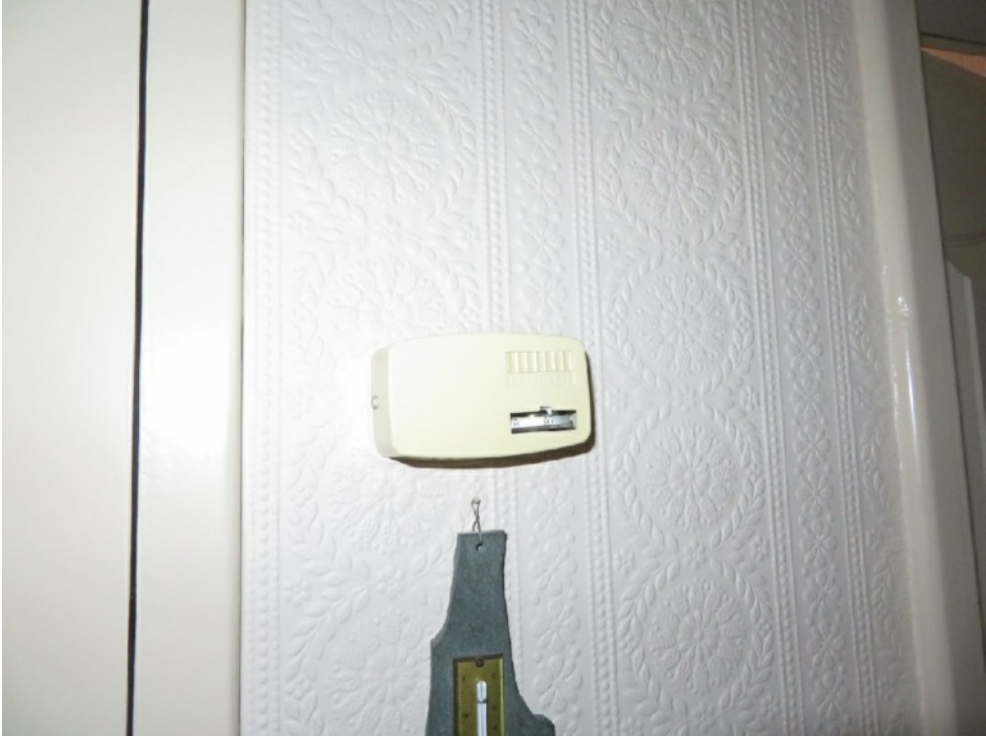
<p>Condition</p>	<p>The boiler and radiator system was in operation during the survey and radiators were warm to the touch. The hot taps were also tested and hot water was delivered.</p> <p>I suspect the controls, particularly the room thermostat, are not working correctly if at all. The thermostat was set at 80 degrees Fahrenheit but the radiators were not hot, as would be expected with a thermostat set at that level.</p> <p>See section 6.2 regarding testing the full gas system before you purchase.</p>

<p>Faulty thermostat</p>

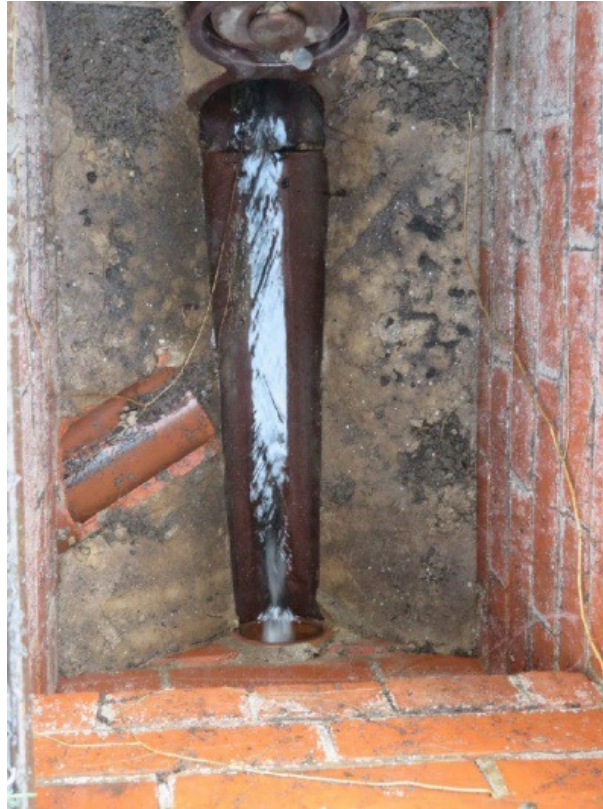
Condition	<p>There were some roots noted in the front inspection chamber.</p> <p>As the drains are quite old, if you wish to be certain there are no issues we suggest you ask a member of the National Association of Drainage Contractors to carry out a CCTV inspection. The owners responsibility ends at the boundary of the property.</p>

Roots in drains

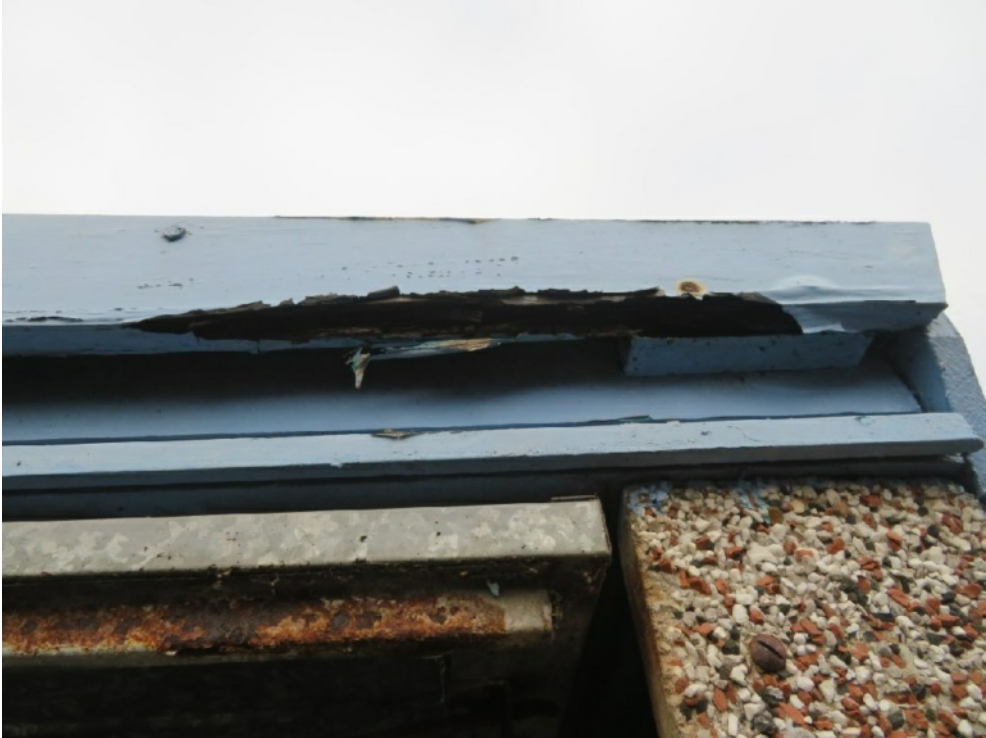
<h3>7.1 Garaging</h3>	Condition rating	2
Construction & Type and Limitations	<p>The garage is of system built concrete walls with a pitched corrugated metal roof. The garage is accessed via a vehicle metal up-and-over door to the front.</p> <p>It was examined from ground level, and with the aid of step ladders where necessary, for signs of bowing or leaning of walls, damaged concrete and render, internal defects, and the condition of the roof both internally and externally.</p>		
Condition	<p>The roof space was examined for signs of bowing, twisting, cracking and failure of roof supports, signs of failure or damage to the roof covering, infestation including birds, insects, animals and beetles (woodworm), and other defects.</p> <p>The outside of the roof covering is rusting. The fascia to the front over the door is rotting. The up and over door was catching slightly on the fascia.</p>

<p>Rot to garage fascia</p>

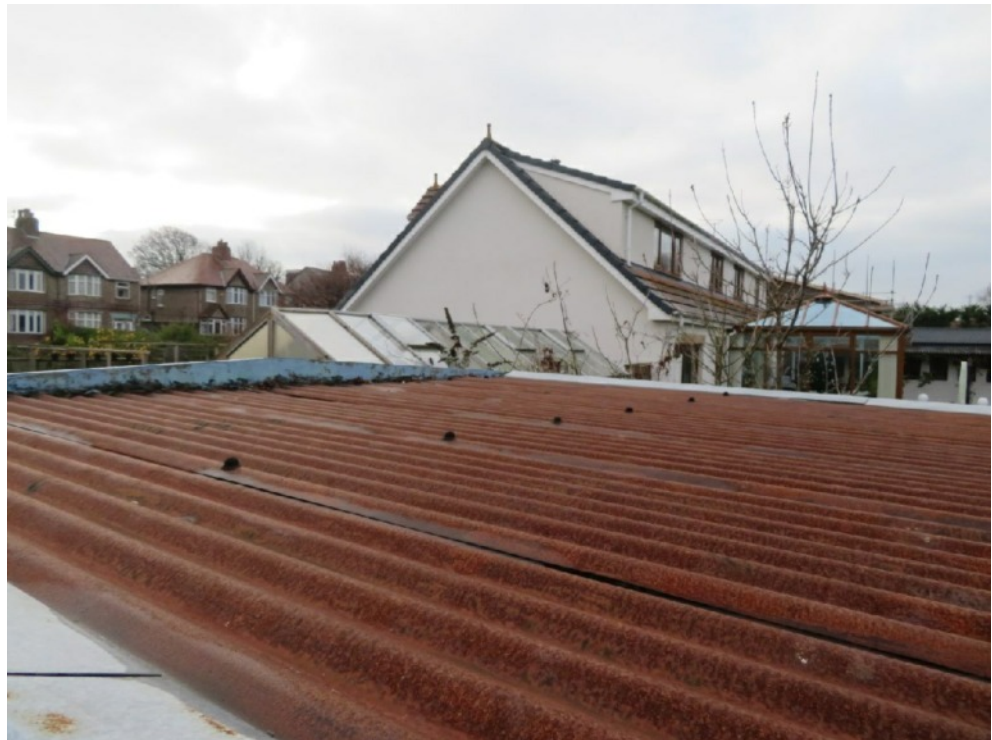
Rust to garage roof

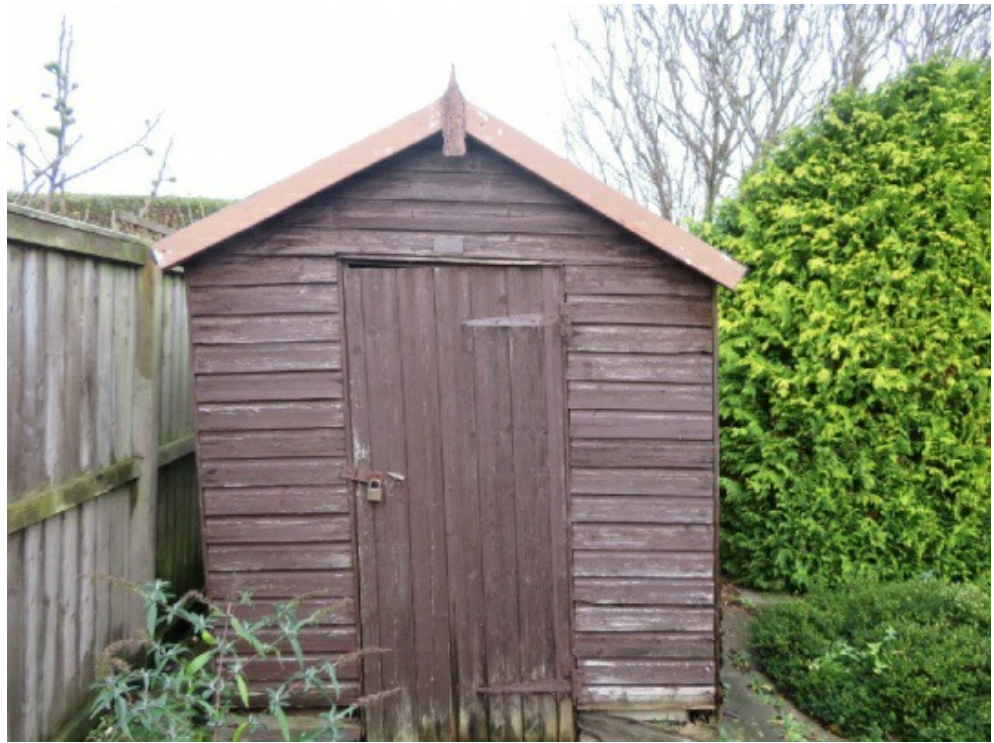
Lean to garden shed

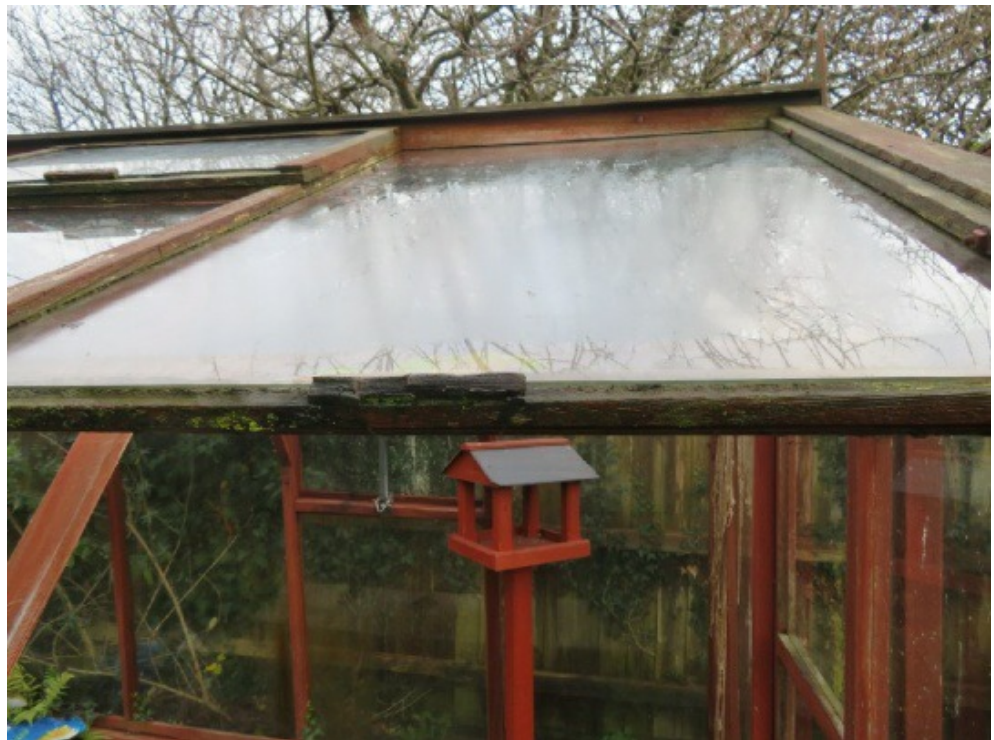
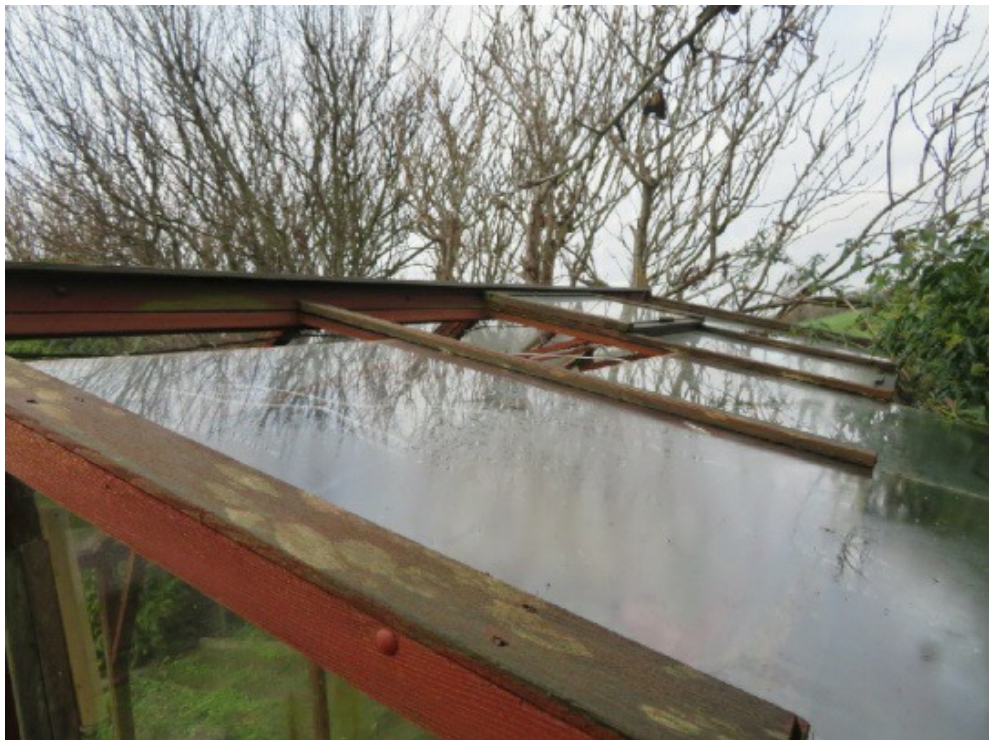
<h2>7.2 Outbuildings and Sheds</h2>	Condition rating	3
Construction & Type and Limitations	<p>There are no permanent outbuildings.</p> <p>The garden shed and greenhouse are of timber construction.</p> <p>They were assessed for general condition and was examined externally and internally to identify areas of rot, damage, leaks and other defects.</p> <p>It was not possible to access the shed internally as it was padlocked and no key was available.</p>		
Condition	<p>The shed is in a poor condition, it is leaning and rot is occurring. The greenhouse is also rotting and the glazed sections to the roof are sliding off due to the rotted supports. See section 3.2.</p>

Rot to glass support on greenhouse

Loose glass to greenhouse

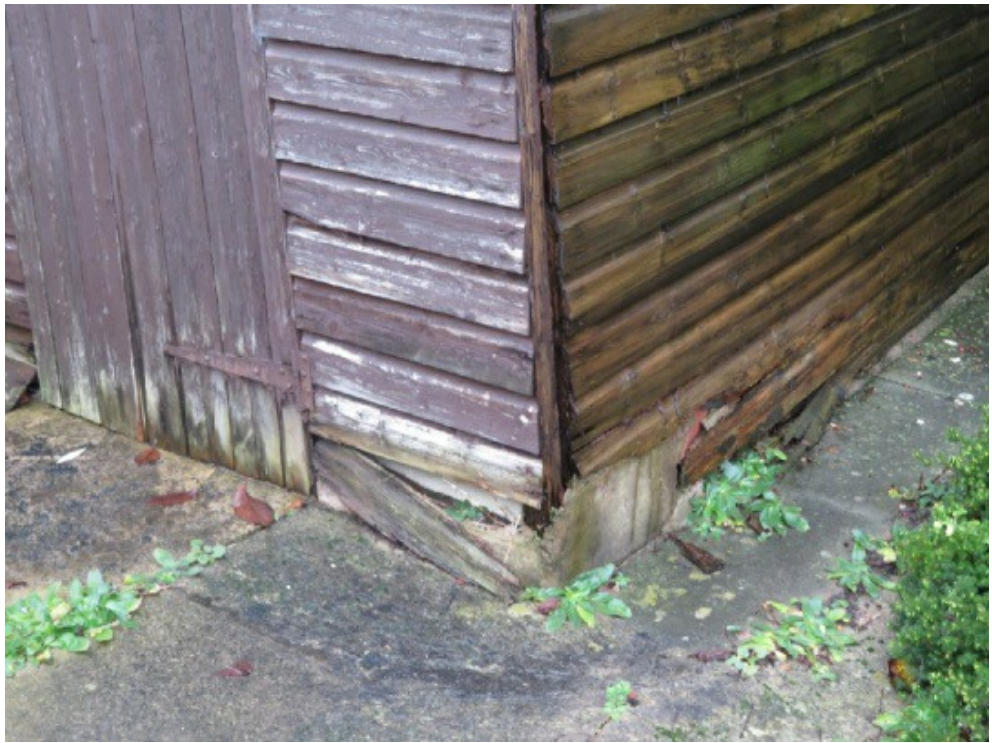
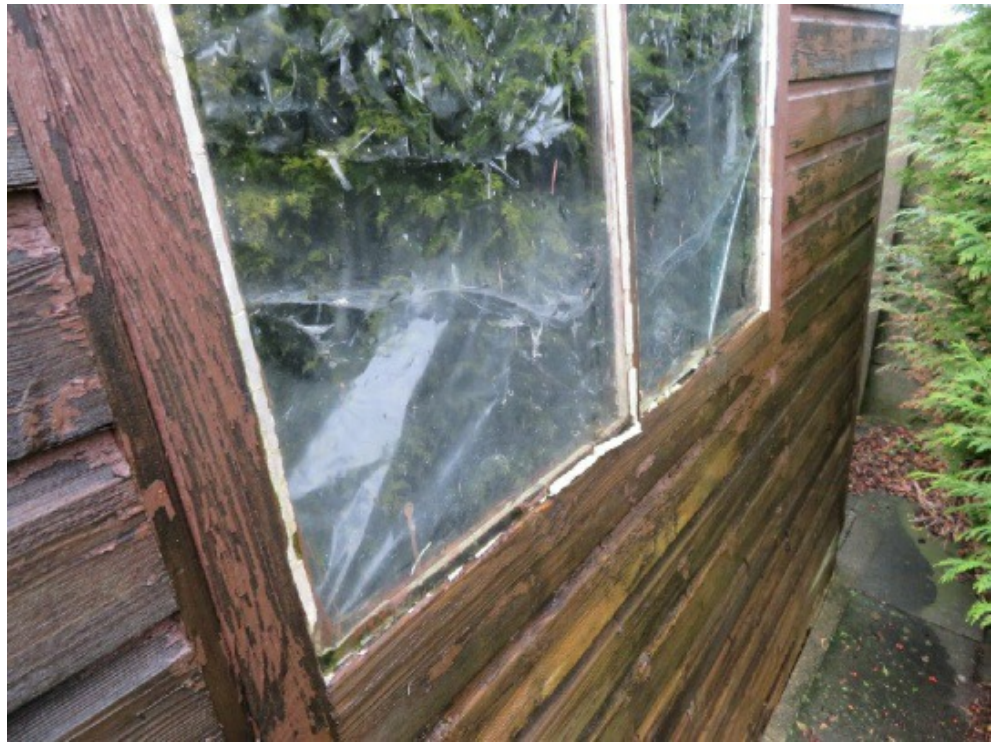
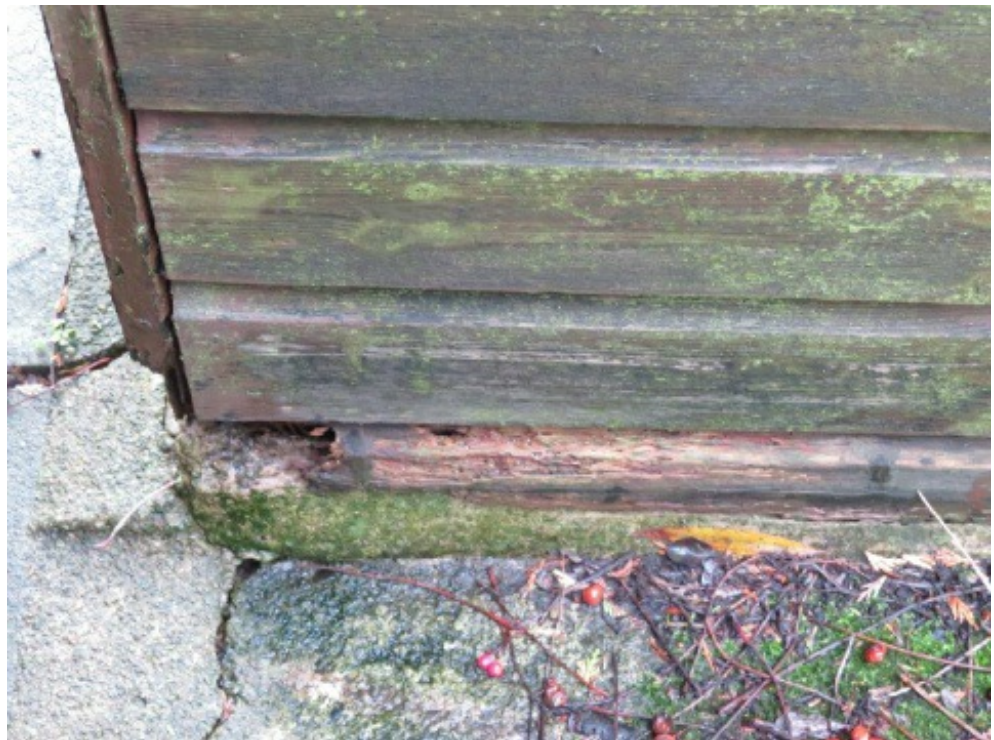
Rot to garden shed
