HOME BUYER SURVEY

REF 3468

The format of this Mi HOME BUYER SURVEY is consistent with the guidance note requirements for a Survey Level 2 as defined by RICS Surveys of Residential Property 3rd edition May 2016

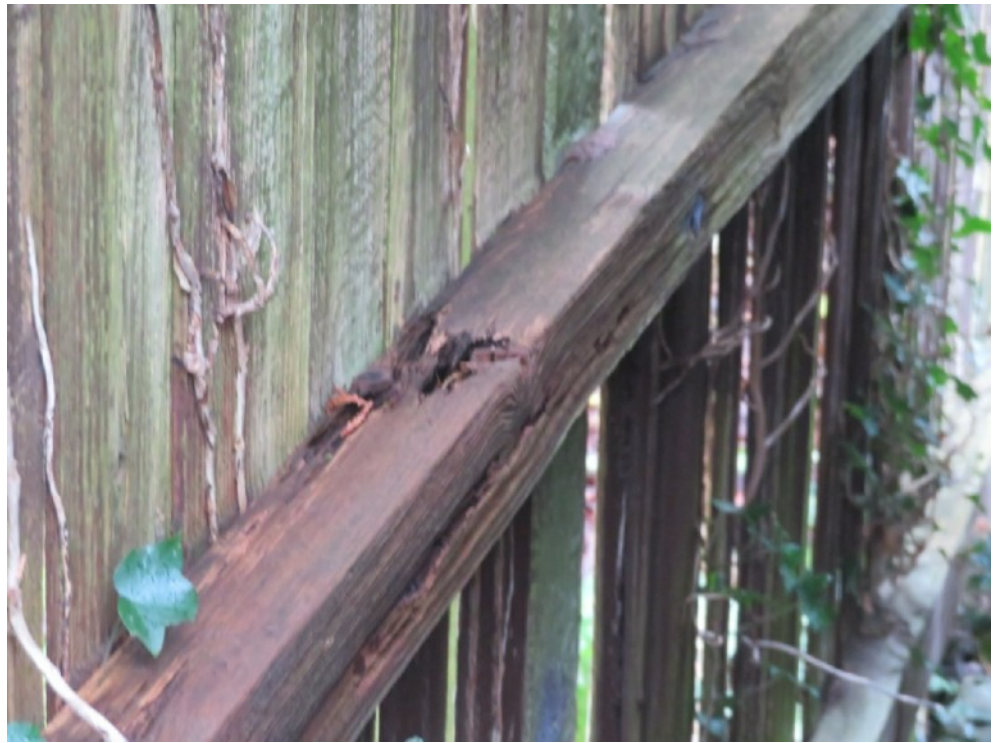
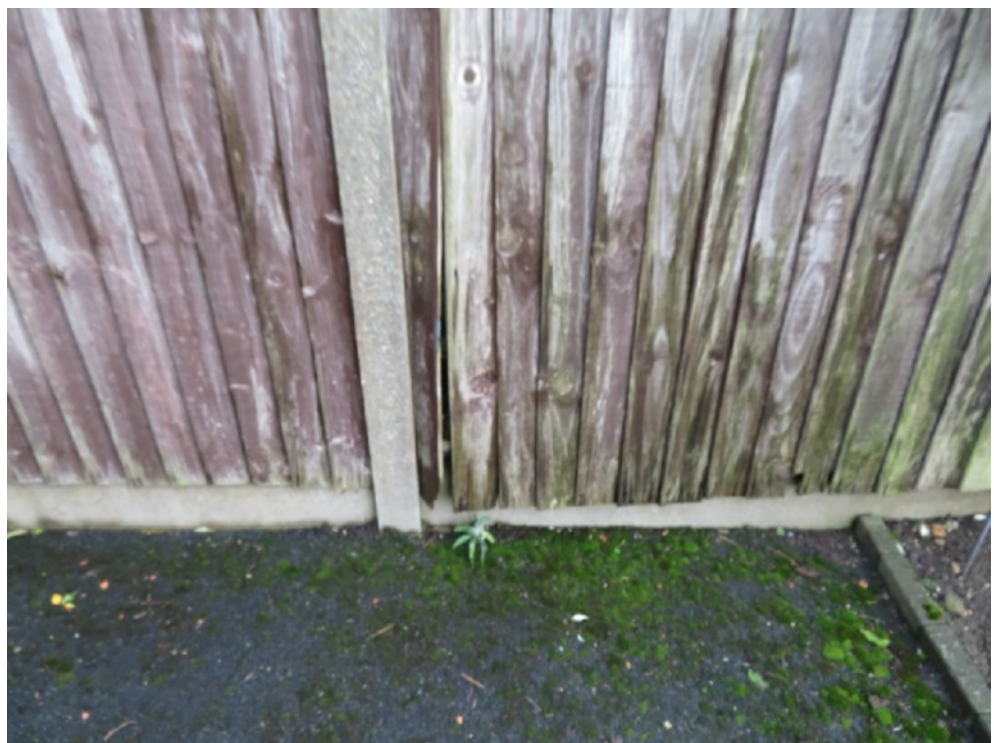
7.3 Grounds	Condition rating	2
Construction & Type and Limitations	<p>There are gardens to the front and rear which are lawned with surrounding borders.</p> <p>There are paths and a patio around the property which are of paving stones .</p> <p>The driveway is to the front and side of the property and is laid to asphalt.</p> <p>The boundaries are defined by a mixture of timber panel fencing and brick walls.</p> <p>The grounds around the house were inspected for any indications of land failure or movement, or other defects that would have a material effect on the property as a whole.</p> <p>The grounds were inspected for signs of Japanese Knotweed and other invasive species. See section 3.3.</p>		
Condition	<p>There is no evidence of any damage from flooding.</p> <p>The gardens are both presented in a fair condition.</p> <p>The driveway surface is in a serviceable condition and is reasonably level but cracks are occurring.</p> <p>The fencing is presented in a poor condition with rot occurring to various parts and a loose panel to the front right hand side.</p>

Rot to fence

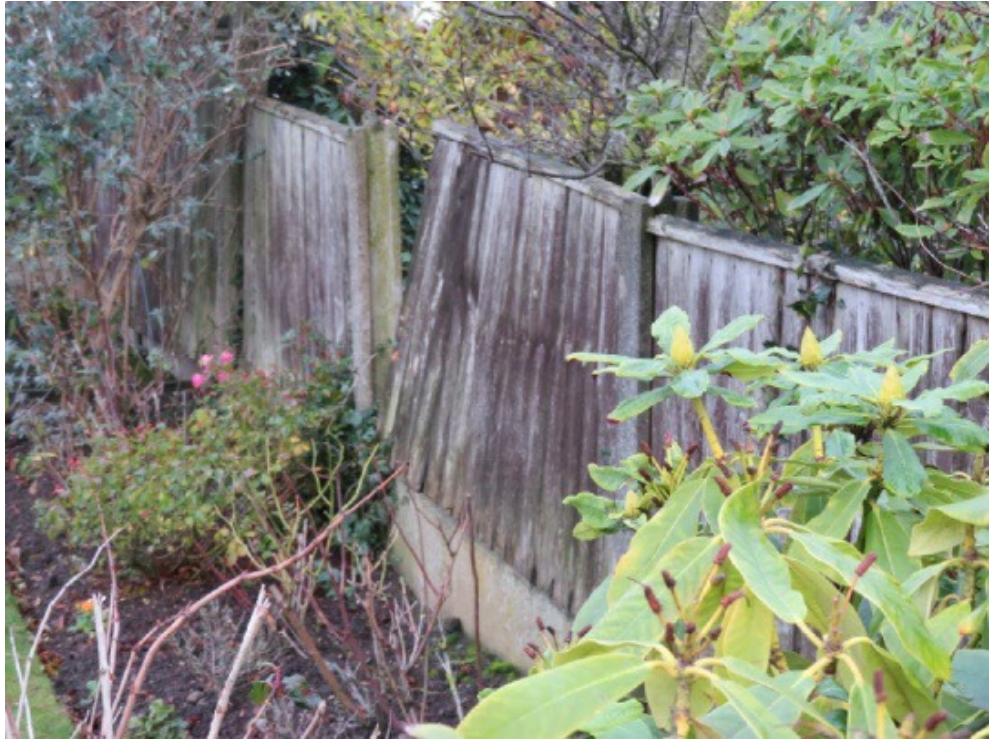
Loose fence panel

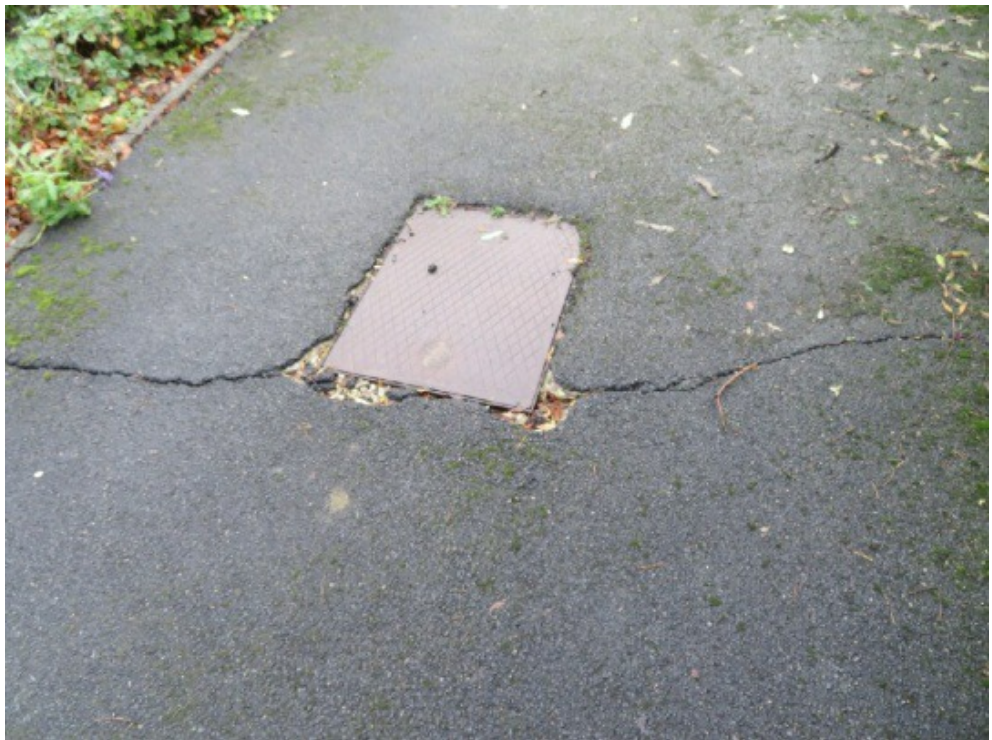
Crack to driveway
