Mi HOME BUYER SURVEY

HOME BUYER SURVEY

REF 5111

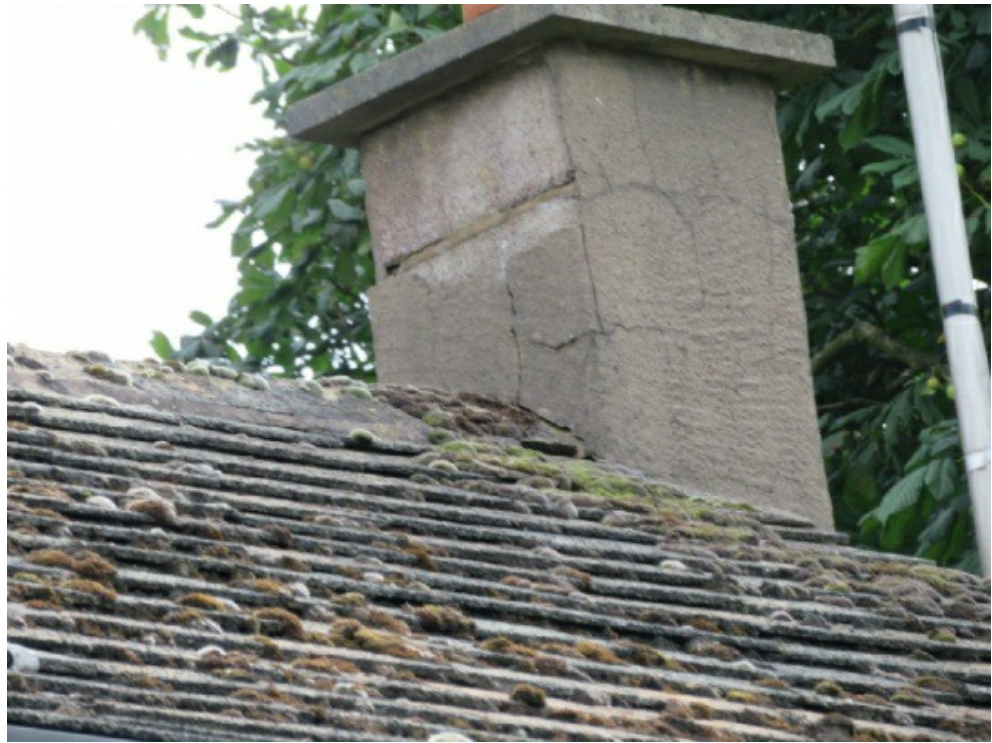
4.1 Chimney Stacks	Condition rating	2
Construction & Type and Limitations	<p>The chimney stack is stone built and is rendered with a sand-cement finish. It has one pot which provides a flue to the LPG fire in the living room. The flashing at the base of the stacks at the junction with the roof slopes is of lead.</p> <p>The chimney was examined from ground level with the aid of binoculars for possible defects including undue movement, distortion, chemical or weather related damage, brickwork, render and pointing damage and other evidence of failure.</p> <p>Due to limited viewing angles it is not possible to see all faces of the chimney stack from ground level, and it is assumed that the condition of those faces not visible is similar to that of the visible faces.</p>		
Condition	<p>All flashings and pointing seen were in a fair condition. However the render was cracked and some was missing. Render is normally used for weather protection and does not allow rain to penetrate to the masonry. Consequently if water does penetrate to the masonry it will not be allowed to evaporate through the render. The masonry can get wet when the render is cracked or missing, it will then start to penetrate internally, therefore any cracks to the render should be repaired as quickly as possible.</p> <p>The pot has a rain cowl fitted to allow flue gases to escape but prevent vertical rain entering the flue line.</p> <p>The stack must be maintained in the normal way.</p>

Cracked render to chimney stack

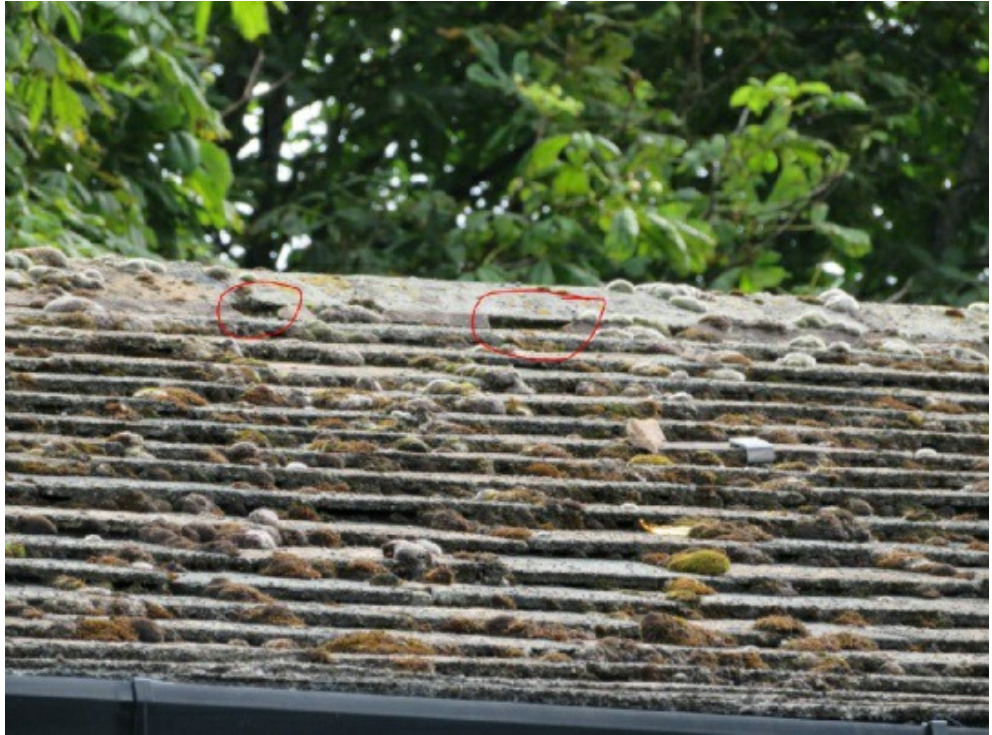
4.2 Roof Coverings	Condition rating	3
Construction & Type and Limitations	<p>The main roof slopes are pitched and covered with plain concrete tiles. All ridge tiles are concrete.</p> <p>The roof pitches were examined from ground level with the aid of binoculars and using a pole camera, where necessary for possible defects including sagging, collapse, broken/missing/damaged tiles, holes, and other evidence of failure.</p>		
Condition	<p>All tiles seen were in a fair condition with no evidence of any major failures or defects. The mortar at the verges (side most run of tiles) is complete and intact with no evidence of any major weathering (I was unable to check the right hand gable without trespass). The top line of ridge tiles is even with no evidence of any undue levels of flexing or bowing. If ridge tiles are not bedded in well with mortar they are prone to being lost in high winds. A few of the ridge tiles to this property have incomplete mortar beds which would benefit from repair.</p> <p>When moss builds up on roofs it can eventually damage the tiles with obvious consequences. Therefore roofs will always benefit if the moss is cleaned off. There is an excessive amount of moss to this roof which would benefit greatly from its removal. There are even trees starting to grow over the single storey section. The amount of moss and foliage growth will start to damage the roof tiles if not removed as soon as possible.</p>

Incomplete mortar to ridge tiles

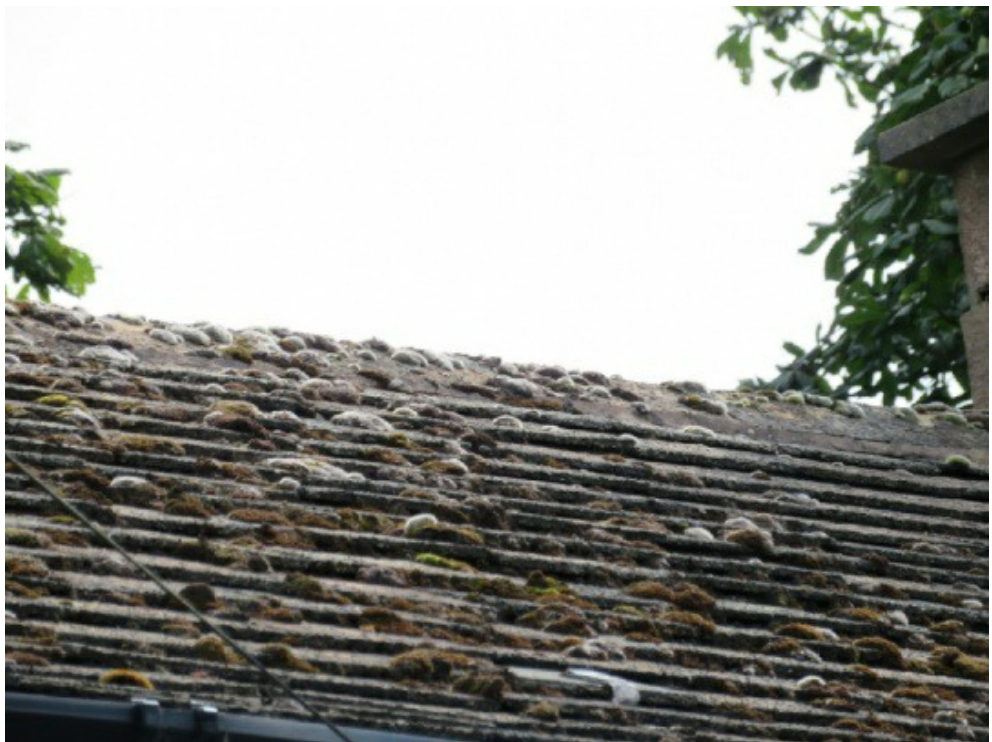
Moss on roof

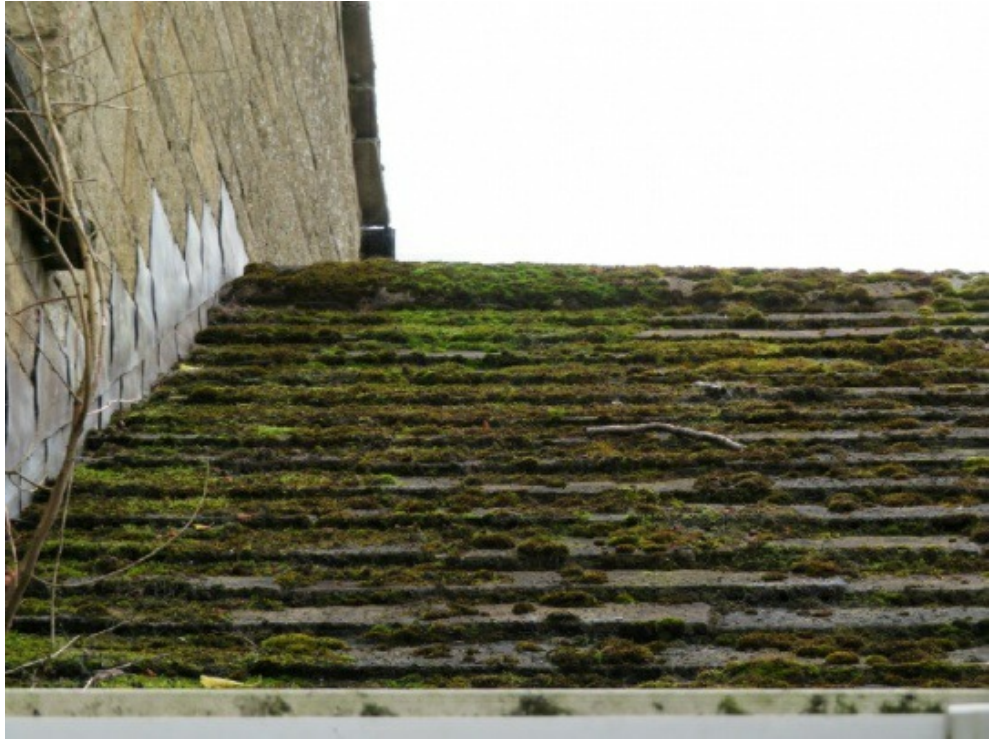
Moss on roof

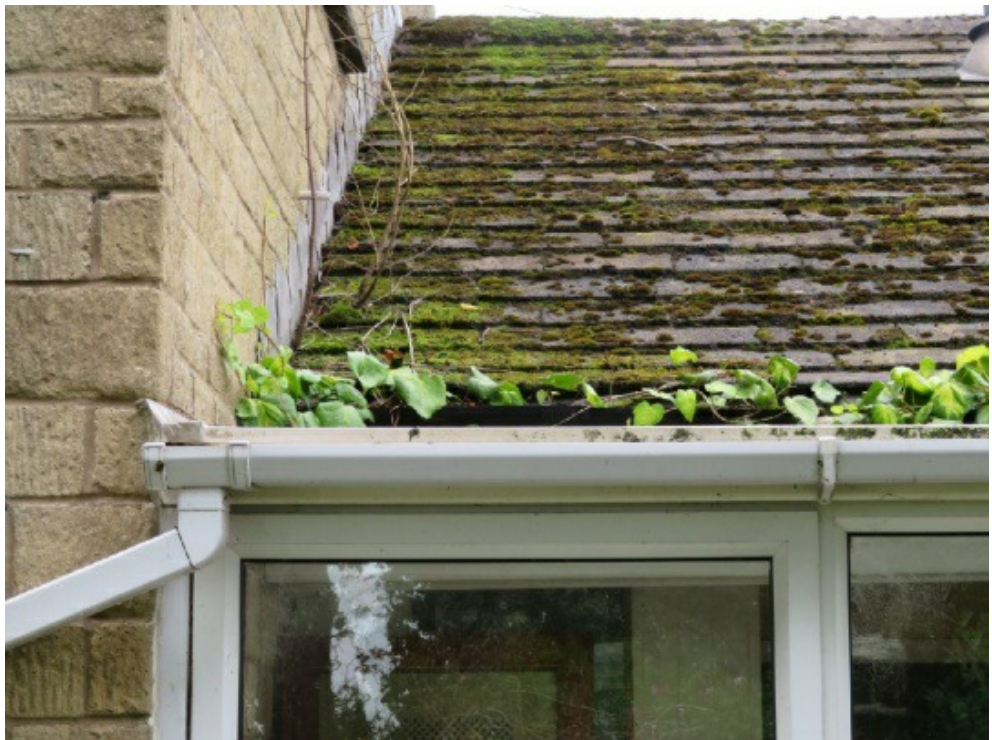
Tree growth on roof

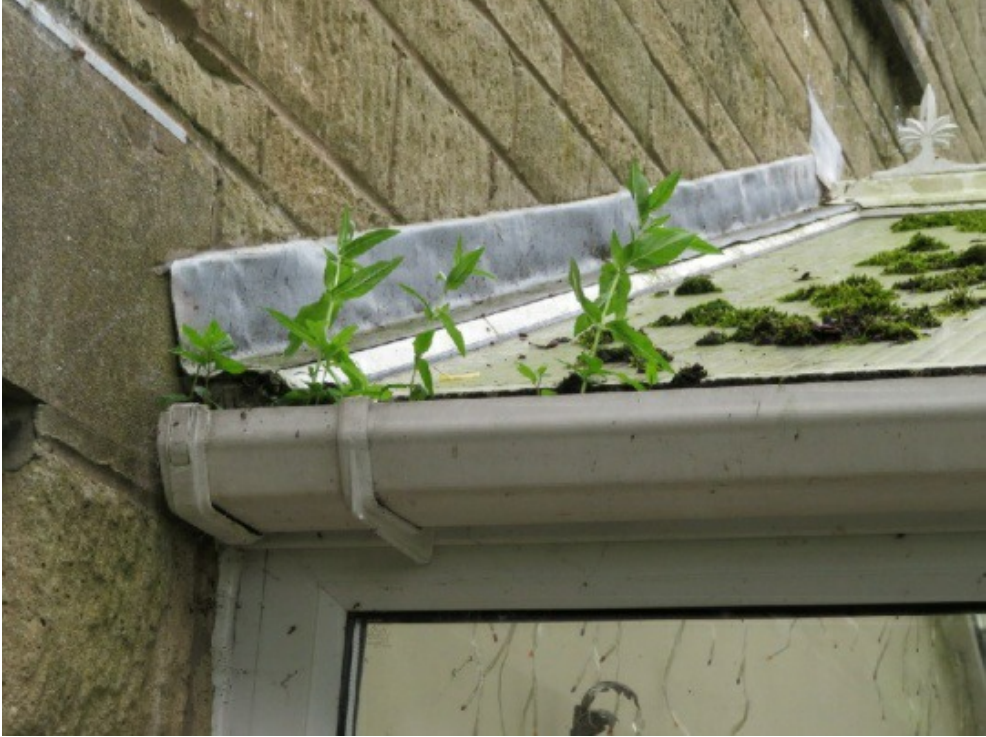
<h3>4.3 Rainwater and Above Ground Drainage Fittings</h3>	Condition rating	3
Construction & Type and Limitations	<p>The rainwater gutters and downpipes are PVC throughout. The waste stack is PVC.</p> <p>An inspection was carried out from ground level with the aid of binoculars where necessary to look for possible areas of leakage, misalignment, overflow and other defects. The soil stack was examined for any signs of damage, leakage, cracking and evidence of significant wear.</p> <p>As it was dry at the time of survey only a limited assessment could be made as to the effectiveness of the rainwater fittings.</p>		
Condition	<p>The gutters are currently in fair condition and alignment. There were no significant leaks noted but all gutters require examining periodically and clearing of moss, leaves and silt which will inevitably accumulate. There was an excessive amount of silt and foliage growth to the gutters which needs removal before they start to overflow and damage the walls and foundations.</p> <p>The top of the waste stack would benefit from having a bird cage added to avoid birds nesting on top of the stack.</p>

<p data-bbox="826 1592 1023 1624">Growth in gutter</p>

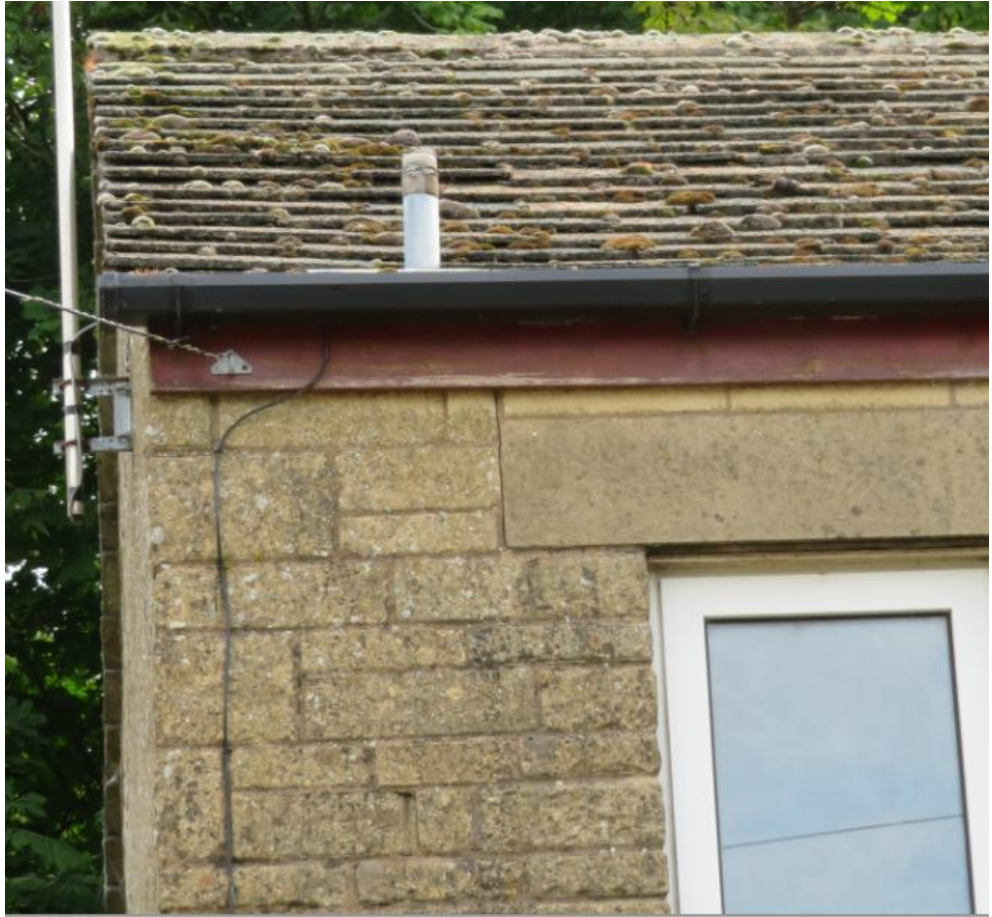
Lack of birds nest

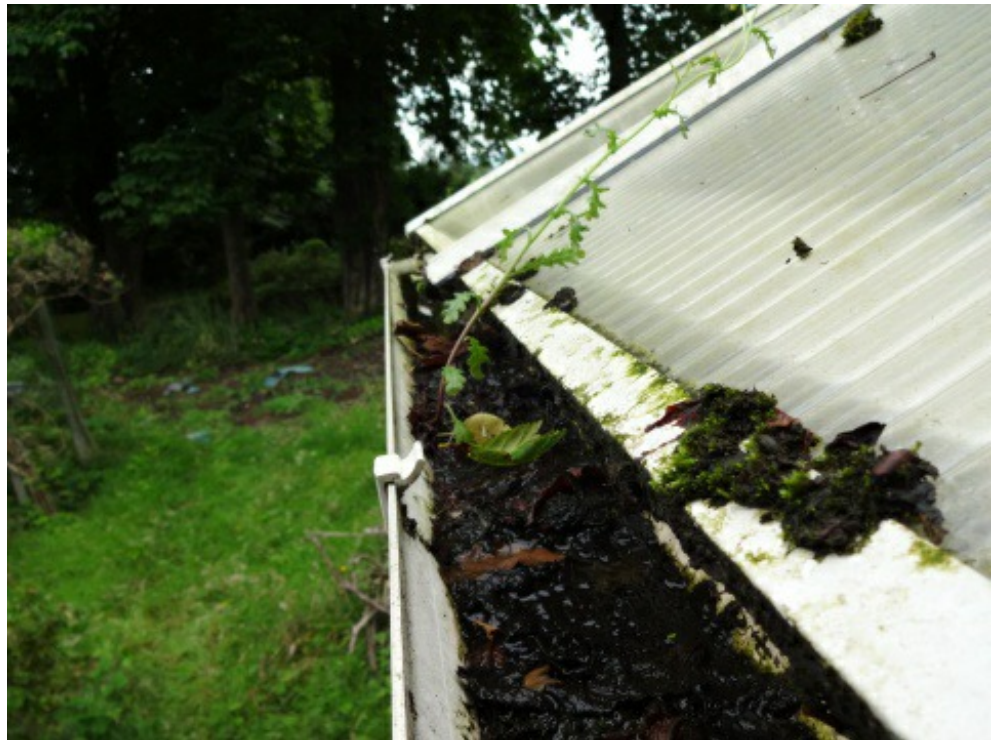
Blocked gutter

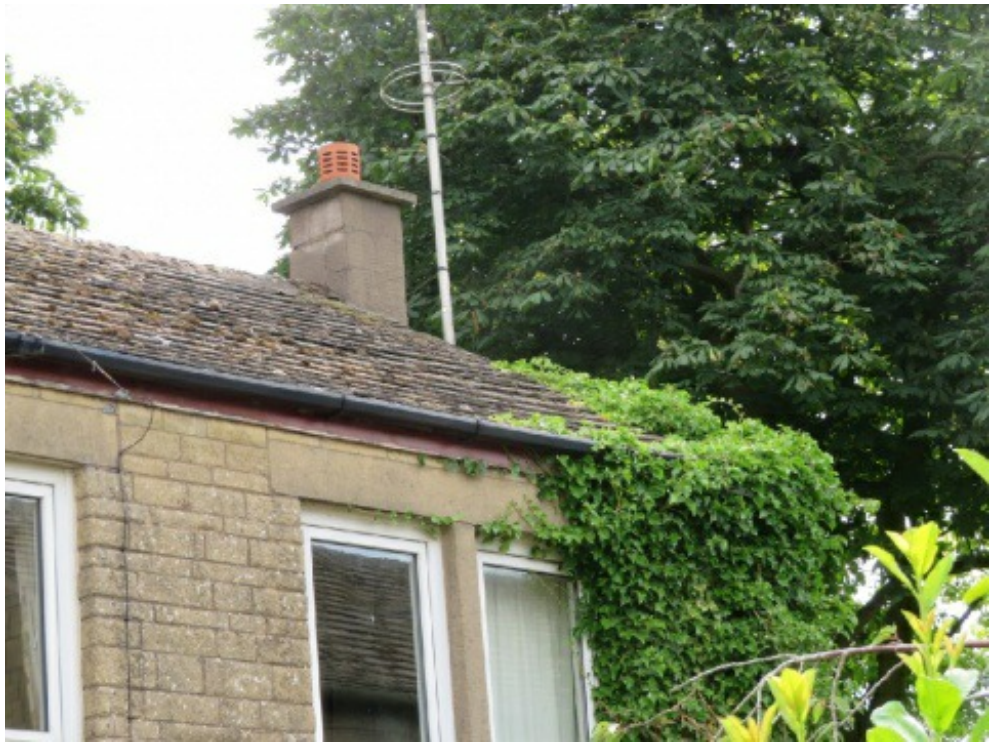
Condition	<p>Foundations I have not undertaken exposure of the foundation structures during the course of my inspection, as this is impractical in a building survey of this type.</p> <p>Movement Stability and vertical alignment is generally satisfactory. Condition and alignment of the brickwork is fair. There is no evidence of any significant bulges or major structural cracks. There is no evidence of foundation cracking at ground level.</p> <p>The British Geological website indicates the ground is of sandstone and mudstone which is a solid base and hence not liable to move adversely. No other evidence of movement was seen other than that which would normally be expected in any building of this age.</p> <p>Other Aspects There is no evidence that the wall cavities have been filled with insulation (cavity wall insulation) and it is unlikely that they would have been filled at the time of construction. The energy efficiency of the property may be improved by installing insulation, however not all properties are suitable for having cavities filled and a survey by a specialist company should be conducted prior to any installation.</p> <p>Air bricks are visible at the base of the walls. These are present to ensure adequate ventilation to the under floor voids to minimise the build-up of moisture that can promote the development of rot and other defects in the materials that support the floors. It is essential that a free flow of air is maintained through the air bricks. At the time of the survey some airbricks were hidden by foliage growth.</p> <p>I noted some eroded pointing on my visit, pointing should always be repaired as soon as it is spotted. There was also a gap around a pipe entering the rear wall which requires sealing.</p> <p>There are a lot of climbing plants to the walls, which whatever your opinion on their looks, will eventually cause damage to the property and I would recommend they are removed completely.</p>

Climbing plants

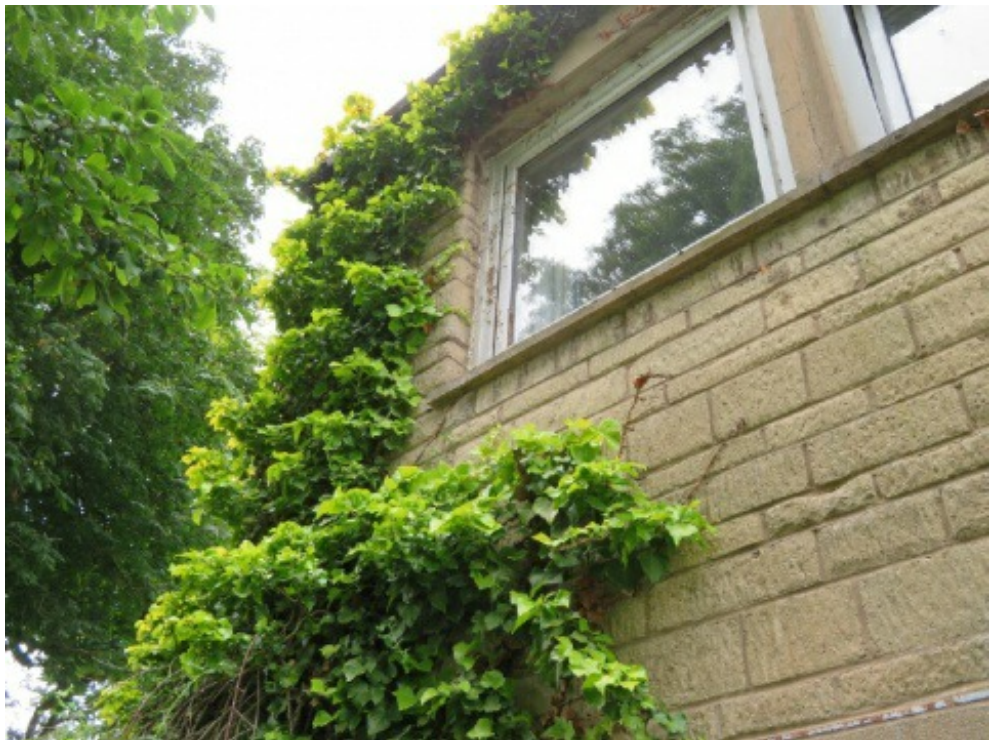
Climbing plants

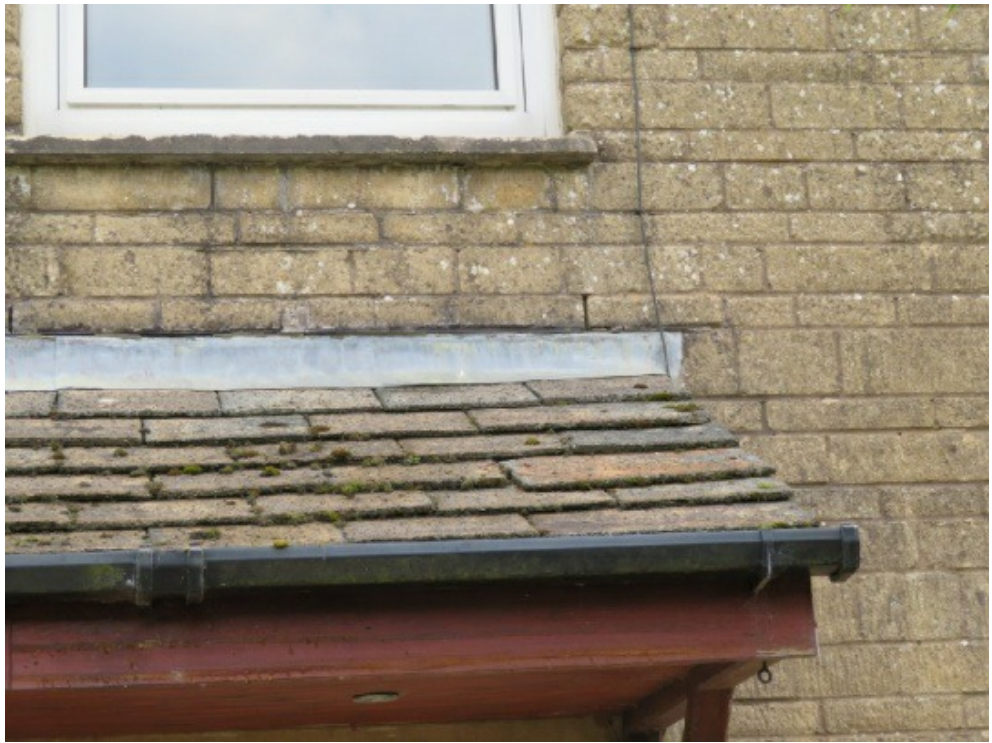
Eroded pointing

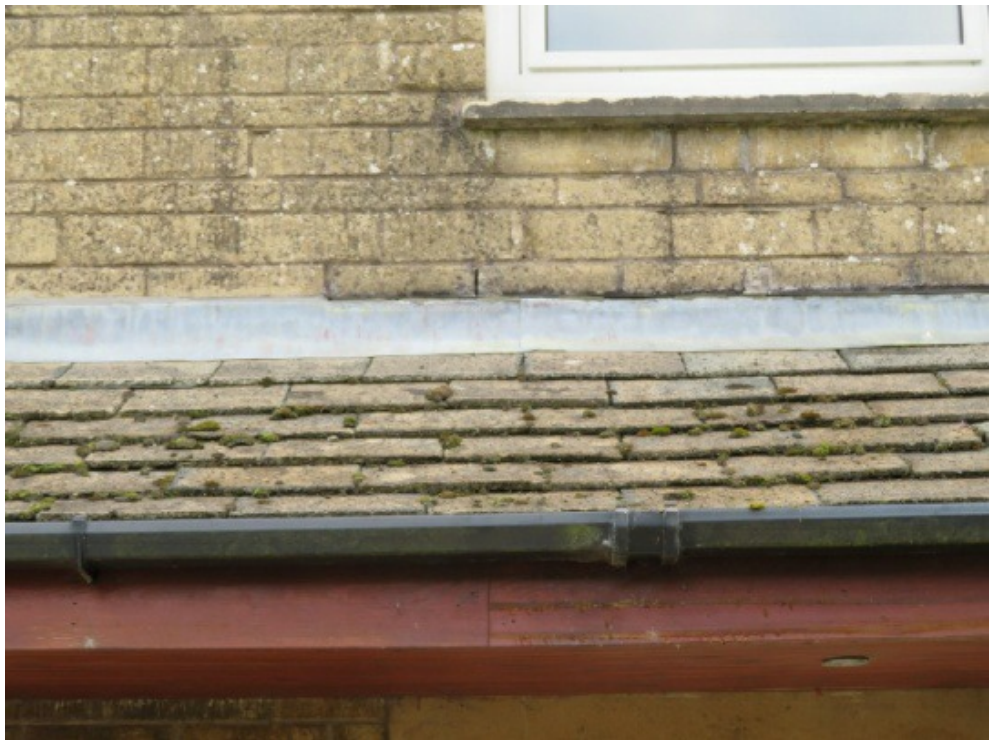
Eroded pointing

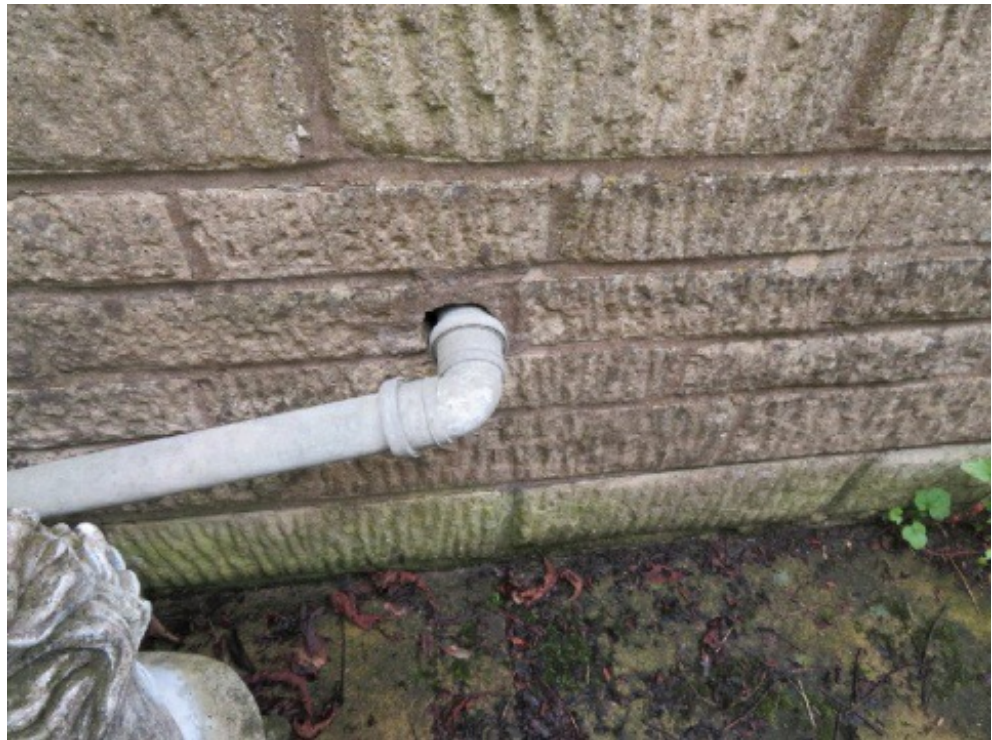
Gap around pipe at rear

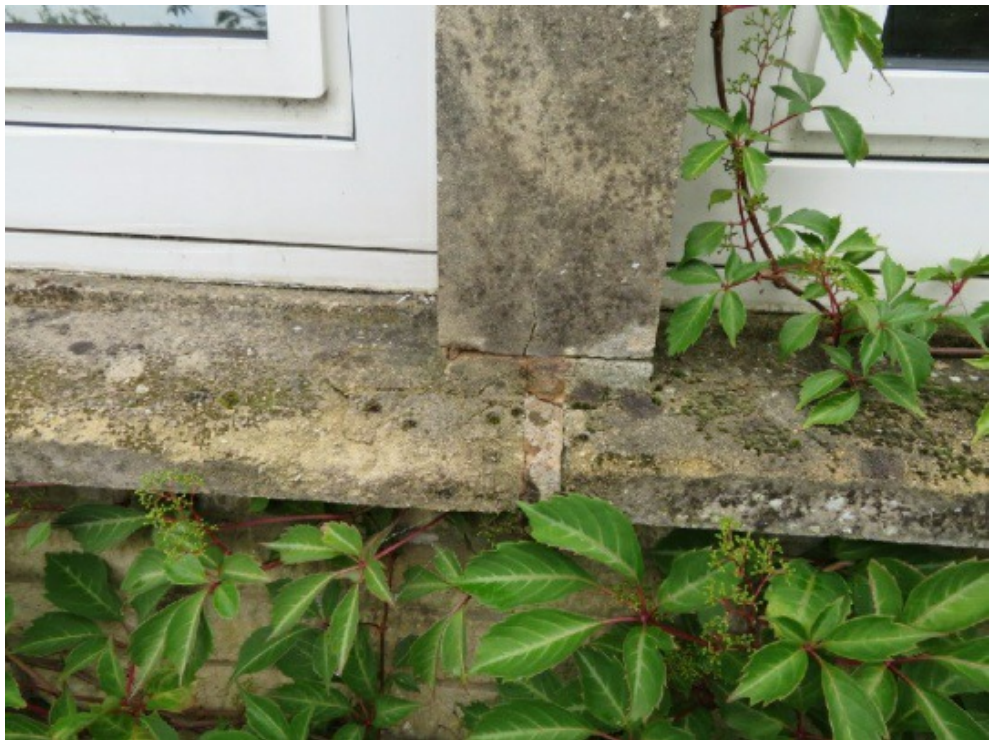
Cracked mullion

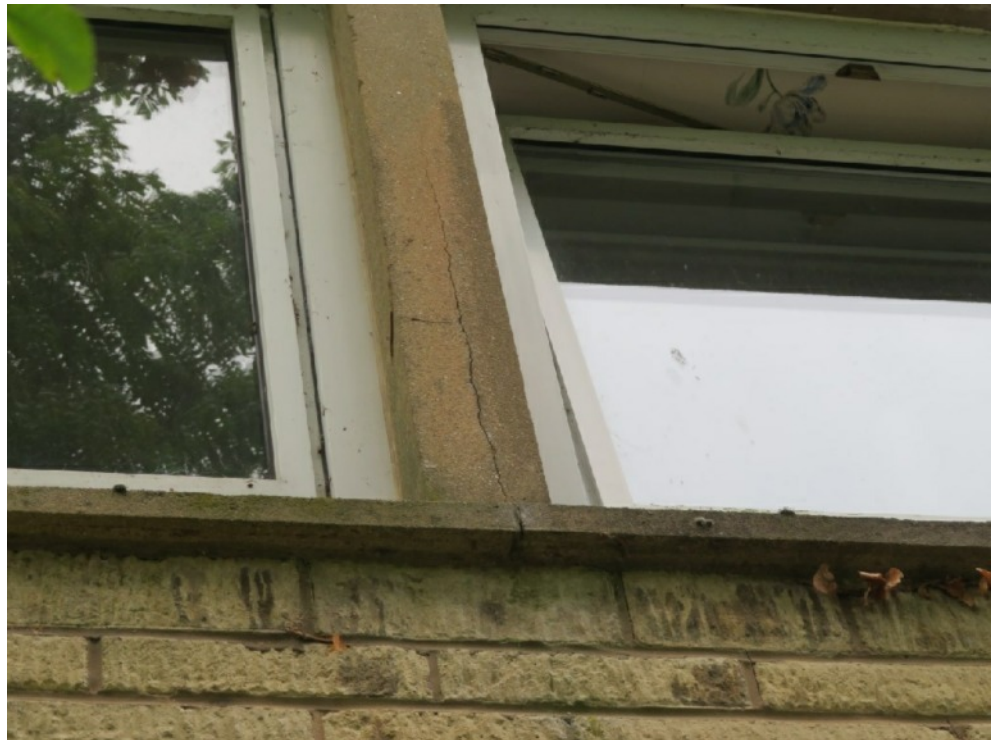
Cracked mullion

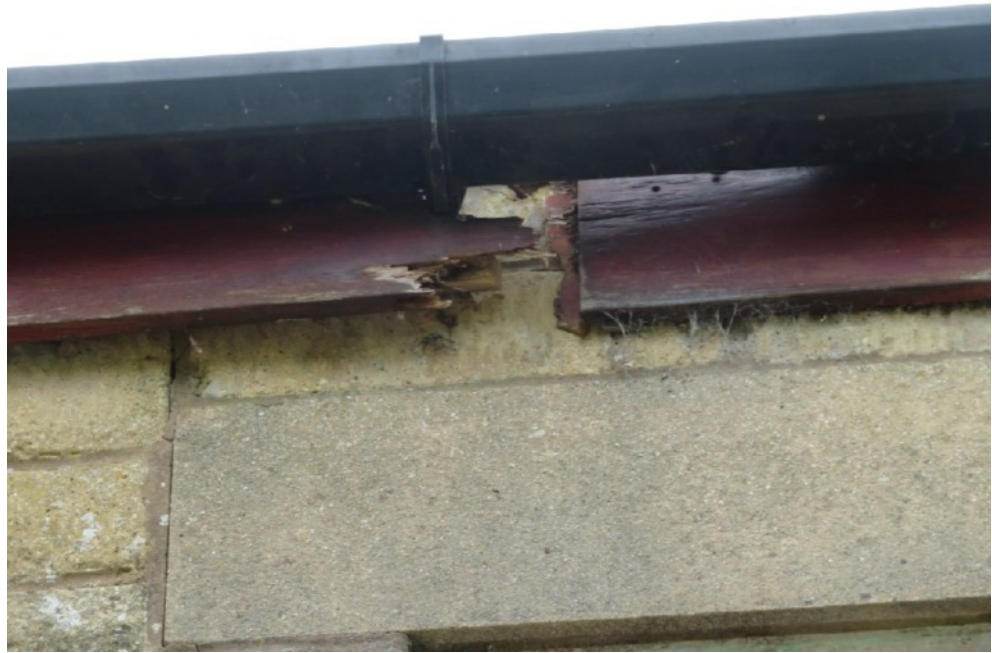
4.6 External Joinery and Finishes	Condition rating	3
Construction & Type and Limitations	<p>This includes such items as woodwork at the roof edges, fascias, and trim panels. Decorated areas include such items as windows, doors, walls, timbers at roof edges, porches.</p> <p>The fascias are all of timber construction.</p> <p>Fascia boards are the vertical timbers to which the gutters are normally fixed. All such materials were examined from ground level for indications of poor maintenance, rot and other damage.</p> <p>Decorations were examined from ground level with the aid of binoculars from vantage points within the grounds of the property and suitable public areas around. Decorations were examined for signs of wear and tear, peeling paint, lack of oiling where applicable and other defects.</p>		
Condition	<p>Most of these timbers are reasonably sound, have been maintained and appear to be in a serviceable condition. There is no immediate requirement for any redecoration. However a section of fascia to the front is broken and rotting and appears to be losing its grip on the wall. This could bring down the gutter if it were to fail and fall. It therefore needs immediate repair.</p> <p>There are areas where peeling paint is visible. Some redecoration is now required or consideration given to replacing all boards with modern PVC equivalents.</p>

Broken and rotten fascia

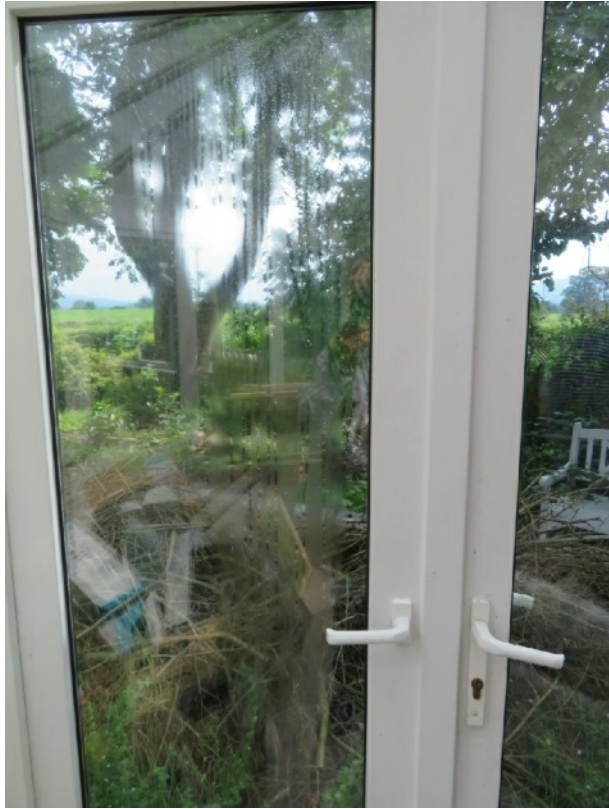
4.7 Conservatories and Porches	Condition rating	3
Construction & Type and Limitations	<p>There is a conservatory to the rear of the property. It is of UPVC construction with glazed sections on three sides, a pitched polycarbonate roof and is on a brick dwarf wall.</p> <p>The conservatory structure was examined for indications of leaking, bowing, leaning, cracking and undue movement, failure or damage of the floor, walls and roof, separation from the main building, and other defects.</p>		
Condition	<p>Access to the conservatory is gained by an open wall section with no external quality doors between the two parts. As this is open, building regulation approval would have been required in addition to any planning approvals gained. Your Legal advisor should check these matters during the conveyancing process. I was informed the conservatory was added around the same time as the conversion (2001).</p> <p>The exterior door from the conservatory is misted (failed seal) and therefore the glazing needs replacing.</p> <p>The downpipe to the conservatory does not discharge to a drain or soakaway but is supposedly meant to enter a water butt. However, on my visit it was discharging into mid air and if left will damage the conservatory walls and foundations. It could also affect the house walls as well.</p>

Misted (failed seal) window to conservatory

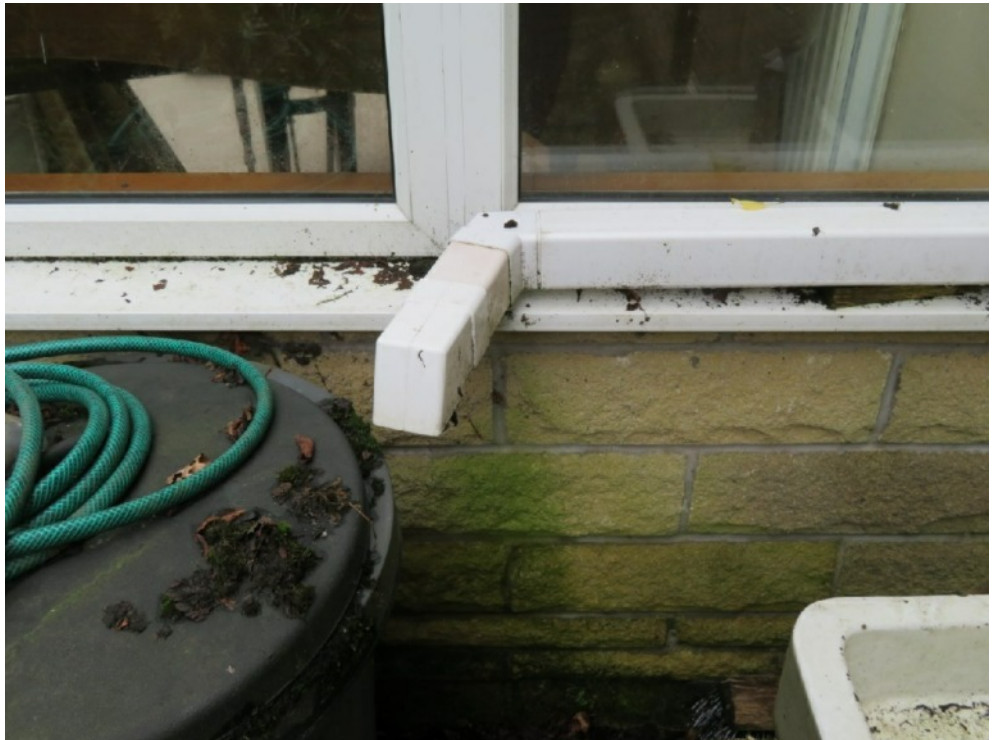
Downpipe from conservatory

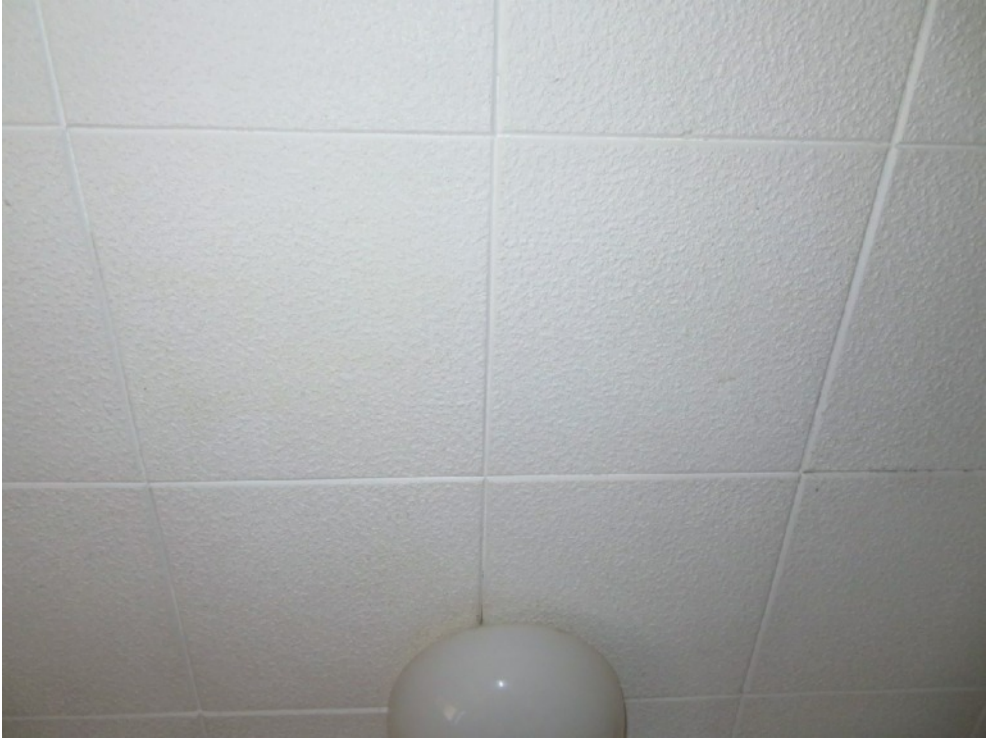
Condition	<p>All internal ceilings have been maintained and all surfaces are presented in a fair decorative order.</p> <p>Plasterboard: There was some visible hairline cracking to some plaster boarded areas. This is normal thermal expansion movement and within tolerance levels.</p> <p>Advice: Some ceilings within the property have a textured finish. Some textured ceiling finishes can contain asbestos and hence should not be drilled, sanded or removed without protective equipment and/or specialist advice. See section 3.2.</p> <p>Any such materials that do contain asbestos are harmless unless airborne fibres are present. At the time of survey no areas of flaking, powdering or similarly damaged material were noted indicating that no specific risk currently exists. Painting or plaster skimming of textured surfaces normally ensures that any asbestos fibres are securely encapsulated and will not present any risk to health if undisturbed.</p> <p>There was one ceiling that is covered with polystyrene tiles, this is a highly flammable material and emits dangerous toxic fumes in the event of a fire, which can kill far faster than normal fumes and it also emits extremely hot drops of plastic when burning. Therefore these should be removed as soon as possible.</p>

<p>Polystyrene ceiling tiles in bathroom</p>

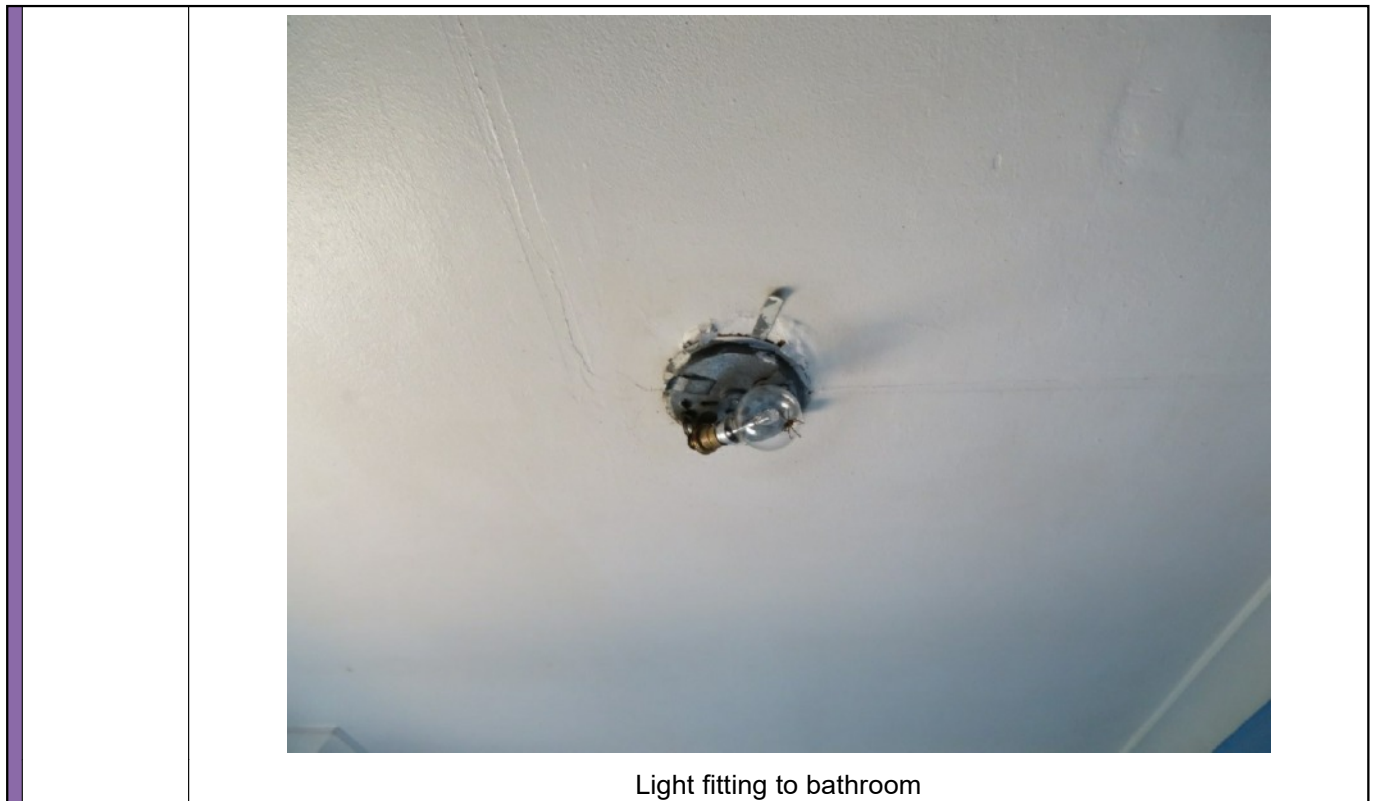
<p>Condition</p>	<p>In general the electrical circuits seen are in a fair condition. PVC cabling was observed at the property and the socket face plates and switch plates are of a suitable modern quality. However to some rooms there may be an insufficient number of sockets for modern living standards, this means a level of new circuitry or rewiring may be required. There are also some specific observations listed below which you may consider require your attention.</p> <p>Observed Issues</p> <ul style="list-style-type: none"> - The light fittings to the bathrooms are not to current standards. All such fittings to bathrooms are required to have the correct Ingress Protection (IP) ratings for dust and moisture. New fittings specifically designed for bathrooms should be considered. - Due to changes for fire protection from 1st Jan. 2016 the consumer unit (fuse box) no longer complies with current regulations. Changes to regulations are rarely retrospective. <p>Some services will be obscured by furniture and other objects at the time of the survey. Upon occupation it is strongly advisable to visually check all socket outlets and switch points for any broken housings or loose fascias. Any damage seen should be repaired accordingly.</p> <p>The NICEIC recommends that electrical installations are subjected to a Periodic Inspection Report (PIR) by a suitably qualified engineer at least every 10 years. They further recommend that a PIR be carried out at any change of ownership of the property to properly assess the safety and compliance level of all circuits and fittings. You can get further information from the Electricity Safety Council www.esc.org.uk/public/guides-and-advice/</p> <p>At the time of survey no documentation was seen to verify that an inspection has been carried out within the last 10 years.</p> <p style="color: red;">From a safety perspective it is essential that you commission an inspection of the electrical installation prior to purchase of the property.</p>

Light fitting to bathroom

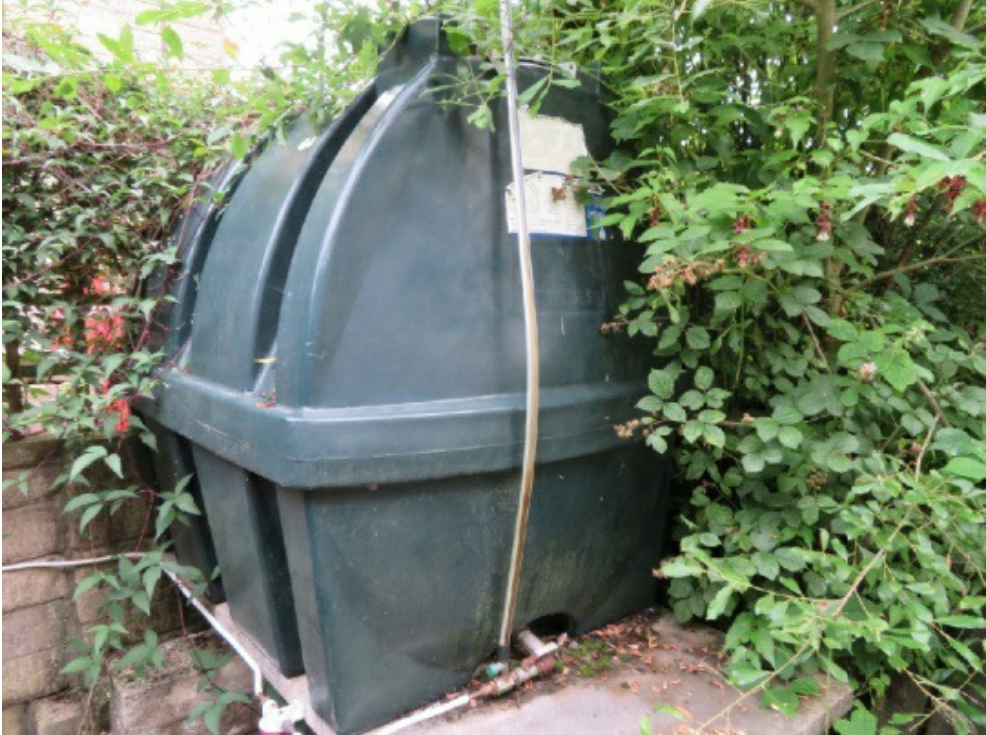
<p>Oil tanks</p>

Condition	<p>I do not believe this tank fully complies with all of the regulations noted above. The installation of the LPG containers does not comply with the HSE regulations, see photo below.</p> <p>Advice: OFTEC recommends that all oil appliances and boilers are inspected and serviced according to manufacturers' guidance, but at least once a year. At the time of survey no documentation was seen to verify that an inspection or servicing has been carried out within the last 12 months. From a health and safety perspective, it is recommended that you commission an inspection and servicing of the oil installation and appliances prior to occupation of the property.</p>

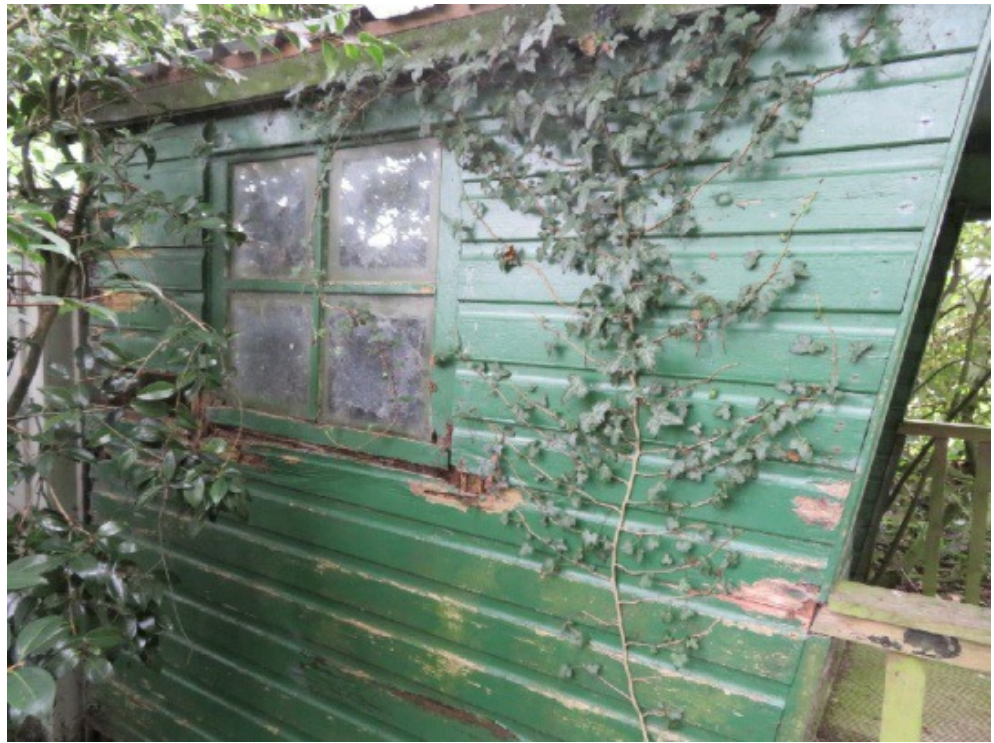
7.2 Outbuildings and Sheds	Condition rating	2
Construction & Type and Limitations	<p>There are no permanent outbuildings.</p> <p>The garden shed is of steel and the summerhouse is of timber construction. There is also a greenhouse.</p> <p>They were assessed for general condition and were examined externally to identify areas of rot, damage, leaks and other defects.</p>		
Condition	The shed is in a fair condition. The summerhouse has rot below the side window. The greenhouse is in a fair condition but is unlikely to be constructed with safety glass, making it a health and safety hazard.

Rot to summerhouse

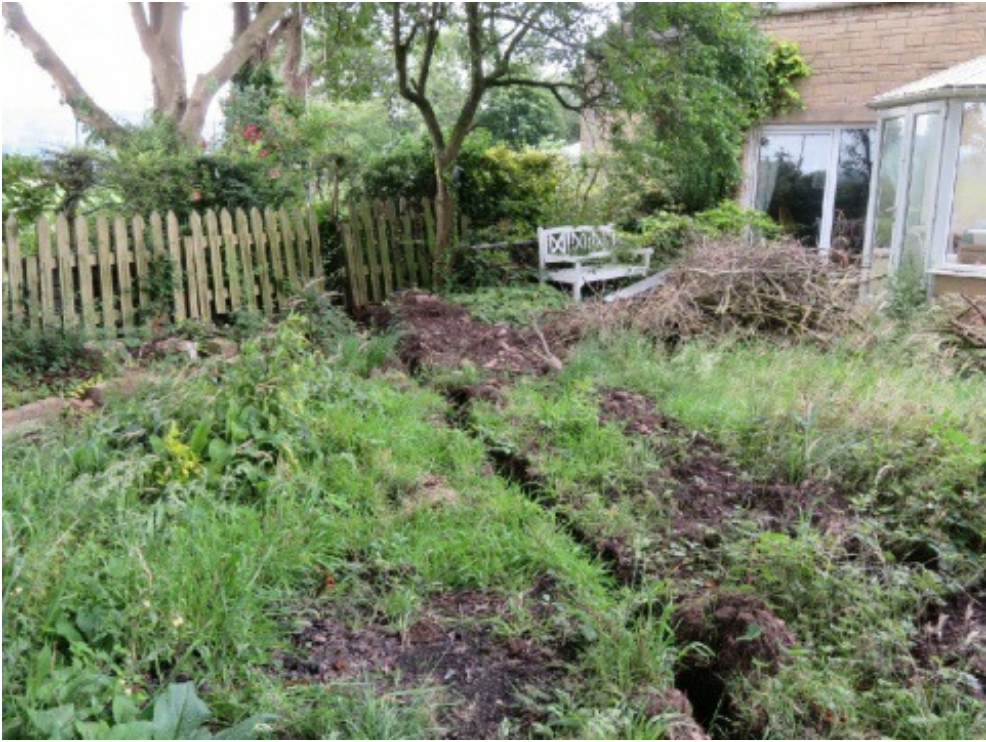
<p>Condition</p>	<p>There is no evidence of any damage from recent flooding.</p> <p>The gardens are presented in a poor condition.</p> <p>The driveway surface is in a serviceable condition and is reasonably level.</p> <p>There is no indication of the ownership of any of the boundary walls, fences or hedges, and in most cases this is not specified by the deeds or title documents. Often, responsibility for boundaries to one side or another has been assumed by subsequent owners. You should ask your conveyancer to advise on any indications of ownership included in the title documents.</p> <p>A trench has been dug in the rear garden to lay cables for broadband.</p>
	<div style="text-align: center;">

<p>Trench for broadband</p> </div>
