BUILDING SURVEY REPORT

REF 8561

The format of this Mi BUILDING SURVEY REPORT is consistent with the guidance note requirements for a Survey Level 3 as defined by RICS Surveys of Residential Property 3rd edition May 2016

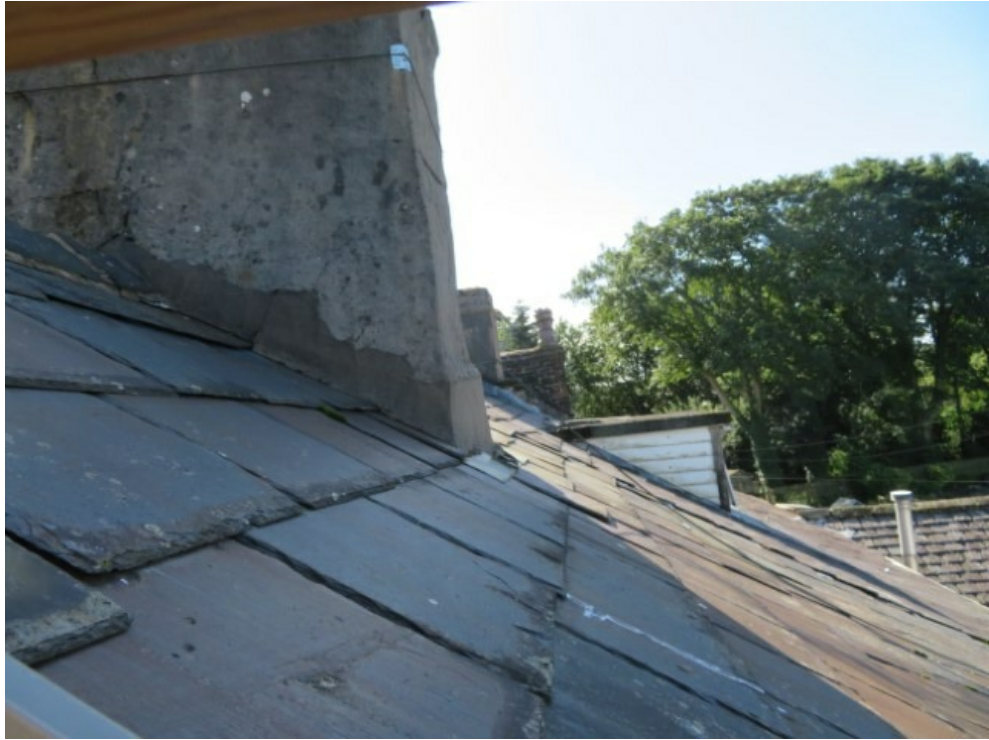
4.1 Chimney Stacks	Condition rating	2
Construction & Type	The chimney stack is brick built and is rendered with a sand-cement finish. It has one pot which provides a flue to the gas fire in the lounge. The flashing at the base of the stacks at the junction with the roof slopes is expected to be of lead, see below.		
Nature of inspection and Limitations	The chimney was examined from ground level with the aid of binoculars for possible defects including undue movement, distortion, chemical or weather related damage, brickwork, render and pointing damage and other evidence of failure.		
Condition	<p>All render and pointing seen were in a fair condition.</p> <p>The pot has an integral rain cowl fitted to allow flue gases to escape but prevent vertical rain entering the flue line.</p> <p>Chimney stacks very often bulge and distort as a result of natural weathering caused by wind-driven rain, sulphate attack and also attacks by condensation and the products of combustion (soot and salts etc). Such problems are very often accentuated by lack of a proper flue lining system. No distortion was noted on my visit.</p> <p>Either the render has been fixed over or there is a distinct lack of lead flashing. No damp was noted internally but you should monitor this on the first floor or carry out an investigation as to whether there is good weather protection in place.</p> <p>No Repair is currently needed. The stacks must be maintained in the normal way.</p>

Lack of lead flashing

Action Required	The chimney stack should be regularly monitored for any indications of damage, instability or other defects. Missing, loose or defective mortar should be re-pointed as necessary.

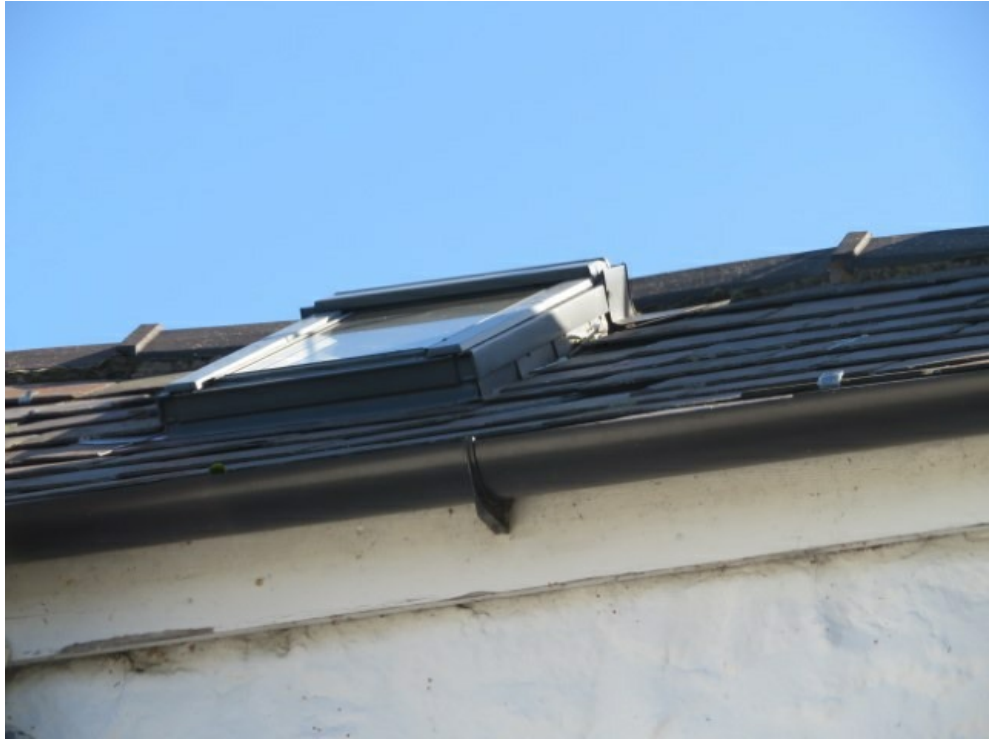
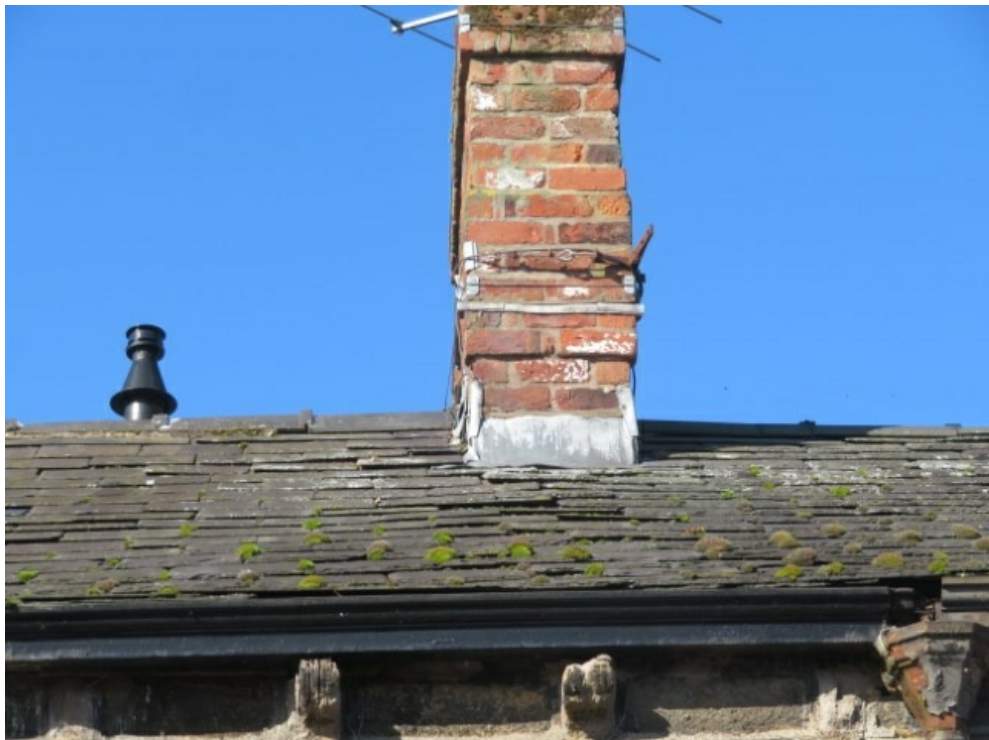
Incomplete mortar to ridge tiles

<p style="margin: 0;">Action Required</p>	<p style="margin: 0;">Any slipped, missing or broken slates on the roof pitches should be repaired and replaced. You should carry out a thorough visual inspection at least once a year, ideally in the Spring to identify and repair any damage that could have been caused by winter weather. Any missing mortar beneath any ridge tiles should be replaced. Any moss or other accumulated plant matter should be cleared</p>

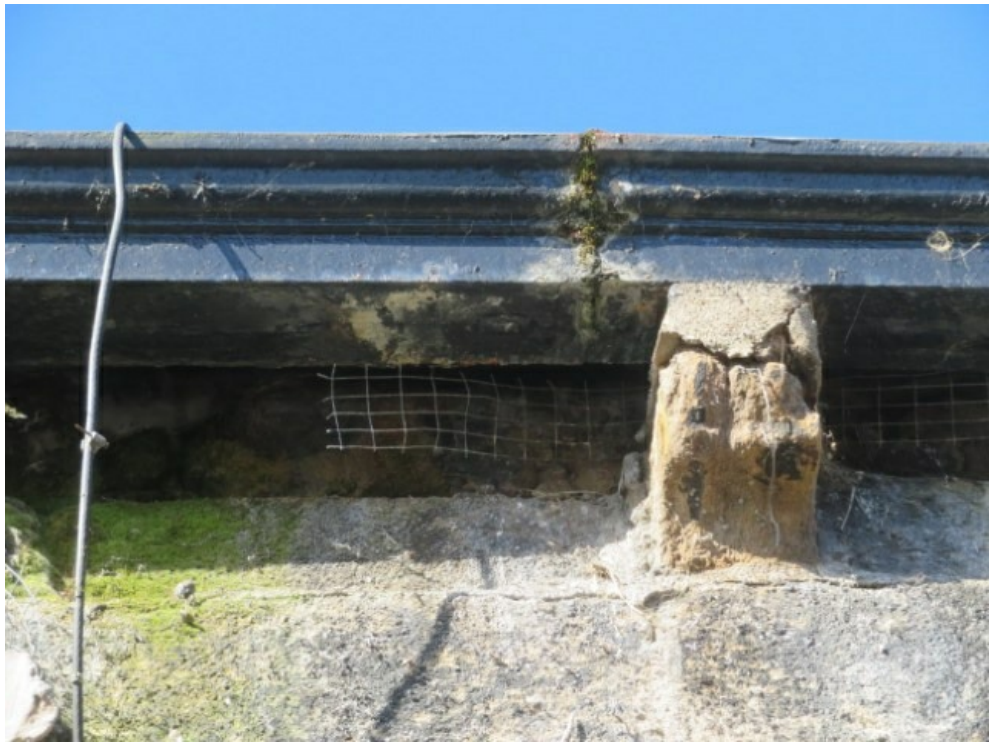
Lack of mesh protection from pests

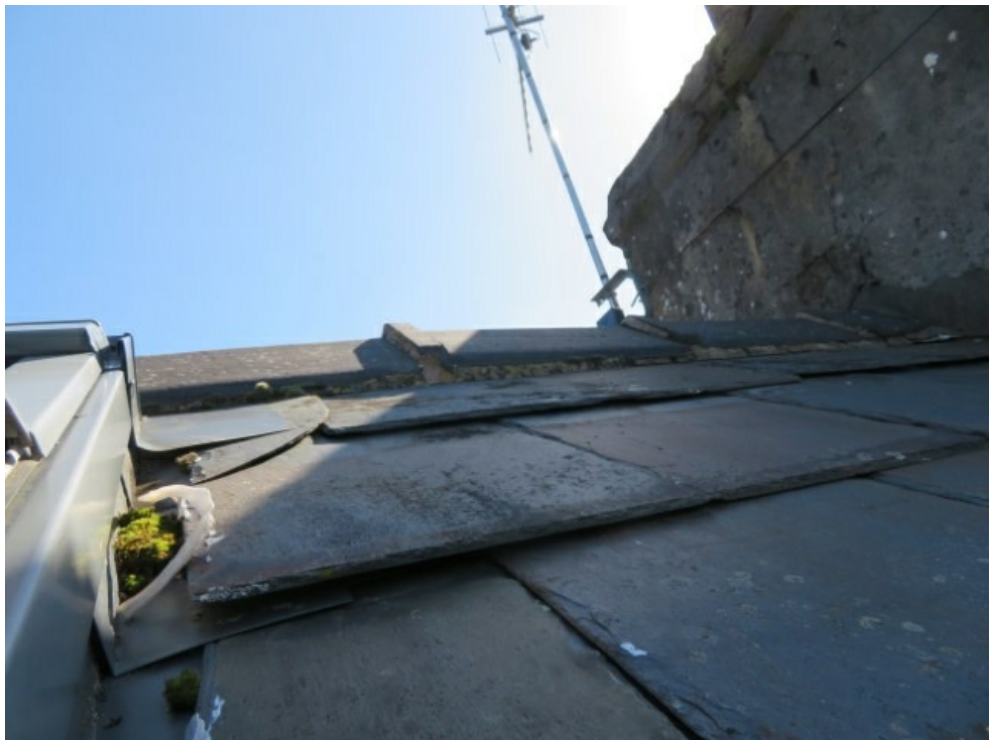
Moss stopping rain run off

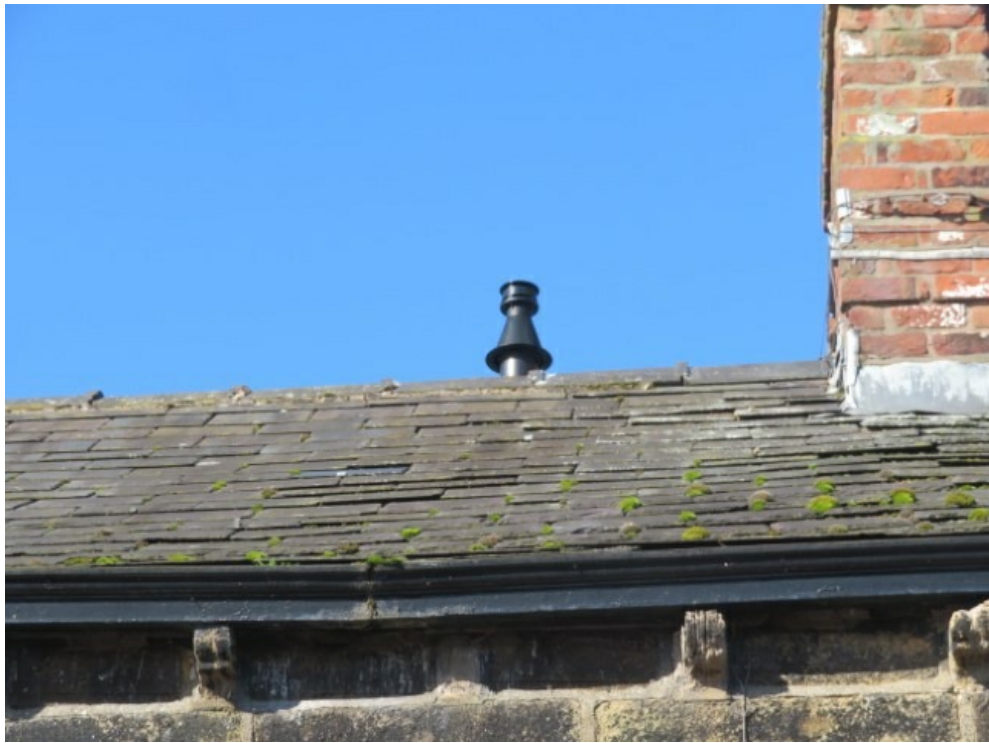
Moss to slates

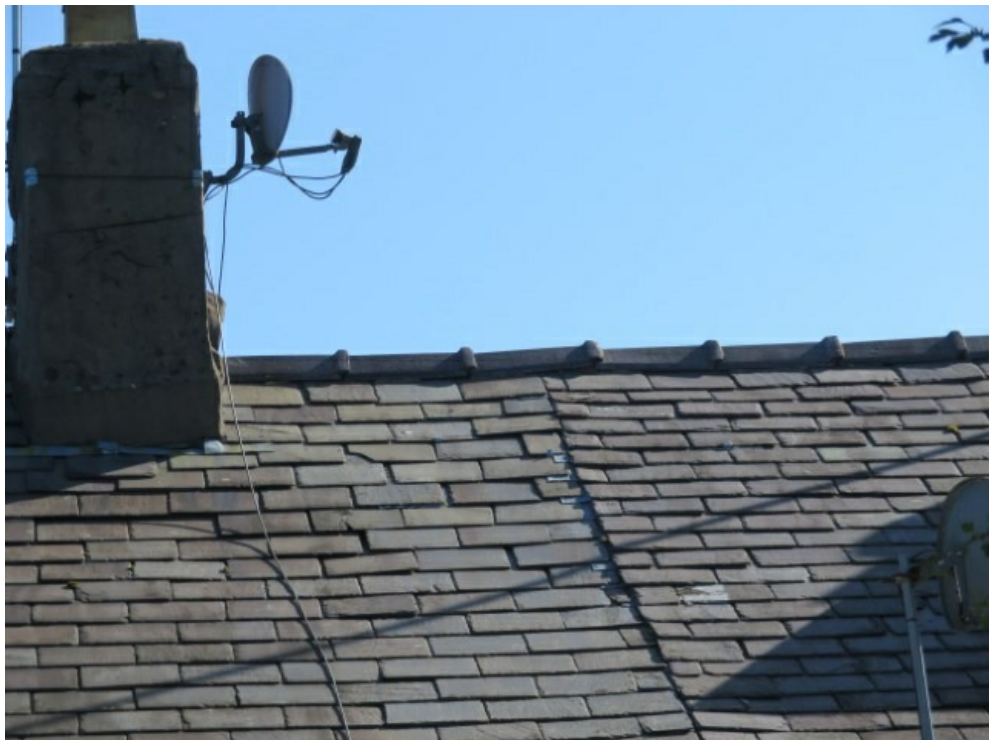
Poor roof junction

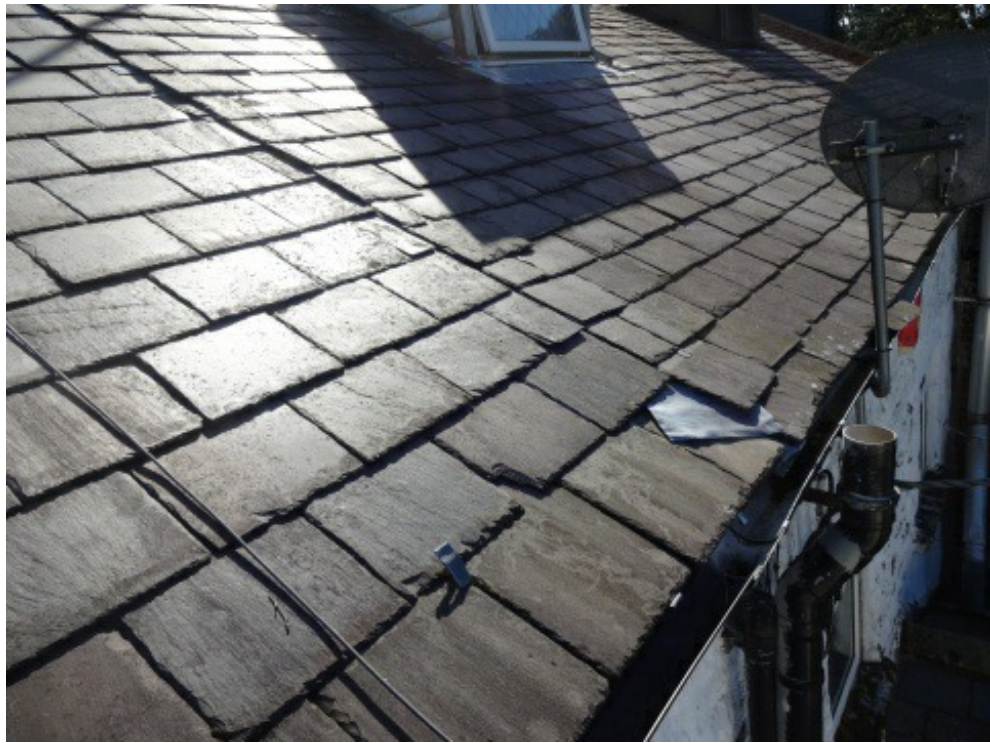
Slipped lead flashing

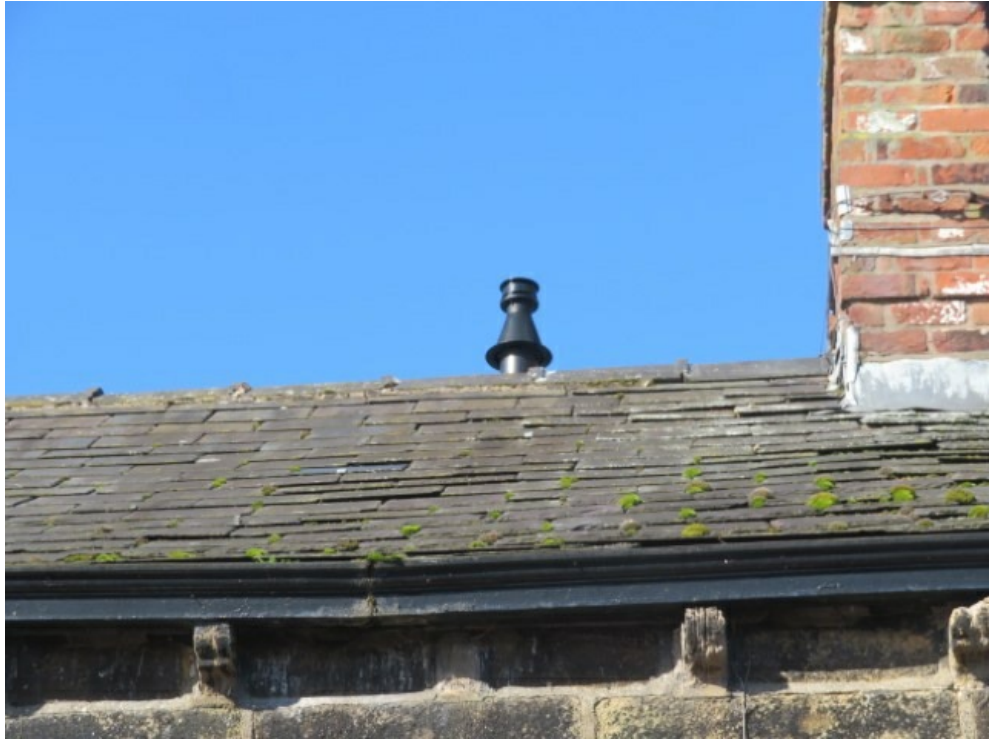
Dip to gutter

Action Required	<p>Gutters and downpipes should be cleaned and inspected regularly to ensure that they are free from blockages and leaks. If it is noted during any heavy rain, that gutters or downpipe joints are leaking, then these must be fixed as soon as possible to prevent water penetration to the property and damage to the foundations.</p>

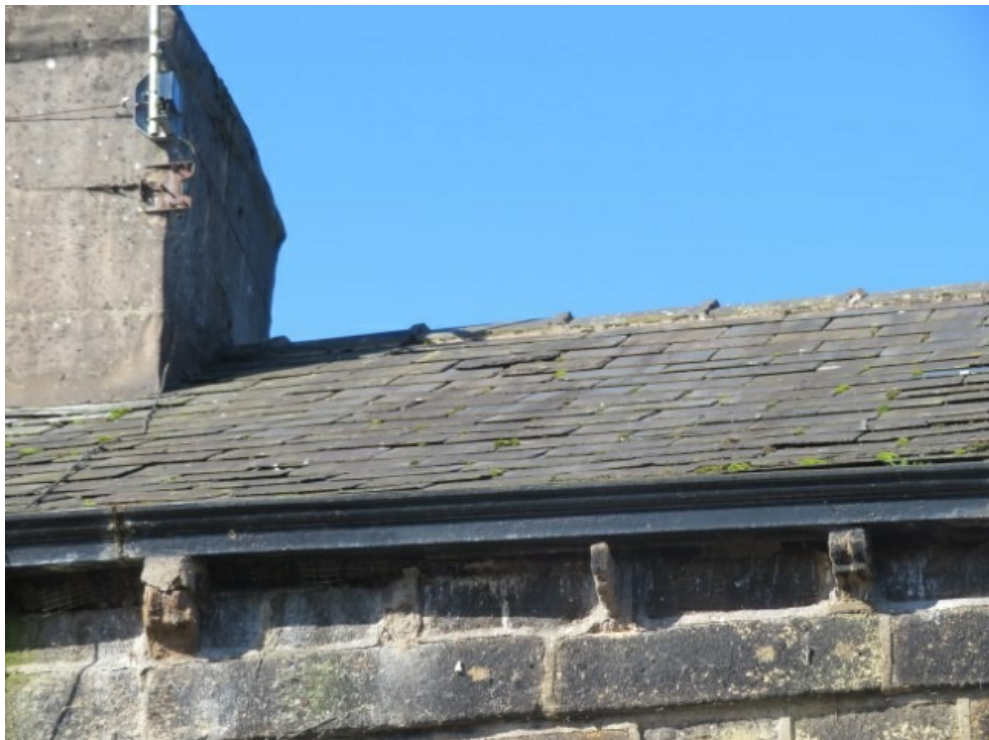
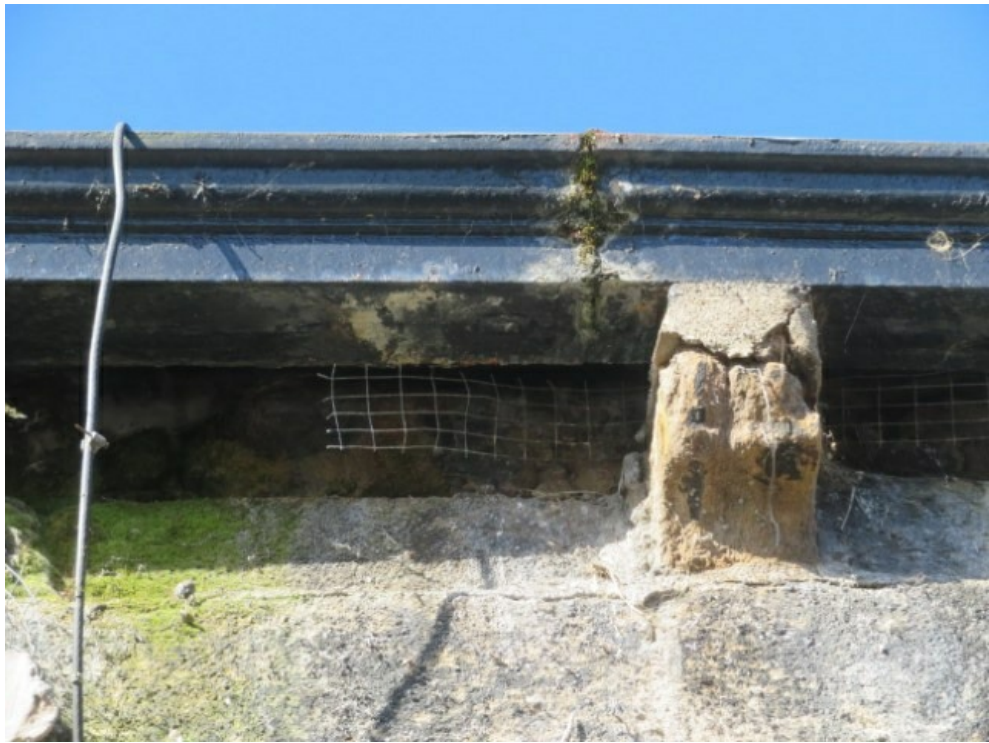
Eroded stone gutter supports

Eroded stone support for gutters

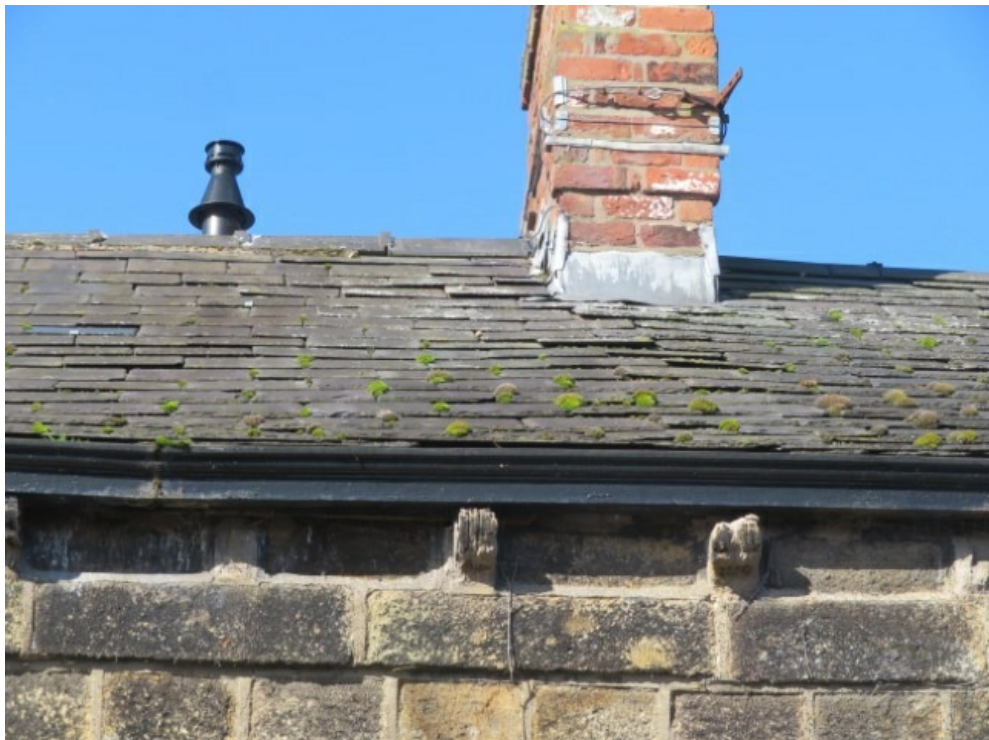
Missing stone gutter support

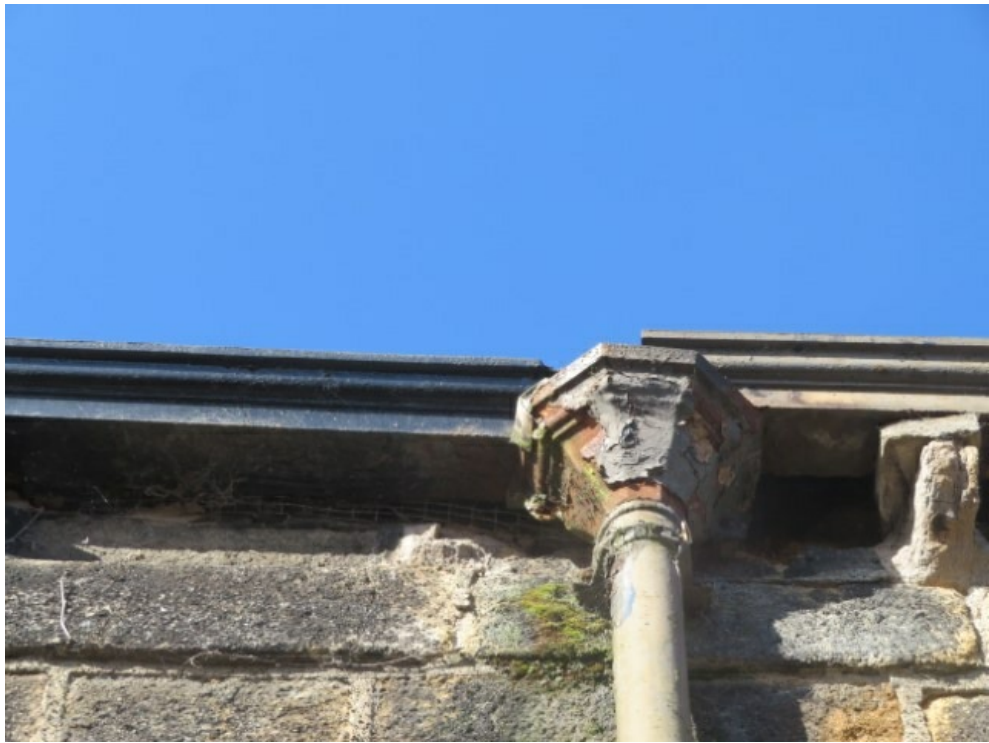
Rusting hopper

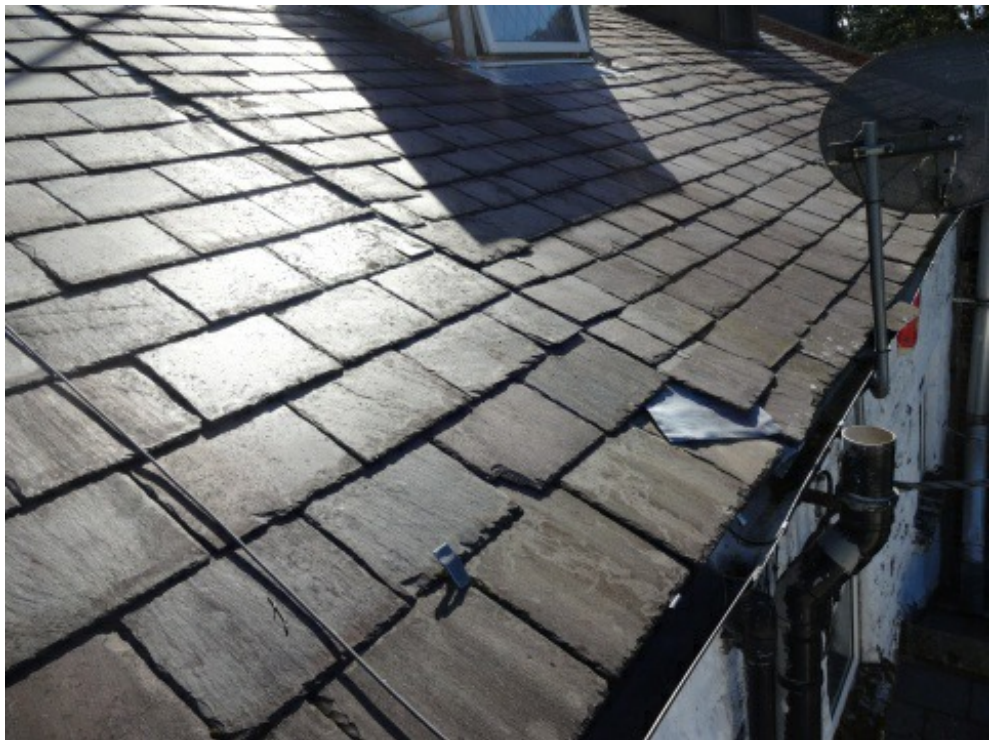
Lack of bird cage to waste stack

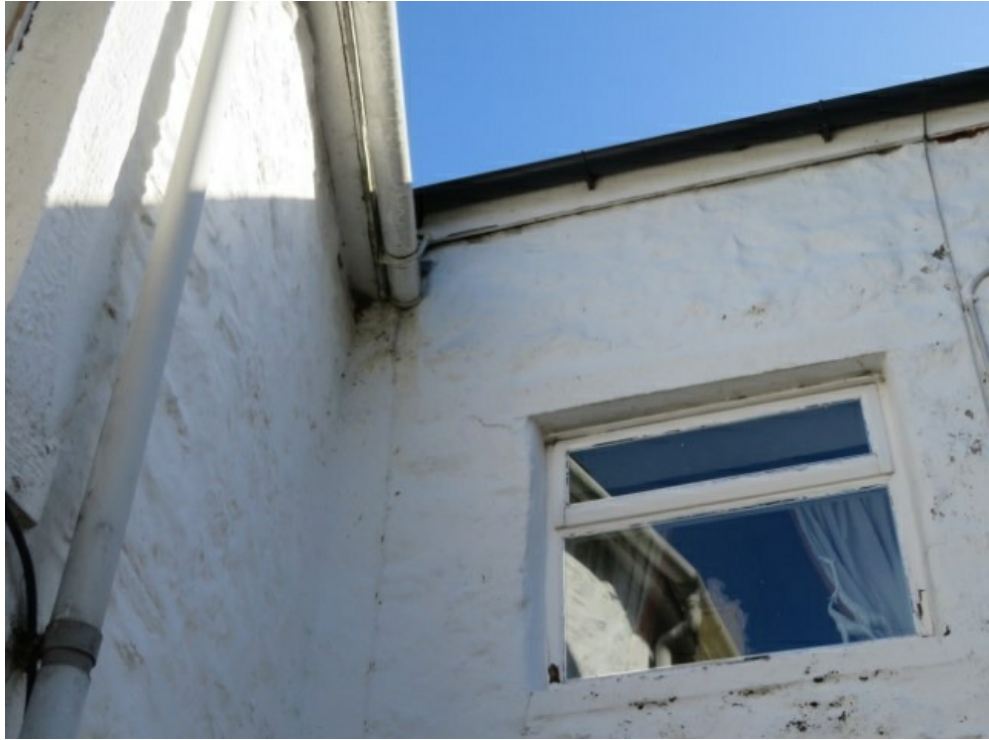
Possible leak to end of gutter

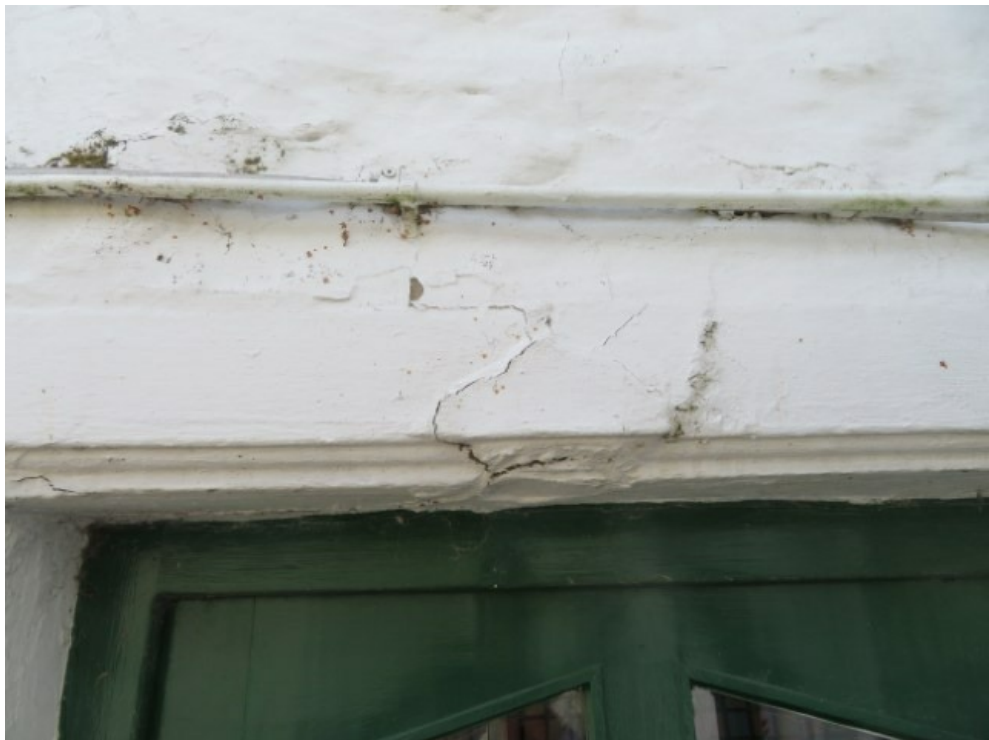
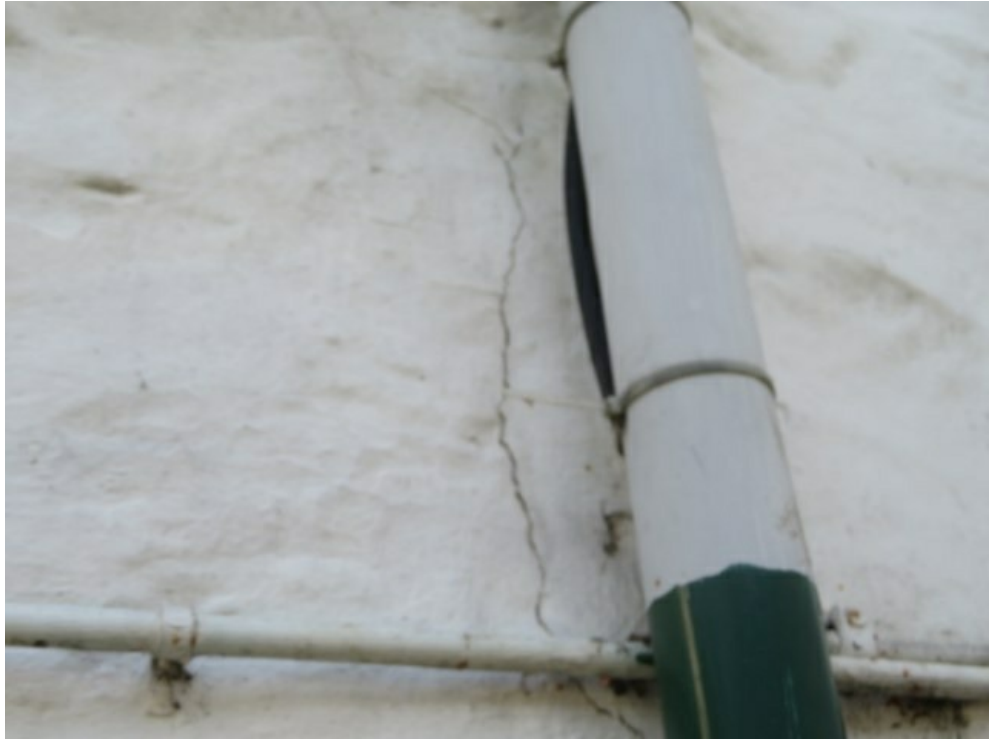
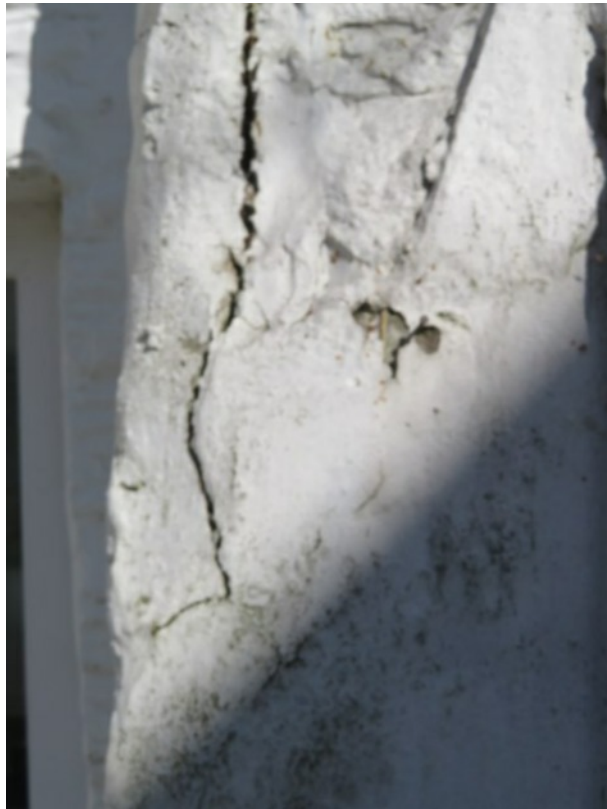
<p>brickwork. Consequently if water does penetrate to the masonry it will not be allowed to evaporate through the render. The masonry can get wet when the render is cracked, it will then start to penetrate internally, therefore any cracks to the render should be repaired as quickly as possible. I noted a number of cracks to the render and probable evidence of damp penetrating behind the render. I am unable to determine if this render is lime or cement from just a visual inspection, however it seems to be quite hard, therefore I suspect it is sand and cement. If it is sand and cement based then cracks will allow damp to penetrate internally, if it is lime based it should allow the walls to breathe, therefore damp should not cause any internal problems. You can get the render tested at a laboratory. The render also reaches ground level which is not to current standards and should be finished 6" (150mm) from ground level with a Bell Mouth Finish, see diagram below. There is an amount of failing render within the ginnell which may be a shared responsibility.</p> <p>The external walls were found to be structurally sound.</p>

Cracks to render

<p>Action Required</p>	<p>Walls should be examined regularly to inspect for changes in the nature of any cracking or other defects that may become apparent.</p>
<p>Additional Information</p>	<p>The Society for the Protection of Ancient Buildings (SPAB) is a good source of information for looking after older buildings. www.spab.org.uk</p> <p>This website offers a list of trade people capable of working on and using the correct materials for older buildings. https://www.buildingconservation.com/directory/allco.php</p>
	<div data-bbox="416 965 1406 1704" data-label="Image"> </div> <p data-bbox="810 1720 1007 1749" style="text-align: center;">Eroded pointing</p>

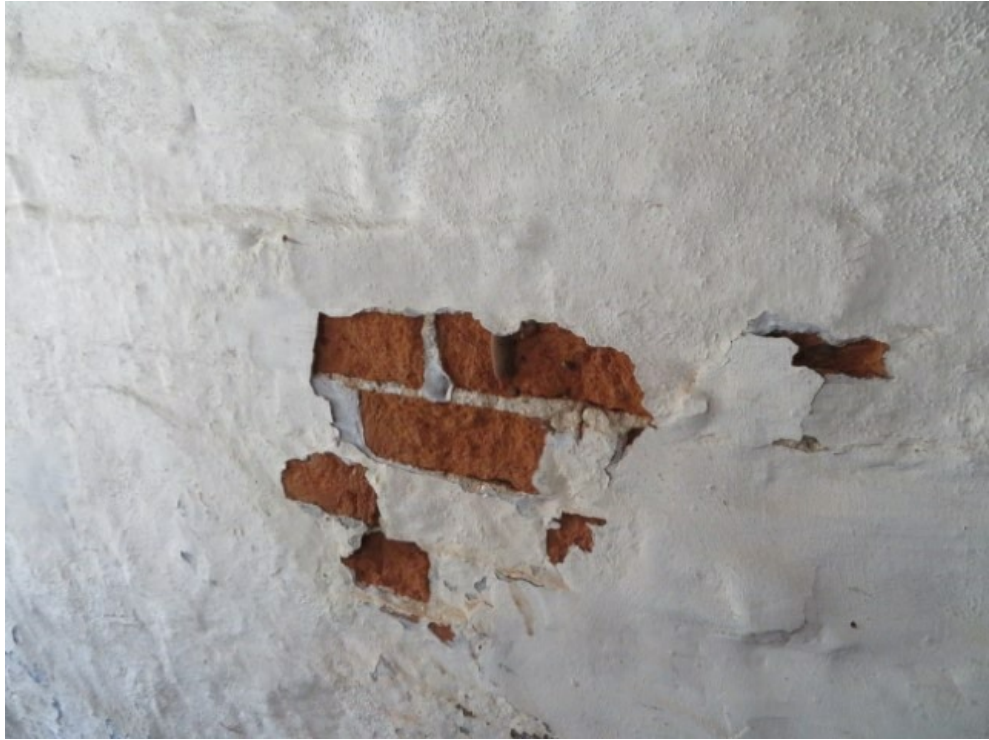
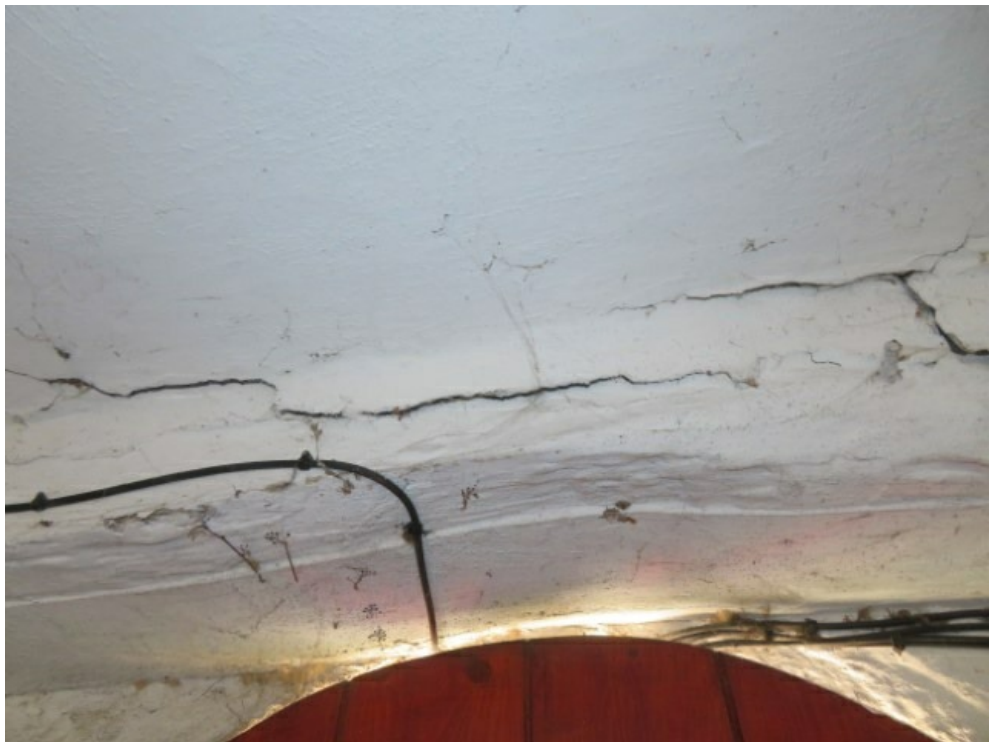
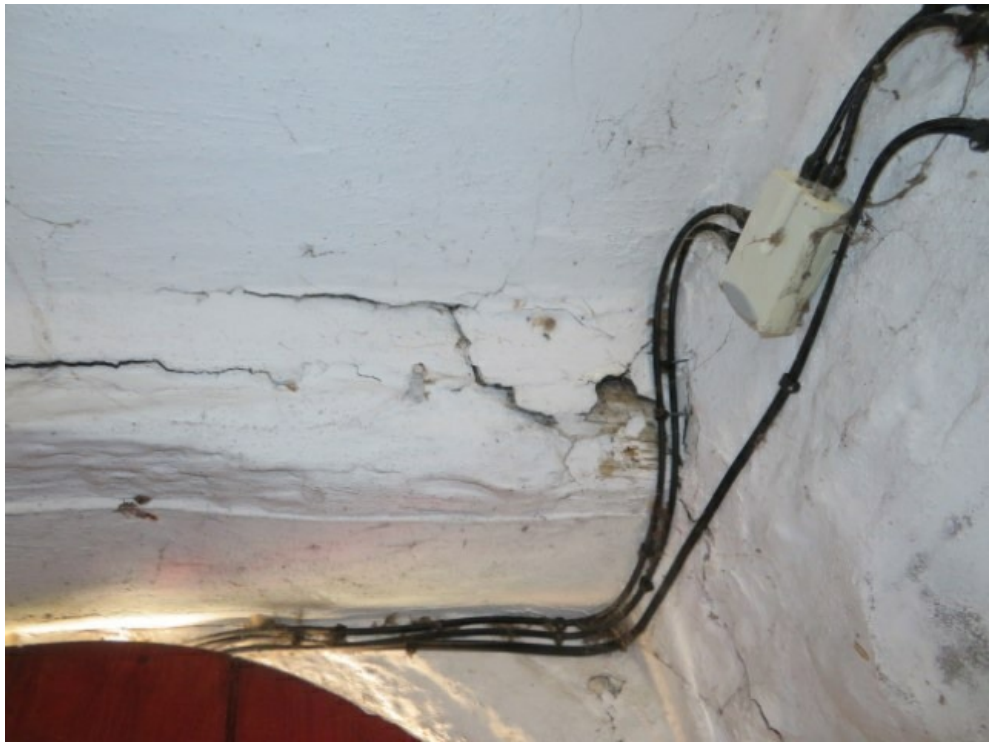
Failed render in ginnell

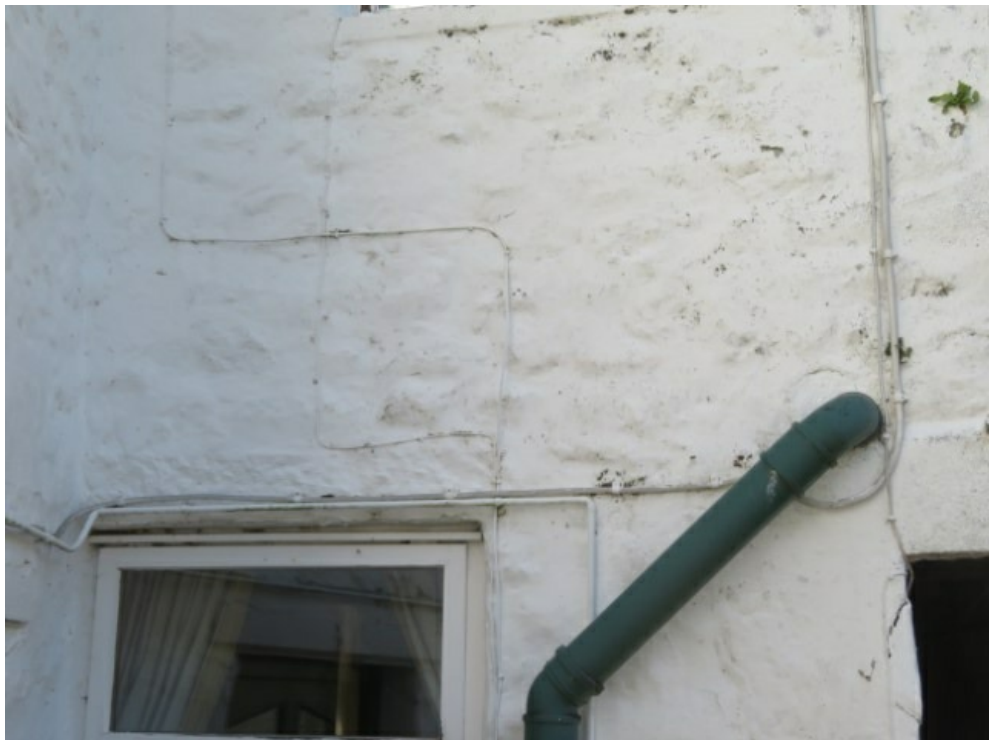
Black stains suggesting damp behind render

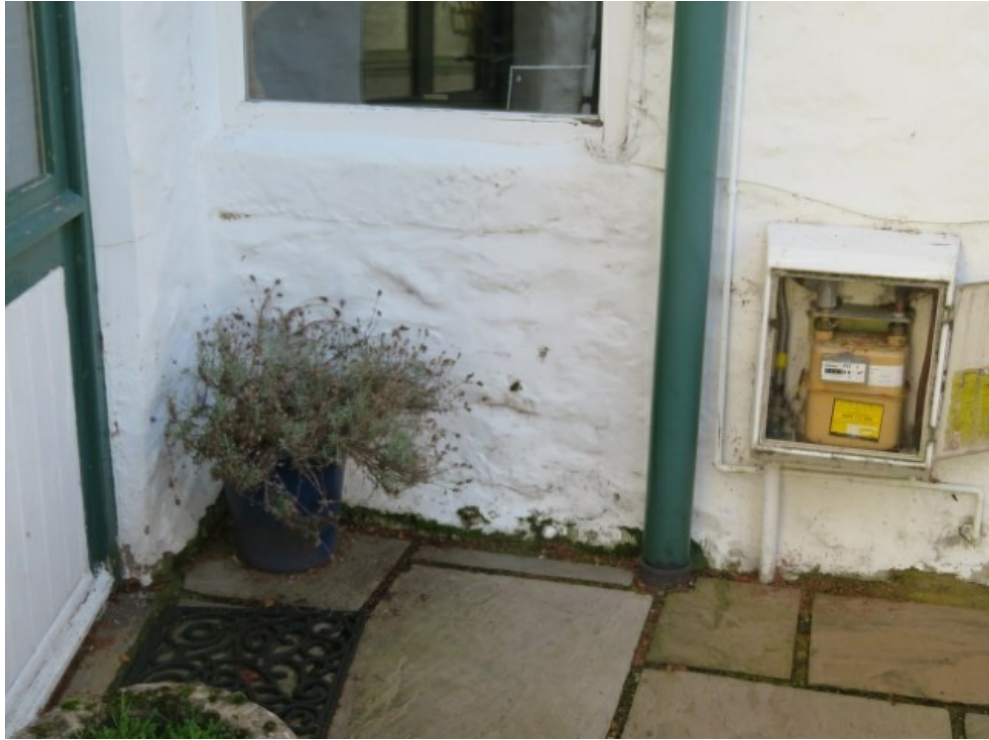
Render to ground level

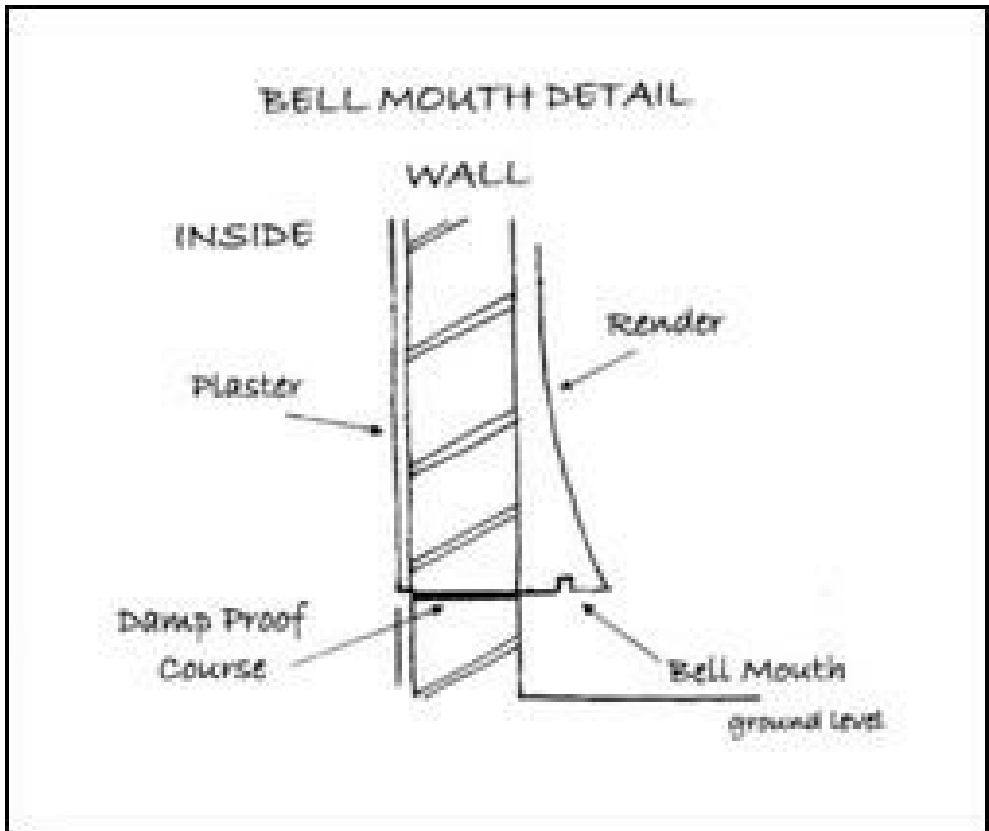
Bell mouth render finish

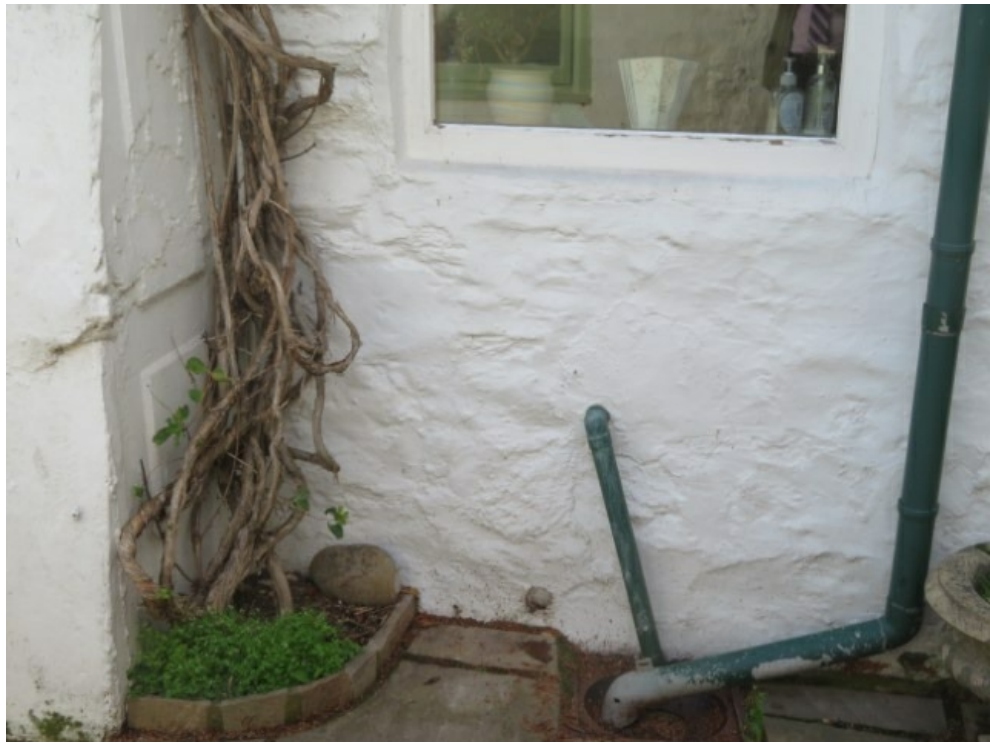
Ivy to wall

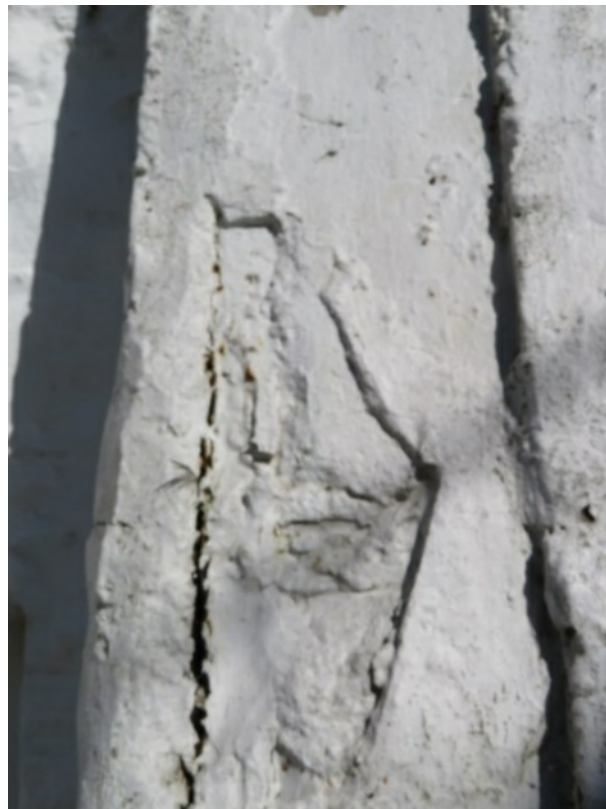
Cracks to buttress

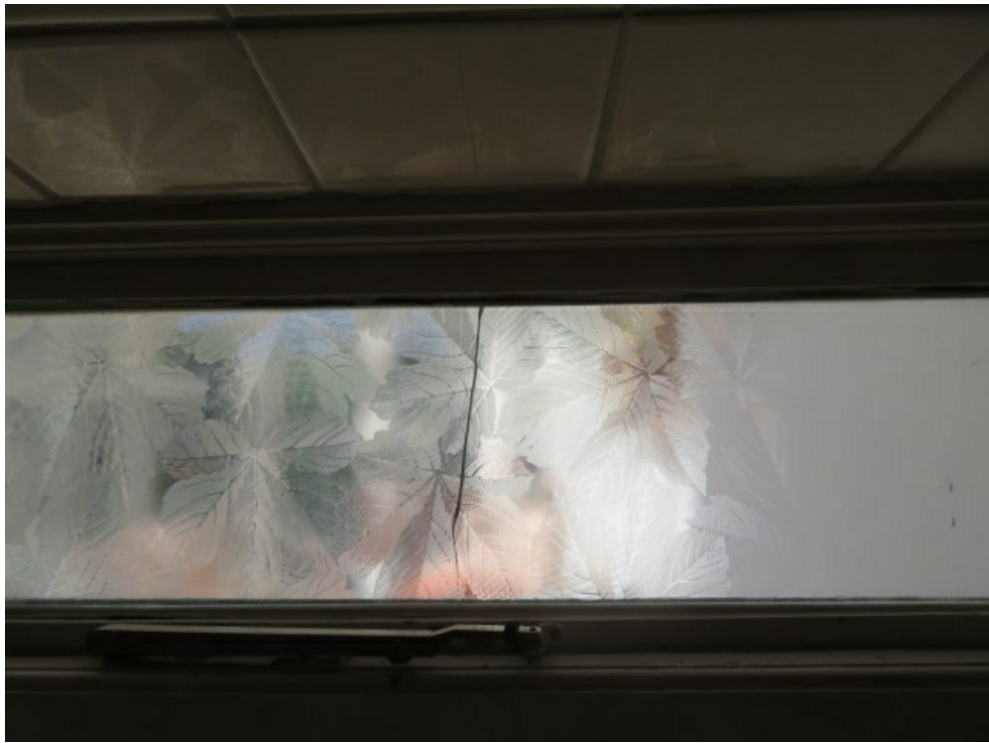
Broken window pane

Action Required	<p>Any future misted double glazing units will require replacement. It should also be considered that, where some sealed units within a window have failed, others may also fail in due course.</p> <p>Replacement to a number of frames is required, subject to consent as mentioned above.</p> <p>Be aware that previous owners may have distributed multiple sets of keys for the windows and doors to individuals not known to you. When purchasing a property, you should consider the cost of replacing all of the door and window locks as soon as possible after you take up occupation. When doing this you should consult your insurers to ensure that you meet their requirements for security, and obtain any discounts that may be available by improving the security of the property.</p>

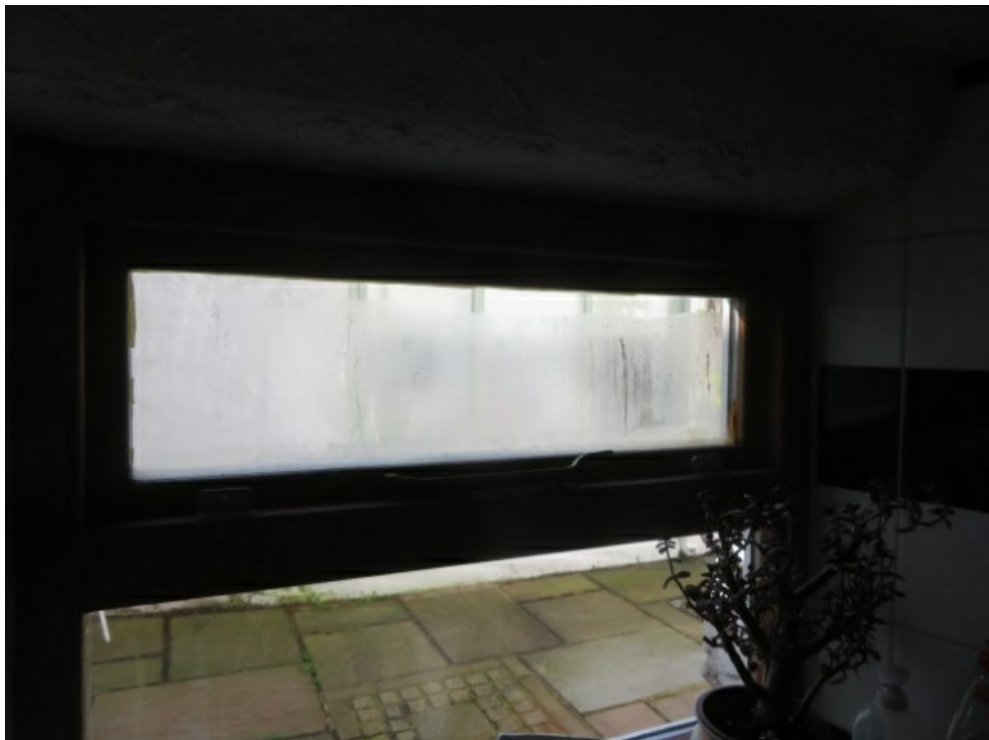
Misted (failed seal) window
