BUILDING SURVEY REPORT

REF 8561

The format of this Mi BUILDING SURVEY REPORT is consistent with the guidance note requirements for a Survey Level 3 as defined by RICS Surveys of Residential Property 3rd edition May 2016

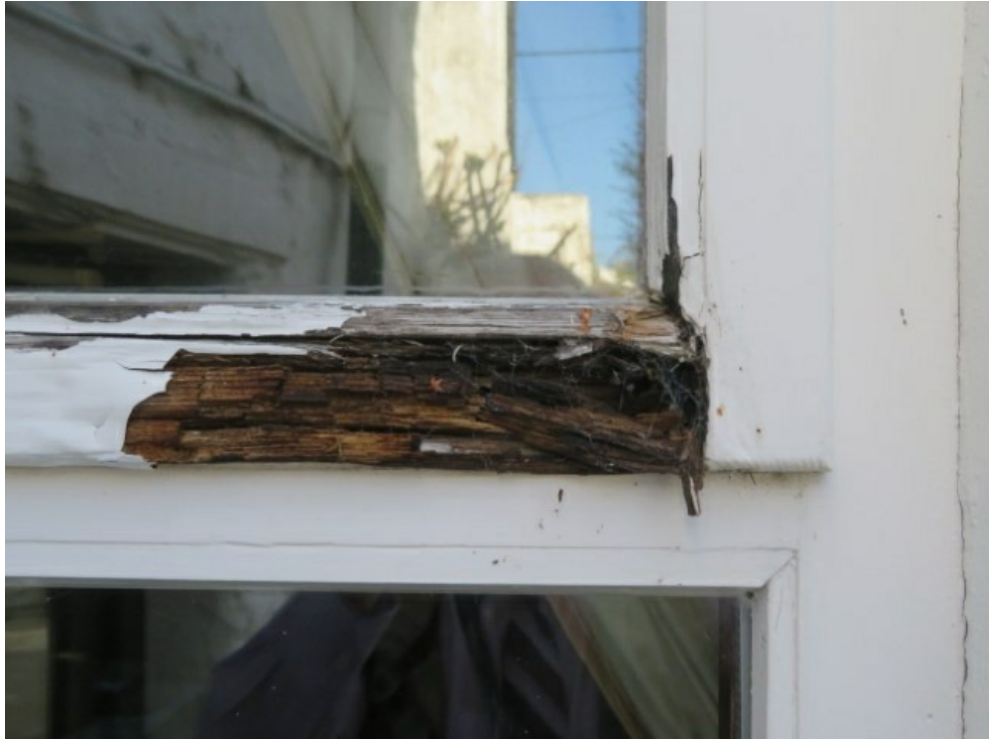
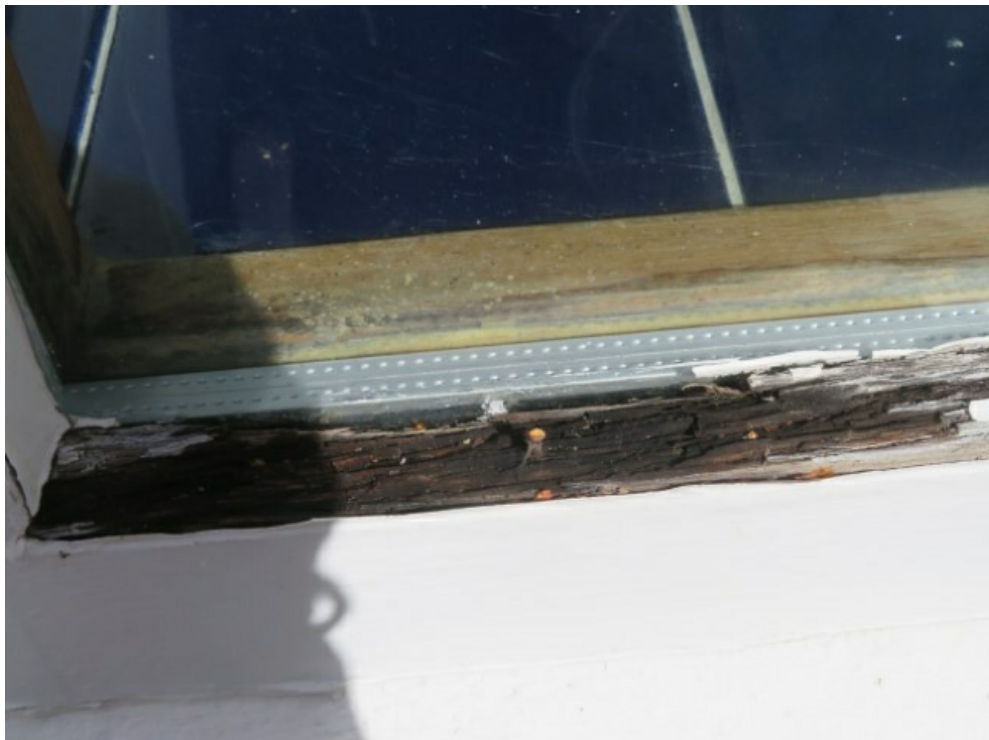
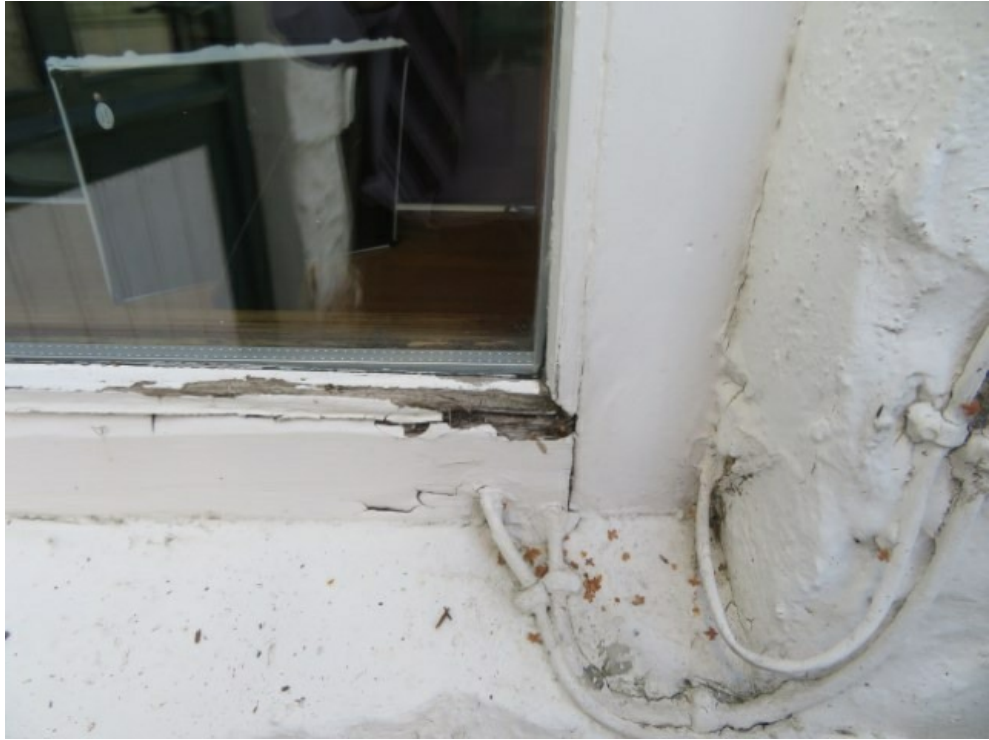
Rot to window frame

Action Required	<p>Any future misted double glazing units will require replacement. It should also be considered that, where some sealed units within a window have failed, others may also fail in due course.</p> <p>Replacement to a number of frames is required, subject to consent as mentioned above.</p> <p>Be aware that previous owners may have distributed multiple sets of keys for the windows and doors to individuals not known to you. When purchasing a property, you should consider the cost of replacing all of the door and window locks as soon as possible after you take up occupation. When doing this you should consult your insurers to ensure that you meet their requirements for security, and obtain any discounts that may be available by improving the security of the property.</p>

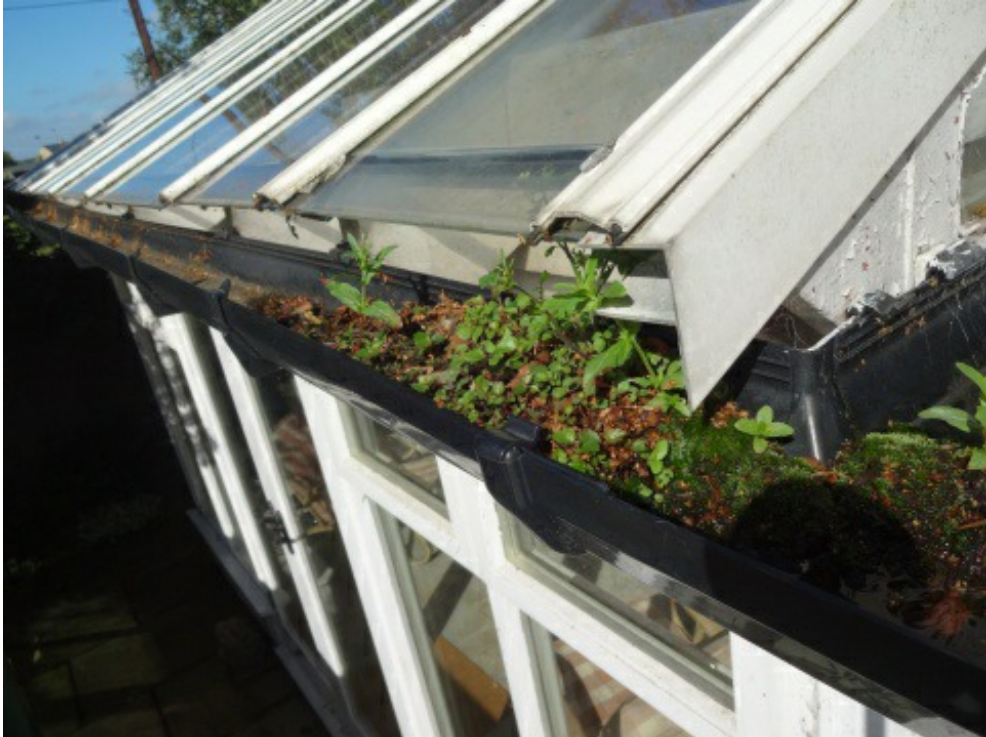
<p>Moss growth in conservatory gutter</p> </div>

Action Required	The conservatory requires extensive repair.		
	<div style="text-align: center;">

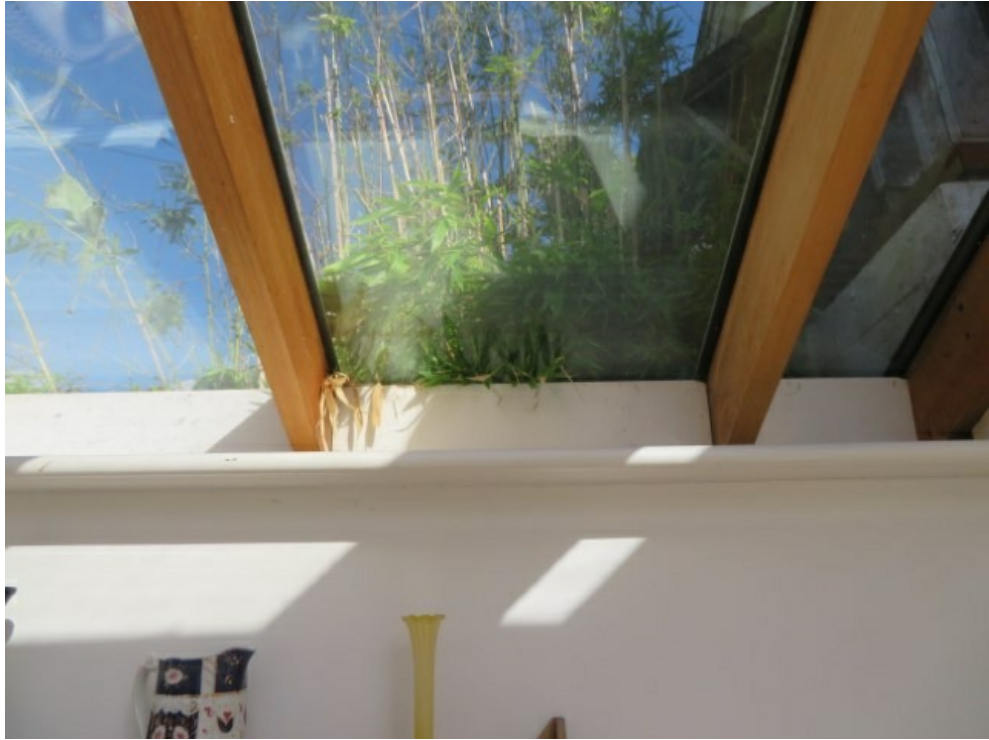
Vegetation growth in conservatory from neighbours property

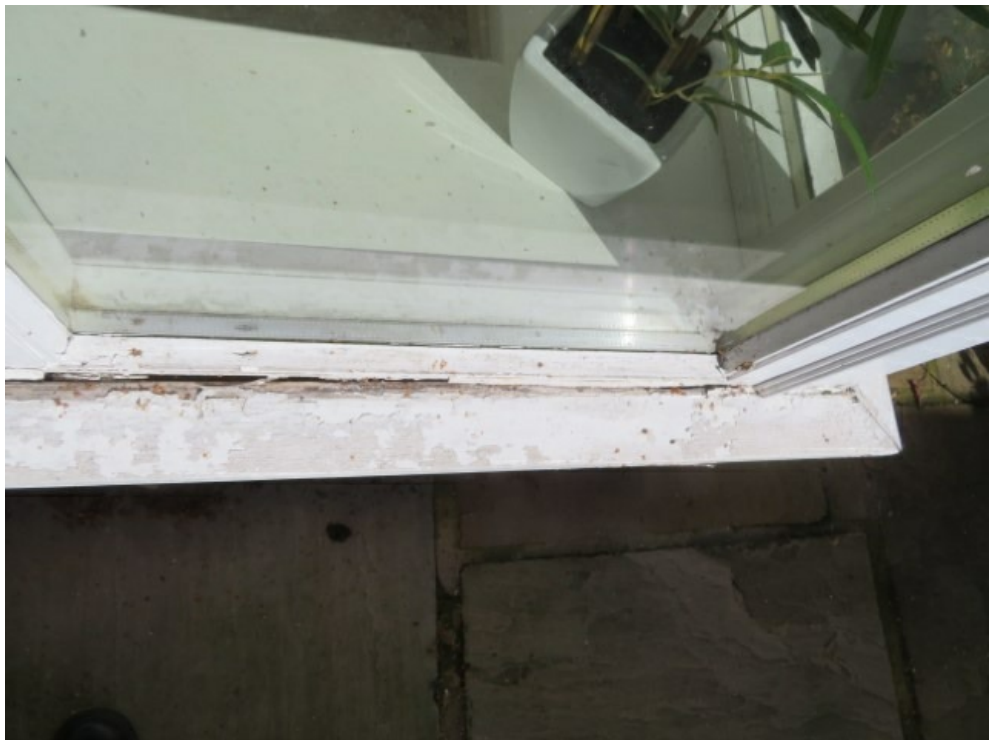
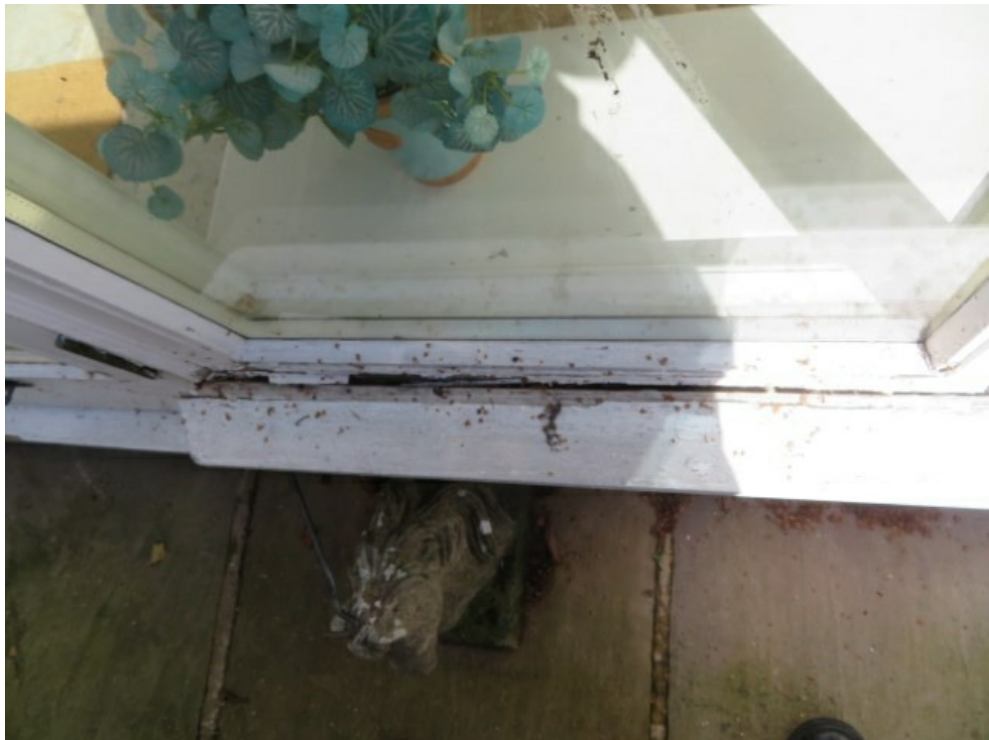
Movement to conservatory window sill

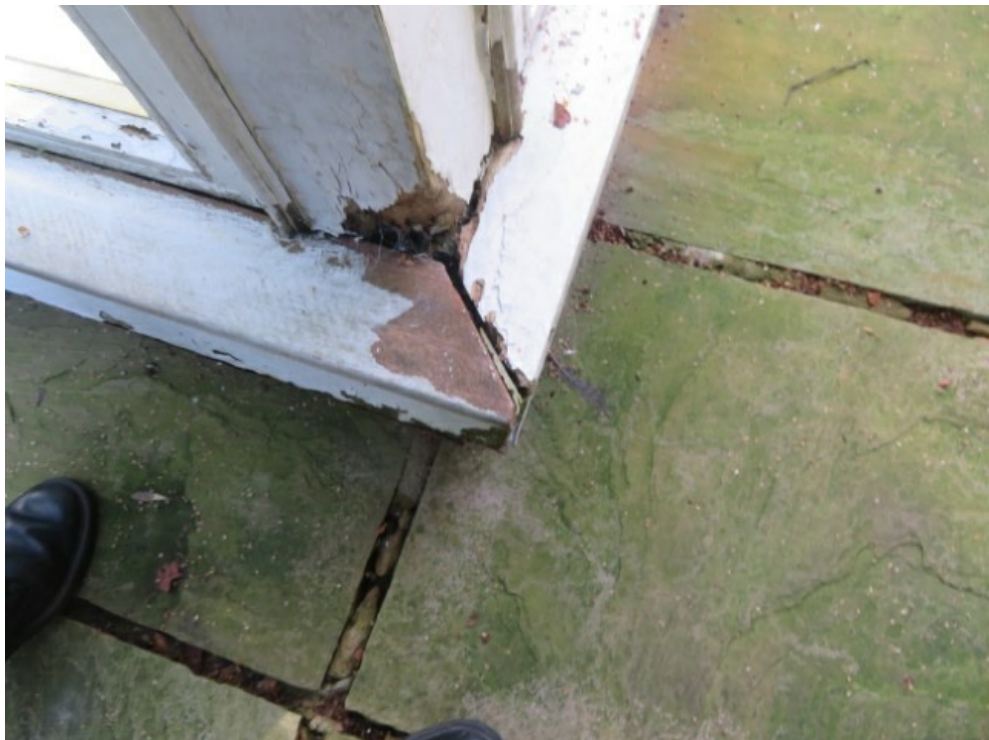
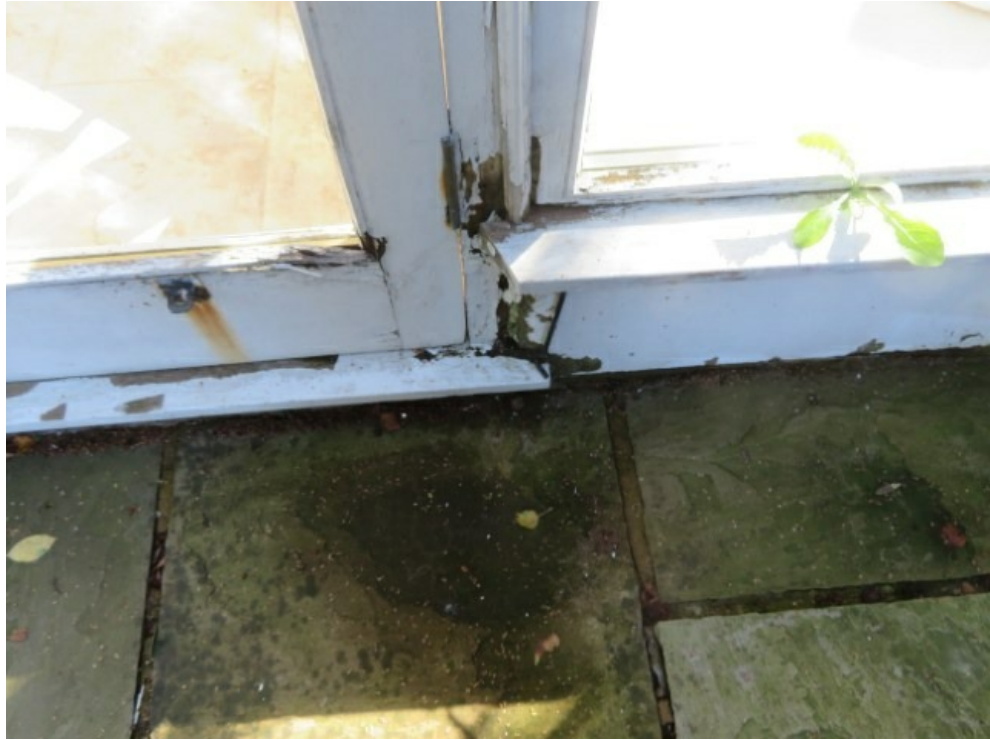
Rot to timber frame

Rot to timber frame and door

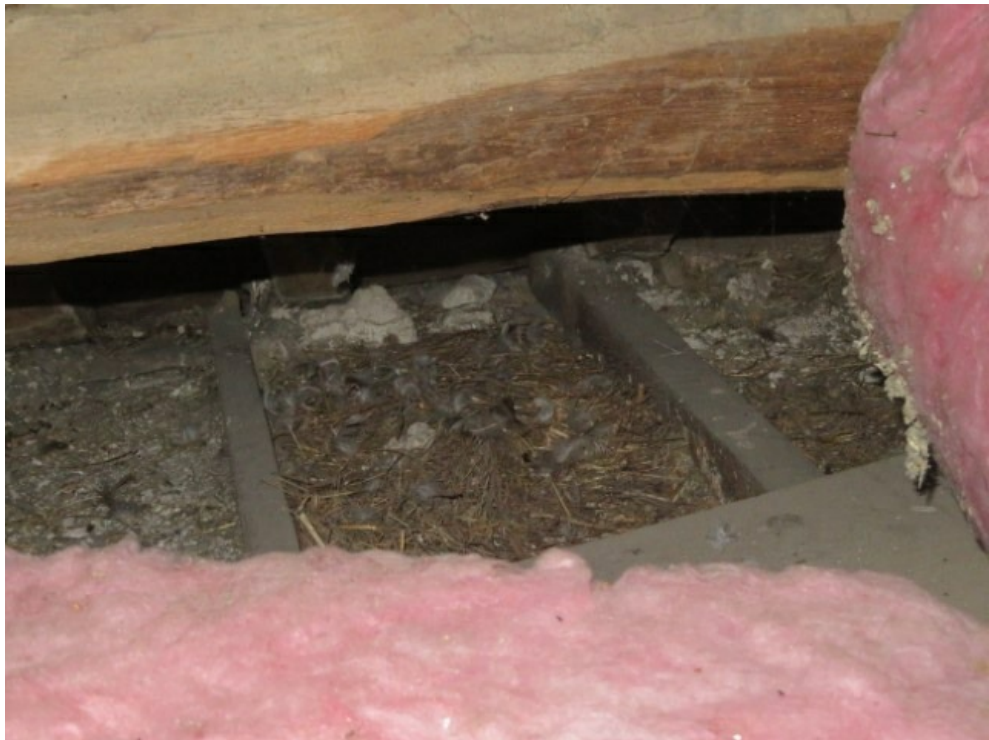
Birds nest in roof

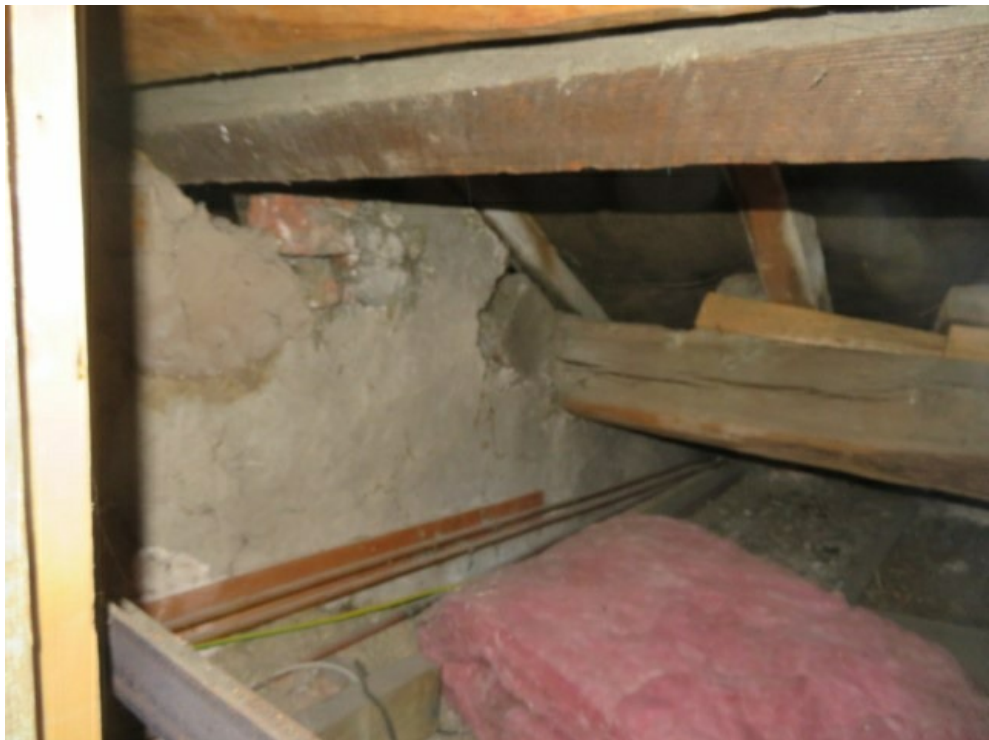
Condition	<p>The roof structure is in a fair condition with reasonable quality timbers throughout. The rafters, purlins and strut timbers are complete with no evidence of any undue stress or cracking. The bitumen undercovering (secondary waterproof covering) is complete with no major tears or missing sections.</p> <p>The roof space is laid with an average of 150mm of wool type insulation at joist level. This is close to the current recommendation of 270mm for maximum energy efficiency.</p> <p>The roof space has gapping below the front gutters to supply ventilation to the roof space. These should be kept clear, with insulation pulled back to free the space at the eaves. Without adequate ventilation condensation can form on the underside of the roof surface and hence introduce dampness to the roof space.</p> <p>As mentioned in section 4.2 there is some mesh to stop pests entering the roof space. However, as also mentioned it was incomplete and I noted evidence of a large birds nest in the roof space. The mesh needs to be complete to avoid pests such as birds, bats or rodents entering.</p> <p>Please see section 3.2 Health and safety issues. There is inadequate protection from fire spread from or to neighbouring properties.</p>

Lack of fire break

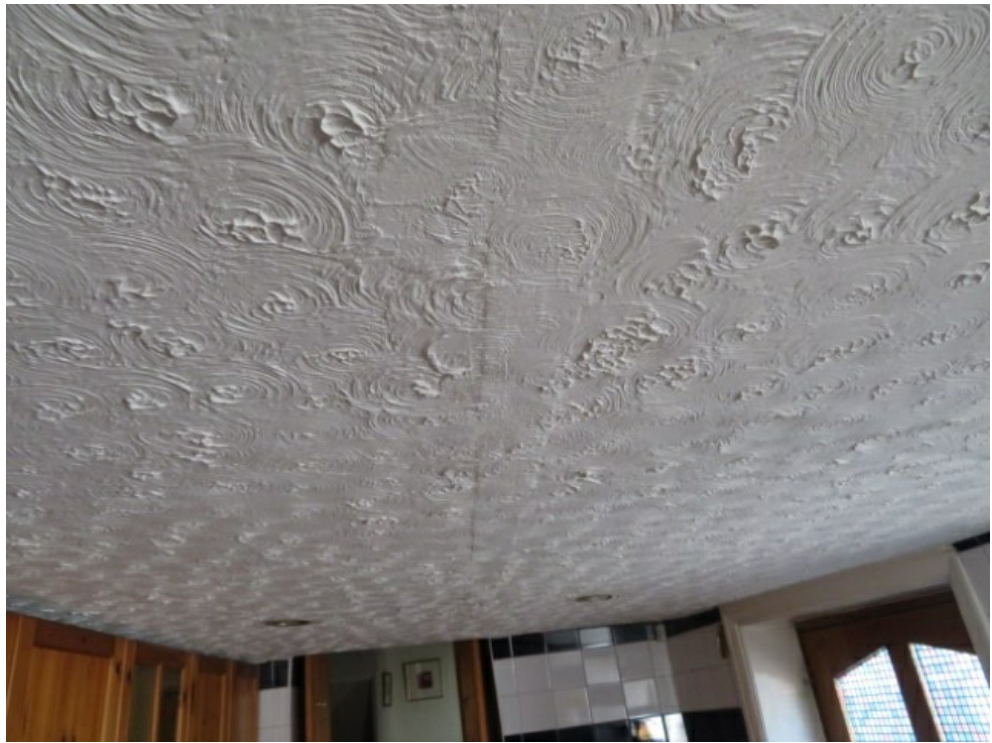
Artex to ceiling

Action Required	<p>Obtain the opinion of an Asbestos Surveyor to confirm if a risk is present due to the cracks to Artex ceilings.</p> <p>Normal future maintenance is required, including filling and redecorating any cracks as necessary.</p>

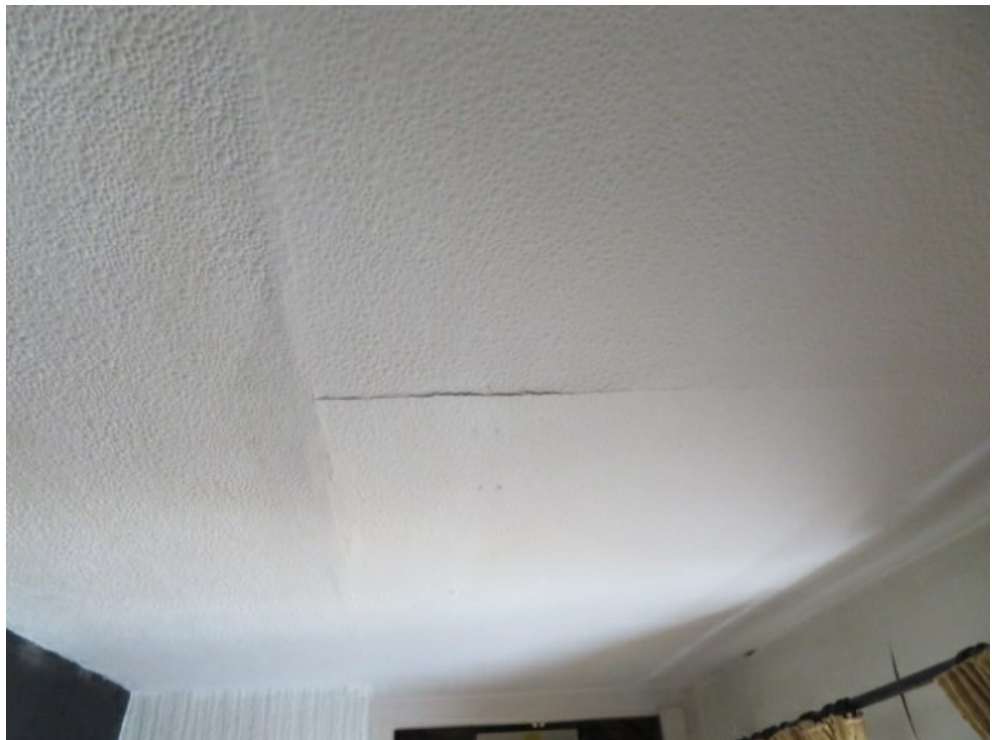
Plasterboard cracks

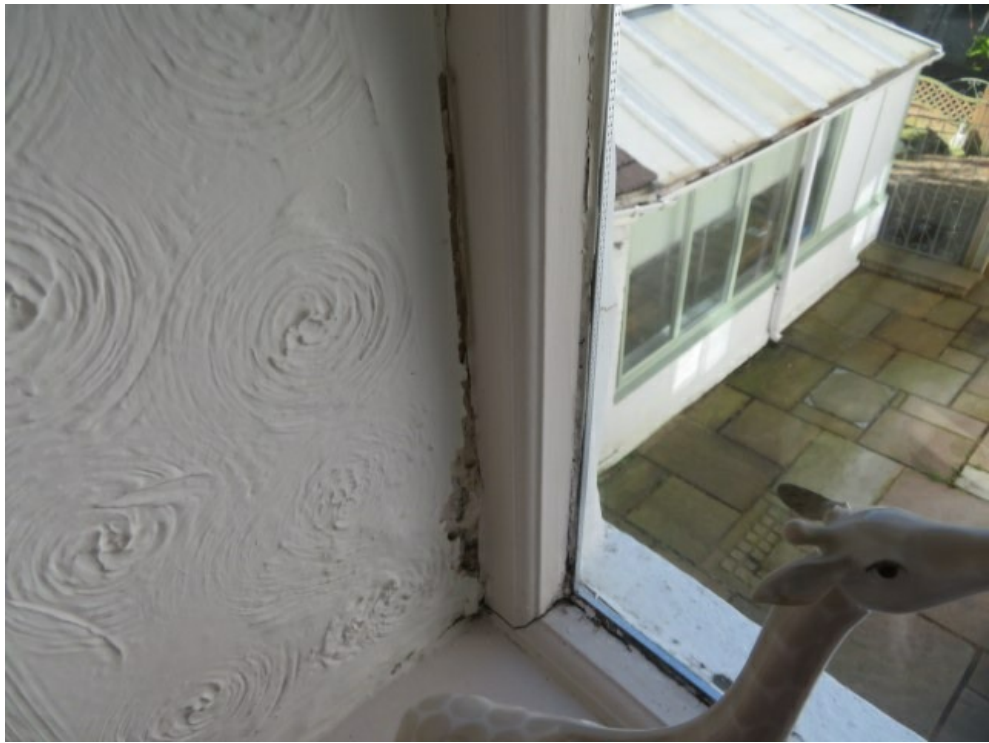
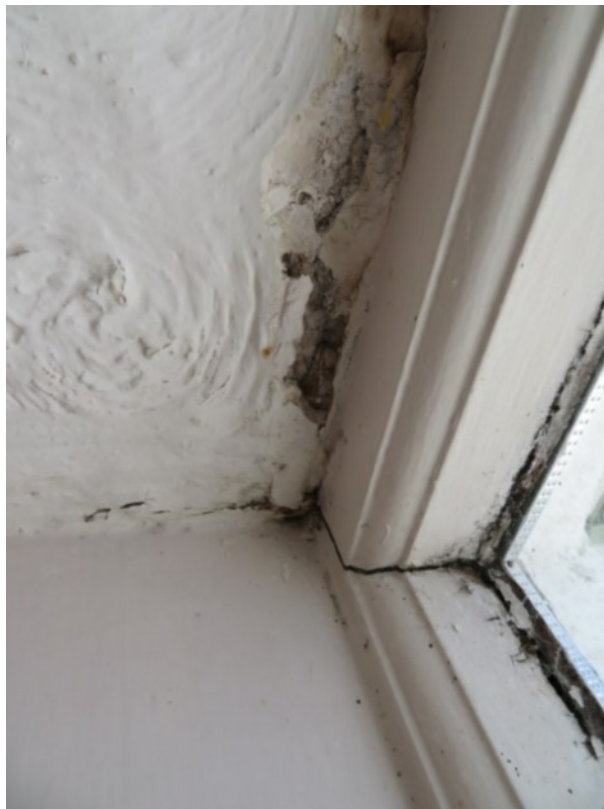
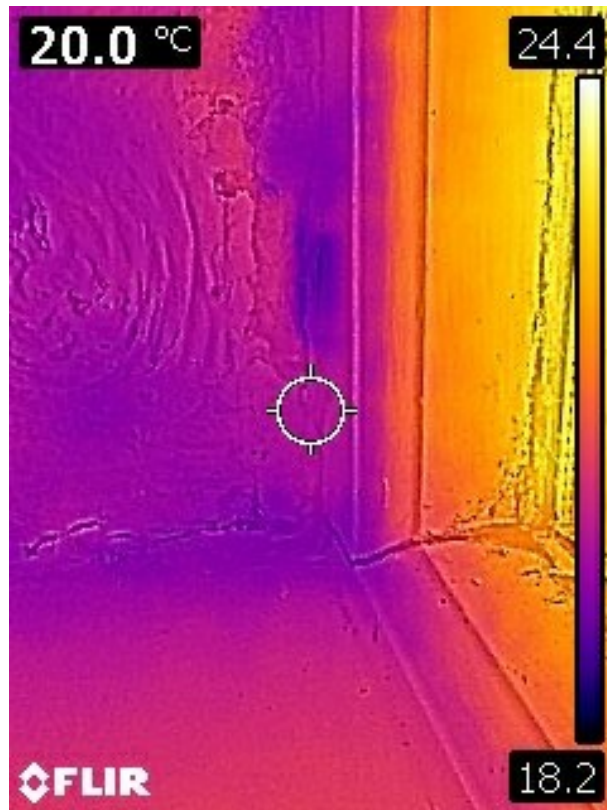
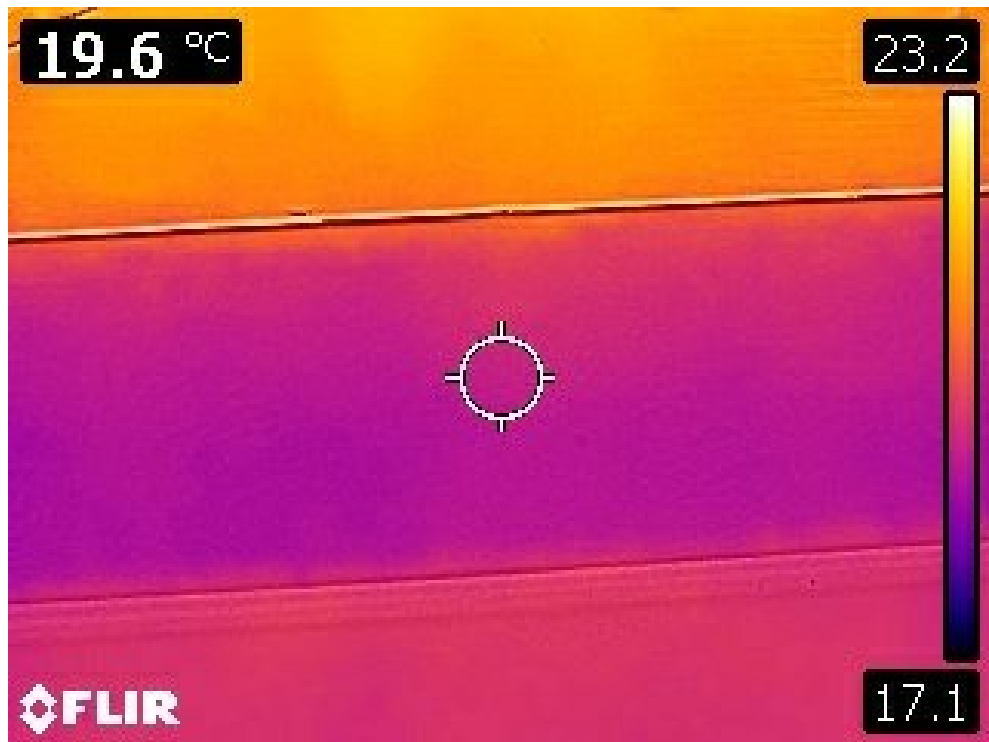
Damp damage to window reveal

Thermal image of damp in window reveal

Thermal image of damp below window sill

Action Required	<p>Normal maintenance is required, including filling and redecorating cracks as necessary.</p> <p>Many of the internal walls are likely to be finished with lath and plaster. It is common for the surface plaster to become detached from the lath and plaster base and to fall away when surface treatments such as wallpaper are removed. You should anticipate that some repairs to the plaster surface will be required when walls are disturbed for any reason.</p>

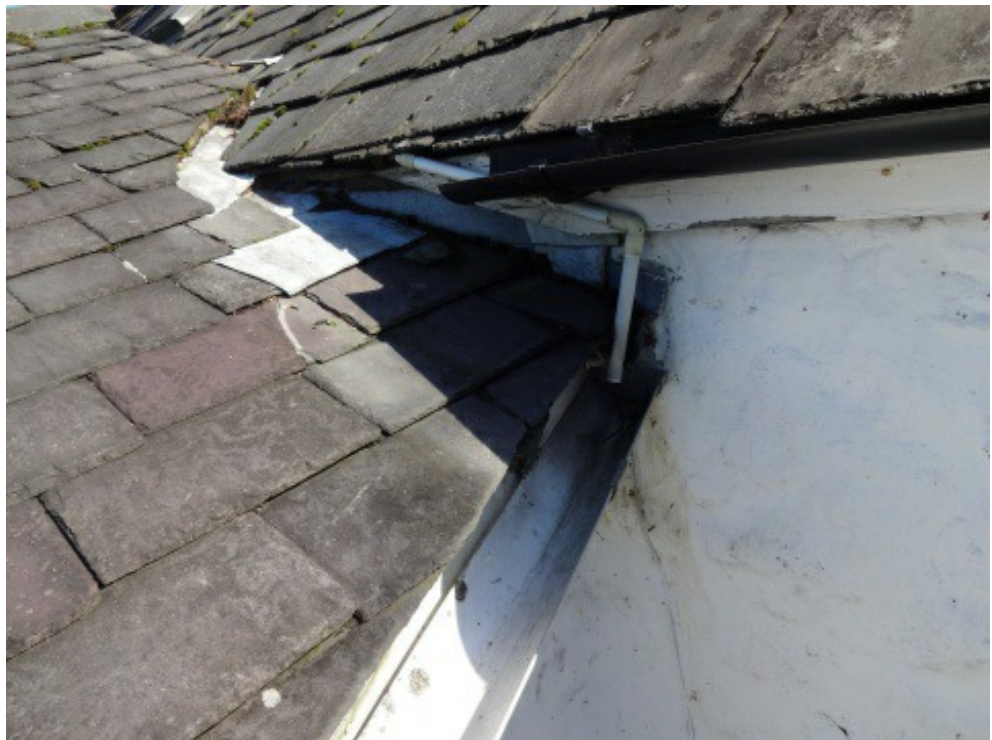
Condensate pipe into gutter

Action Required	<p>Flush through radiator system and add inhibitor</p> <p>No visible repairs were noted; normal maintenance servicing must be continually undertaken.</p> <p>Health and Safety –See also notes in 6.2 regarding the general safety and servicing of the complete Gas system.</p>

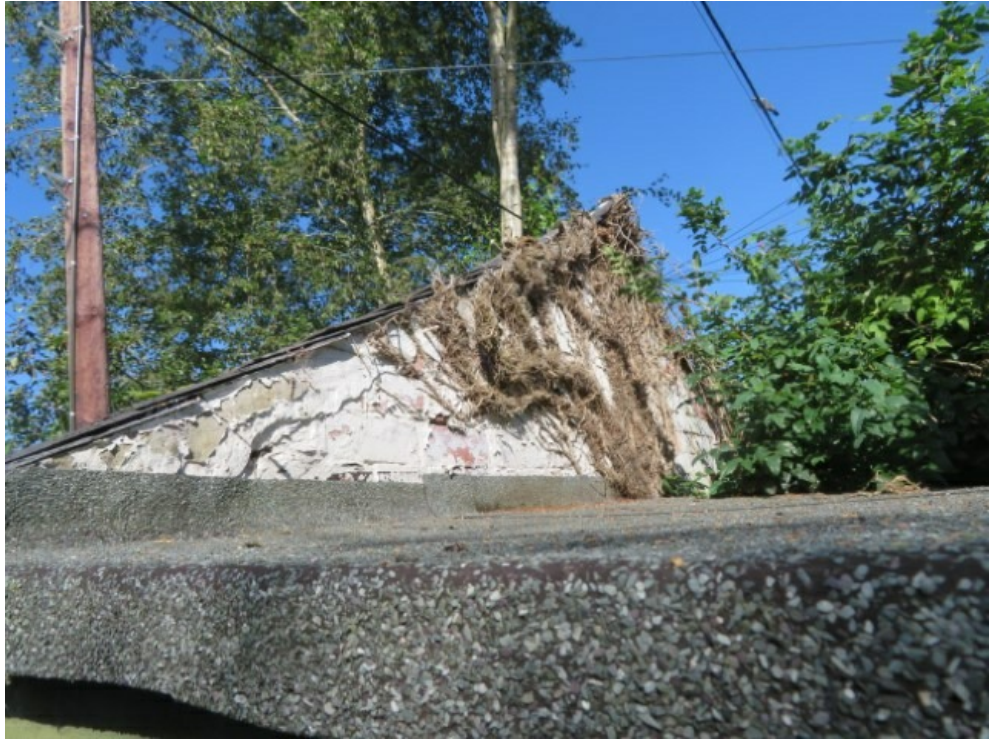
<h2 style="background-color: #0070C0; color: white; padding: 5px;">7.2 Outbuildings and Sheds</h2>	Condition rating	2
Construction & Type	There is a brick outhouse to the rear of the garden with a pitched slate roof. There is also a timber shed attached to this outhouse.		
Nature of inspection and Limitations	They were assessed for general condition and was examined externally and internally to identify areas of rot, damage, leaks and other defects. It was not possible to access the external rear and right side of the buildings due to the proximity of the boundary and foliage growth.		
Condition	They are in a fair condition. There were climbing plants noted to the outhouse wall growing from the neighbour's property.		
Action Required	Normal maintenance, including regular re-treatment of the walls, is required. Foliage and debris should be removed from the outside walls. Compared to traditional coverings such as tiles and slates, most felt roofs have a typical life of 10-25 years. They are also prone to sudden failure and leakage. Periodic re-covering will therefore be necessary. When this is undertaken, the supporting structure may also need some attention.

Climbing plant growth from neighbouring property
