HOME BUYER SURVEY

REF 3468

The format of this Mi HOME BUYER SURVEY is consistent with the guidance note requirements for a Survey Level 2 as defined by RICS Surveys of Residential Property 3rd edition May 2016

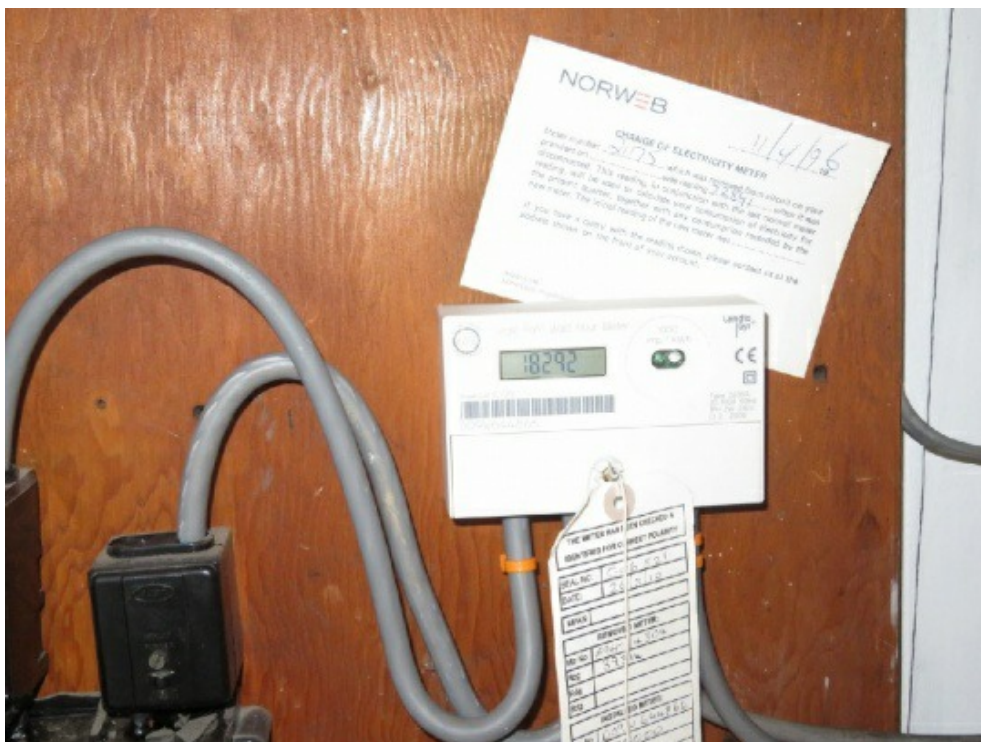
Electric Meter

Condition	<p>In general the electrical circuits seen are in a fair condition. PVC cabling was observed at the property and the socket face plates and switch plates are of a suitable modern quality. However to some rooms there may be an insufficient number of sockets for modern living standards, this means a level of new circuitry or rewiring may be required. There are also some specific observations listed below which you may consider require your attention.</p> <p>Observed Issues</p> <ul style="list-style-type: none"> - The light fitting to the bathroom is not to current standards. All such fittings to bathrooms are required to have the correct Ingress Protection (IP) ratings for dust and moisture. A new fitting specifically designed for bathrooms should be considered. - Due to changes for fire protection from 1st Jan. 2016 the consumer unit (fuse box) no longer complies with current regulations. Changes to regulations are rarely retrospective. <p>Some services will be obscured by furniture and other objects at the time of the survey. Upon occupation it is strongly advisable to visually check all socket outlets and switch points for any broken housings or loose fascias. Any damage seen should be repaired accordingly.</p> <p>The NICEIC recommends that electrical installations are subjected to a Periodic Inspection Report (PIR) by a suitably qualified engineer at least every 10 years. They further recommend that a PIR be carried out at any change of ownership of the property to properly assess the safety and compliance level of all circuits and fittings. You can get further information from the Electricity Safety Council www.esc.org.uk/public/guides-and-advice/</p> <p>At the time of survey a sticker was seen to verify that an inspection has been carried out within the last 10 years.</p> <p style="color: red;">However, from a safety perspective it is essential that you commission an inspection of the electrical installation prior to purchase of the property.</p>

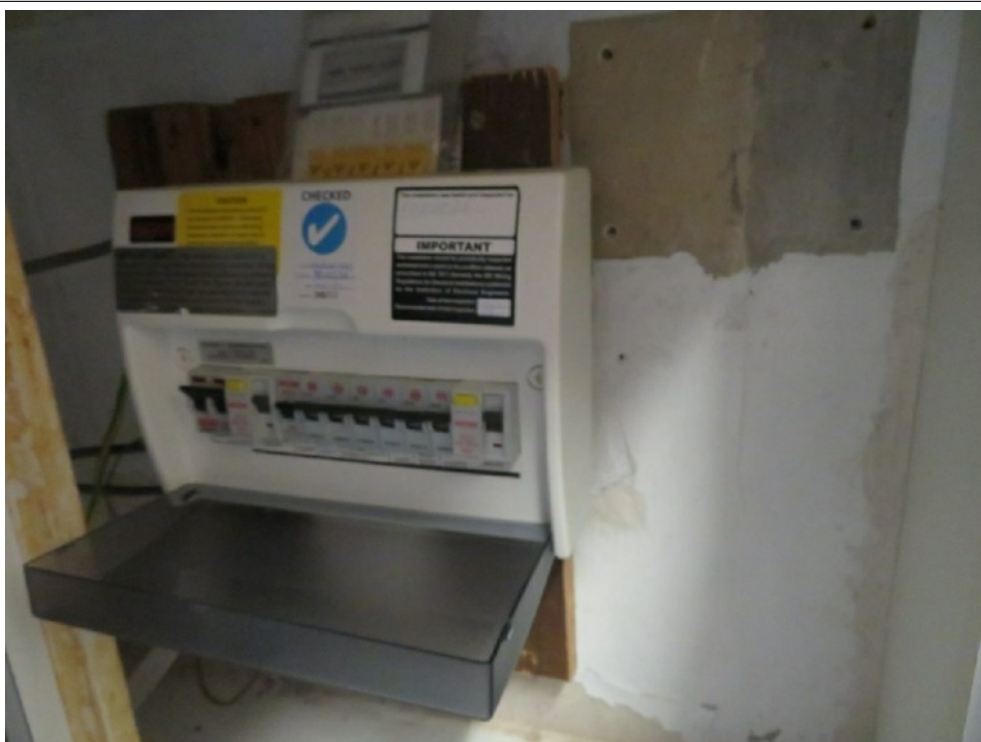
Consumer Unit (fuse box)

6.1 Electricity	Condition rating	HS
Construction & Type and Limitations	<p>There is an underground electrical supply and the meter and consumer unit [fuse box] are located in a cupboard in the kitchen.</p> <p>The consumer unit is a modern unit with MCB's (miniature circuit breakers) and also an RCD (Residual Current device). The electric meter is on a single tariff. The main fuse is rated at 100amps.</p> <p>It is not possible to fully assess the condition and safety of an electrical installation on the basis of a visual inspection only. Distribution wiring is largely concealed and therefore date and quality of installation cannot be verified within in the scope of this inspection.</p> <p>The installation was inspected visually to the extent sufficient to form an overall opinion of the type of installation, the materials used, its apparent age, its visible condition and the need for further investigations. No testing of the installations or appliances was carried out other than operation in normal everyday use.</p>

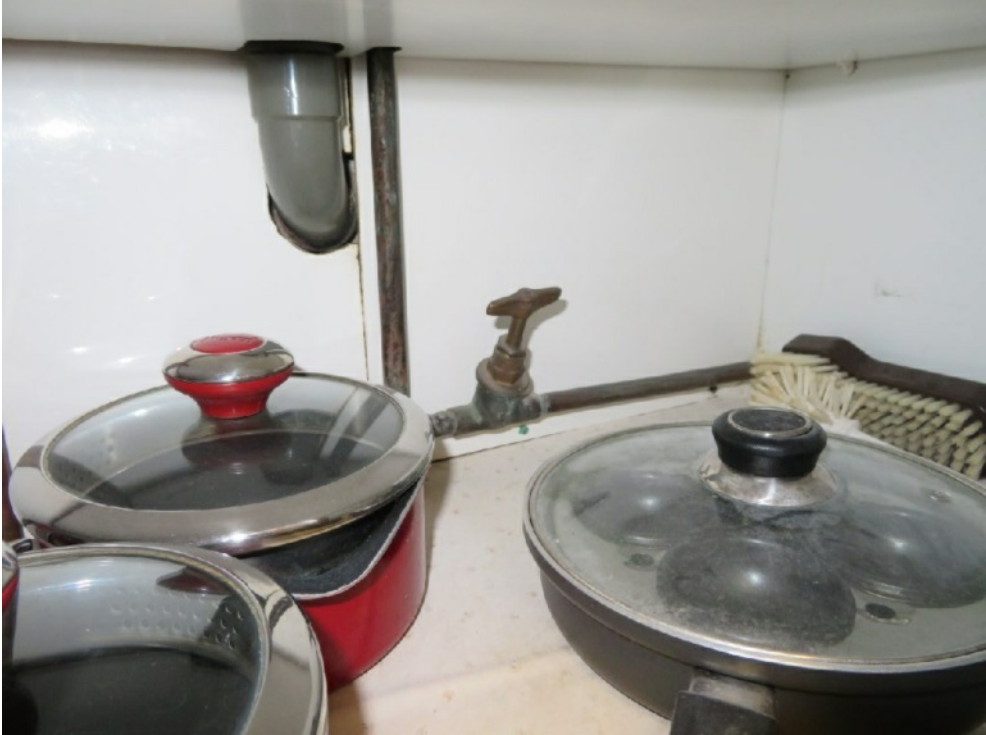
</div> <p style="text-align: center;">Water stop tap</p>

<h2 style="margin: 0;">6.3 Water</h2>	Condition rating	1
Construction & Type and Limitations	<p>There is a mains water supply. The incoming mains pipework is copper and the stop valve is under the kitchen sink. The cold water storage tank and heating feed & expansion tank are made of plastic and located in the roof space.</p> <p>The system is a typical gravity fed system – generally only the kitchen sink (and any outside garden tap) have a mains supply. The rest of the cold water draw-off points are probably supplied from the storage tank located in the loft.</p> <p>The visible parts of the system were checked for any obvious signs of leaking, damaged pipes, correct covering and insulation, and other evidence of defects. Water taps were operated to check for flow pressure and correct drainage. The water tanks were checked for signs of damage and correct support across a minimum number of joists.</p>
