Mi HOME BUYER SURVEY

HOME BUYER SURVEY

REF 5111

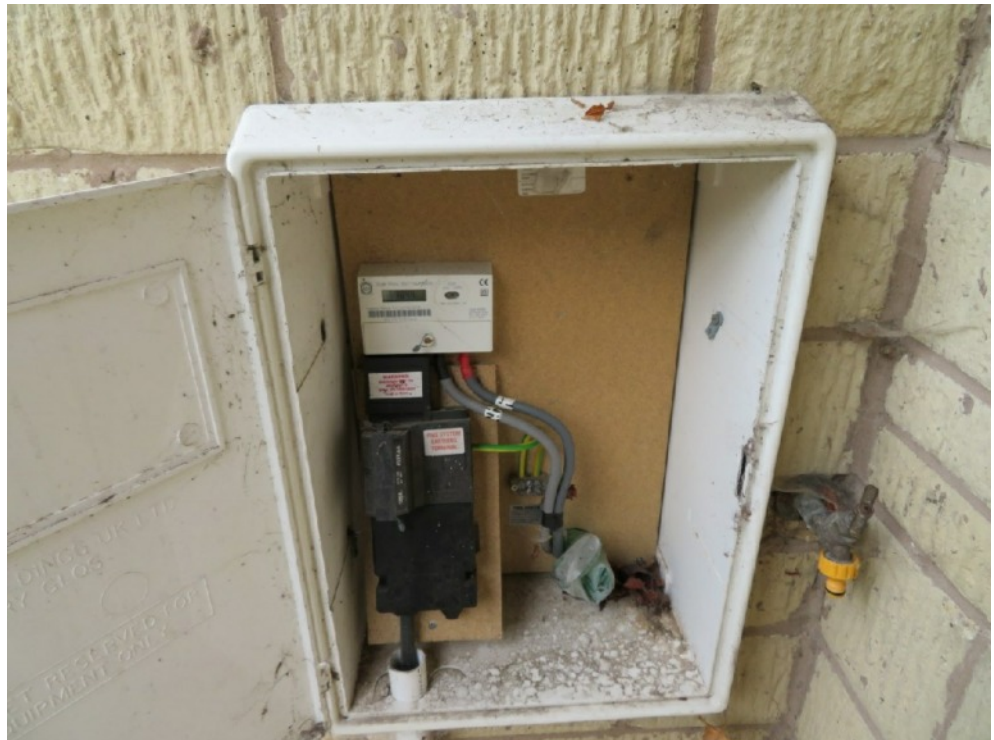
Electric Meter

6.1 Electricity	Condition rating	HS
<p>Construction & Type and Limitations</p>	<p>There is an underground electrical supply and the meter is in an external cabinet to the right hand side wall of the conversion. The consumer unit [fuse box] is located in the "utility".</p> <p>The consumer unit is a modern unit with MCB's (miniature circuit breakers) and also an RCD (Residual Current device). The electric meter is on a single tariff. The main fuse is rated at 100amps.</p> <p>It is not possible to fully assess the condition and safety of an electrical installation on the basis of a visual inspection only. Distribution wiring is largely concealed and therefore date and quality of installation cannot be verified within in the scope of this inspection.</p> <p>The installation was inspected visually to the extent sufficient to form an overall opinion of the type of installation, the materials used, its apparent age, its visible condition and the need for further investigations. No testing of the installations or appliances was carried out other than operation in normal everyday use.</p>

<p>Condition</p>	<p>In general the electrical circuits seen are in a fair condition. PVC cabling was observed at the property and the socket face plates and switch plates are of a suitable modern quality. However to some rooms there may be an insufficient number of sockets for modern living standards, this means a level of new circuitry or rewiring may be required. There are also some specific observations listed below which you may consider require your attention.</p> <p>Observed Issues</p> <ul style="list-style-type: none"> - The light fittings to the bathrooms are not to current standards. All such fittings to bathrooms are required to have the correct Ingress Protection (IP) ratings for dust and moisture. New fittings specifically designed for bathrooms should be considered. - Due to changes for fire protection from 1st Jan. 2016 the consumer unit (fuse box) no longer complies with current regulations. Changes to regulations are rarely retrospective. <p>Some services will be obscured by furniture and other objects at the time of the survey. Upon occupation it is strongly advisable to visually check all socket outlets and switch points for any broken housings or loose fascias. Any damage seen should be repaired accordingly.</p> <p>The NICEIC recommends that electrical installations are subjected to a Periodic Inspection Report (PIR) by a suitably qualified engineer at least every 10 years. They further recommend that a PIR be carried out at any change of ownership of the property to properly assess the safety and compliance level of all circuits and fittings. You can get further information from the Electricity Safety Council www.esc.org.uk/public/guides-and-advice/</p> <p>At the time of survey no documentation was seen to verify that an inspection has been carried out within the last 10 years.</p> <p style="color: red;">From a safety perspective it is essential that you commission an inspection of the electrical installation prior to purchase of the property.</p>

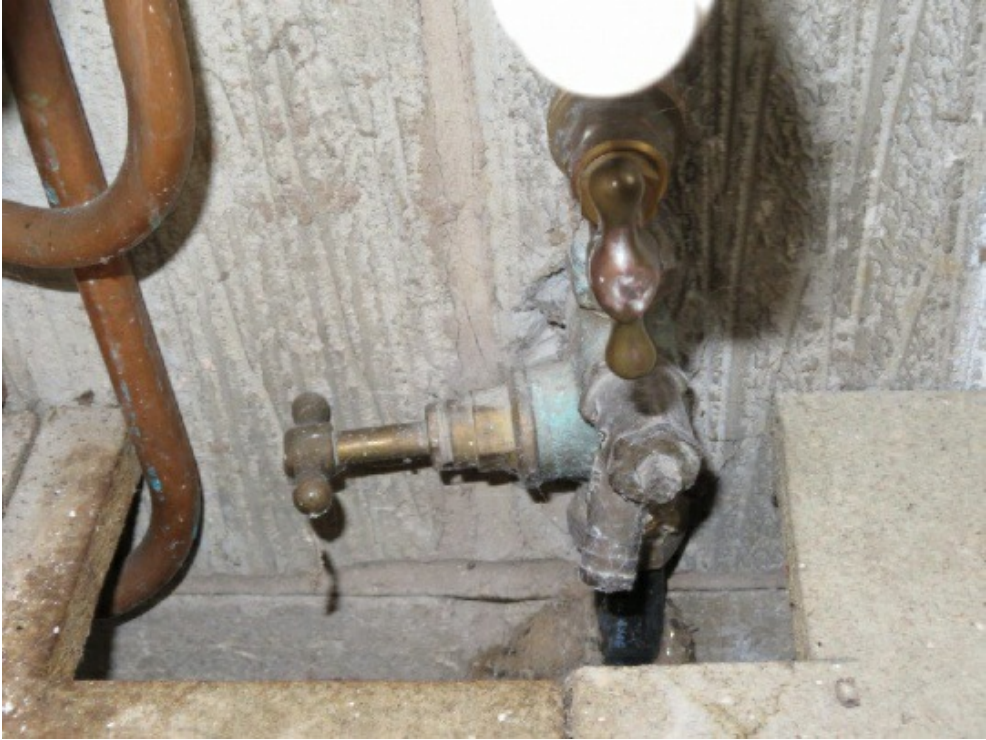
<p style="margin: 0; font-weight: bold;">Water stop tap</p>

<h2 style="margin: 0;">6.3 Water</h2>	<p style="text-align: center; margin: 0;">Condition rating</p>	<p style="margin: 0;">1</p>
<p style="margin: 0;">Construction & Type and Limitations</p>	<p style="margin: 0;">There is a mains water supply. The incoming mains pipework is black plastic and the stop valve is in the "utility".</p> <p style="margin: 0;">The water installation is of the more modern unvented system style. This does not require a cold water storage tank; all the cold water draw-off points are fed directly off the mains supply. There are no water storage facilities (hot or cold) at the property.</p> <p style="margin: 0;">The visible parts of the system were checked for any obvious signs of leaking, damaged pipes, correct covering and insulation, and other evidence of defects. Water taps were operated to check for flow pressure and correct drainage.</p>		
<p style="margin: 0;">Condition</p>	<p style="margin: 0;">No significant defects are noted, all fittings operated as required with water pressures at fair levels.</p> <p style="margin: 0;">The water main is of black plastic pipe. As part of the electrical supplementary bonding wiring, the water main pipe is often used as an earthing point for the supplementary bonding circuit. A plastic pipe removes the opportunity for completing the bonding circuit. All bonding should be checked by a suitably qualified electrician to ensure correct earthing of the circuit</p> <p style="margin: 0; color: red;">As the property is empty it is possible there is some stagnant water within the system. Stagnant water in a system if between 20° and 50°C can cause a risk of legionella disease. Temperature control is the traditional strategy for reducing the risk of legionella in hot and cold water systems. Cold water systems should be maintained, where possible, at a temperature below 20°C. Hot water should be stored at least at 60°C and distributed so that it reaches a temperature of 50°C within one minute at the outlets.</p>
