BUILDING SURVEY REPORT

REF 8561

The format of this Mi BUILDING SURVEY REPORT is consistent with the guidance note requirements for a Survey Level 3 as defined by RICS Surveys of Residential Property 3rd edition May 2016

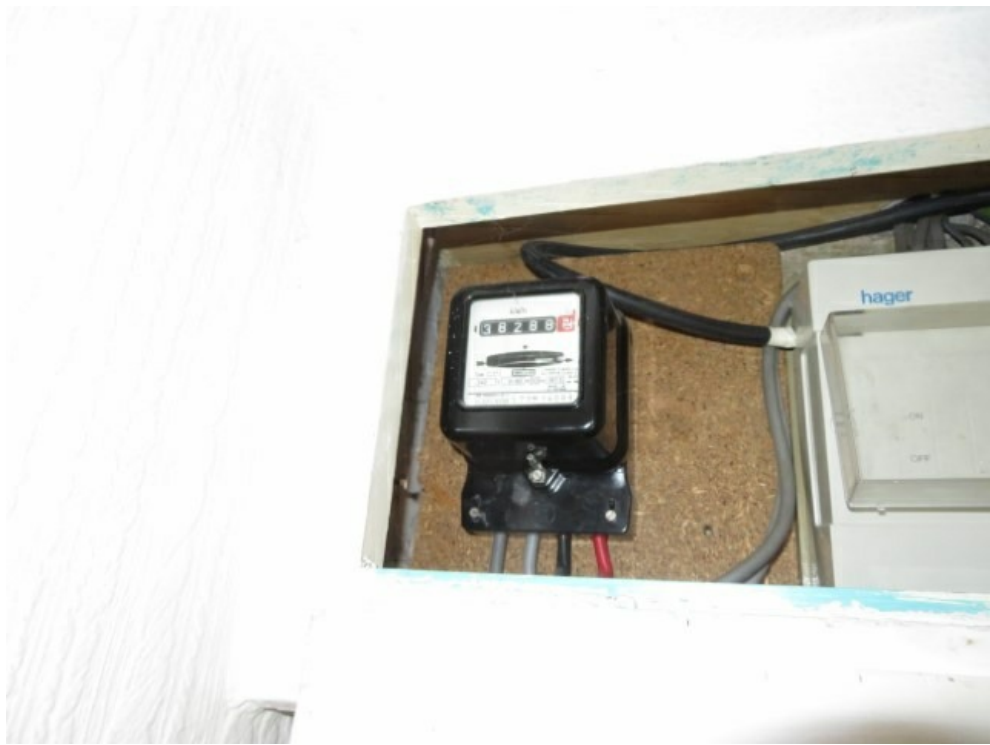
Electric Meter

Condition	<p>In general the electrical circuits seen are in a fair condition. PVC cabling was observed at the property and the socket face plates and switch plates are of a suitable modern quality. However to some rooms there may be an insufficient number of sockets for modern living standards, this means a level of new circuitry or rewiring may be required. There are also some specific observations listed below which you may consider require your attention.</p> <p>Observed Issues</p> <ul style="list-style-type: none"> - The light fittings to the bathrooms are not to current standards. All such fittings to bathrooms are now required to have the correct Ingress Protection (IP) ratings for dust and moisture. New fittings specifically designed for bathrooms should be considered. - Due to changes for fire protection from 1st Jan. 2016 and previous changes, the consumer unit (fuse box) no longer complies with current regulations. Changes to regulations are rarely retrospective.

Action Required	<p>Some services will be obscured by furniture and other objects at the time of the survey. Upon occupation it is strongly advisable to visually check all socket outlets and switch points for any broken housings or loose fascias. Any damage seen should be repaired accordingly.</p> <p>The NICEIC recommends that electrical installations are subjected to a Electrical Installation Condition Report (EICR) by a suitably qualified engineer at least every 10 years. They further recommend that a EICR be carried out at any change of ownership of the property to properly assess the safety and compliance level of all circuits and fittings. You can get further information from the Electricity Safety Council www.esc.org.uk/public/guides-and-advice/</p> <p>At the time of survey no documentation was seen to verify that an inspection has been carried out within the last year.</p> <p>From a safety perspective it is essential that you commission an inspection of the electrical installation prior to purchase of the property.</p>

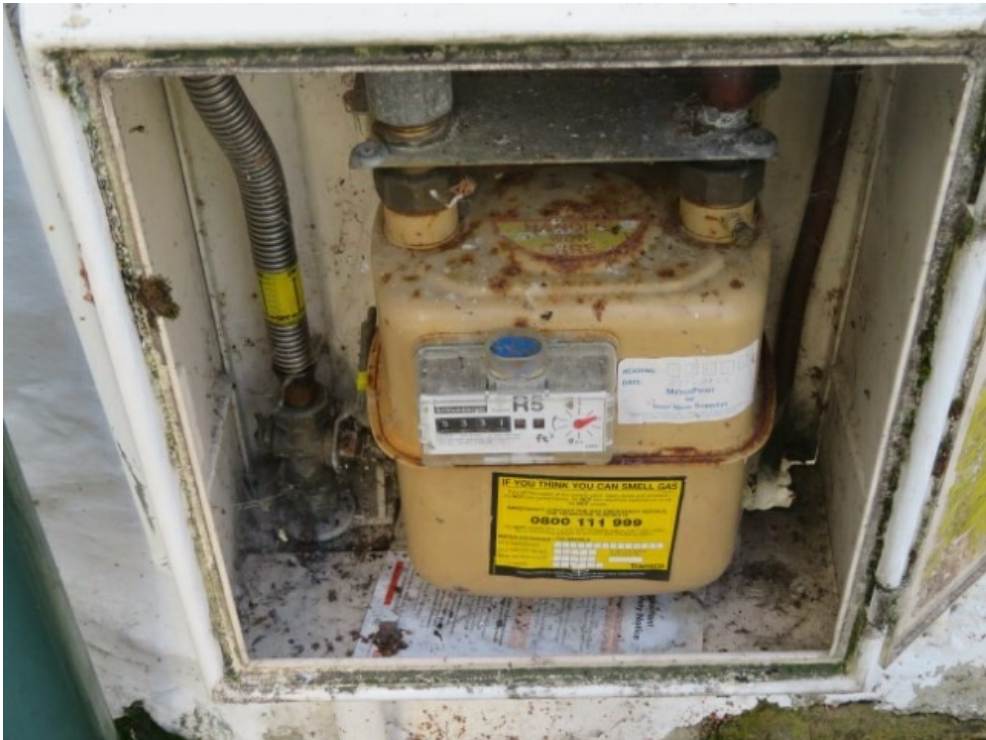
<p style="text-align: center;">Gas Meter</p>

6.2 Gas / Oil	Condition rating	HS
Construction & Type	There is a mains gas supply and the meter and valve are located in an external cabinet to the rear of the property. The gas supplies the heating boiler, gas fire and the kitchen services.		
Nature of inspection and Limitations	The system was inspected for any obvious signs of leakage and damage to the supply pipes where visible.		
Condition	No significant defects were noted but see health and safety advice below.		
Action Required	<p>Advice: Gas Safe recommends that all gas appliances and boilers are inspected and serviced according to manufacturers' guidance, but at least once a year. At the time of survey, no documentation was seen to verify that an inspection or servicing has been carried out within the last 12 months. As the property may be unoccupied, parts of the system may not have been in use for a while. These observations increase the risk of any hidden issues.</p> <p>From a health and safety perspective, it is recommended that you commission an inspection and servicing of the gas installation and ALL appliances (including the boiler, gas fire and gas hob) prior to purchase of the property.</p>

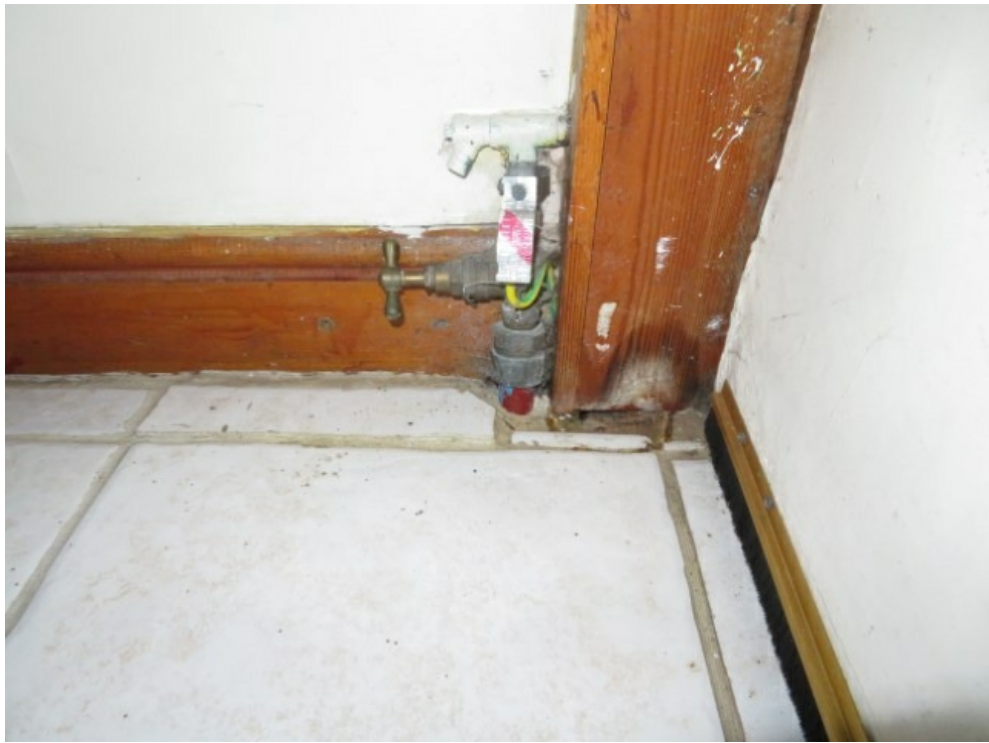
Water stop tap

6.3 Water	Condition rating	2
Construction & Type	<p>There is a mains water supply. The incoming mains pipework is blue plastic and the stop valve is adjacent to the front door.</p> <p>The water installation is of the more modern unvented system style. This does not require a cold water storage tank; all the cold water draw-off points are fed directly off the mains supply. There are no water storage facilities (hot or cold) at the property.</p>		
Nature of inspection and Limitations	<p>The visible parts of the system were checked for any obvious signs of leaking, damaged pipes, correct covering and insulation, and other evidence of defects. Water taps were not operated to check for flow pressure and correct drainage as the water was turned off.</p>		
Condition	<p>No obvious significant defects are noted, I would recommend you have a qualified plumber at the property when the water is turned back on.</p> <p><i>As the property may be unoccupied it is possible there is some stagnant water within the system. Stagnant water in a system if between 20° and 50°C can cause a risk of legionnaires disease. Temperature control is the traditional strategy for reducing the risk of legionella in hot and cold water systems. Cold water systems should be maintained, where possible, at a temperature below 20°C. Hot water should be stored at least at 60°C and distributed so that it reaches a temperature of 50°C within one minute at the outlets.</i></p>

Action Required	<p>Check the installation for evidence of leaks or other defects on a regular basis i.e. approximately every 6 months, or sooner. Leaks most often occur at pipe joints and where pipes are subject to movement or physical damage, such as airing cupboards, roof spaces and under sinks.</p>

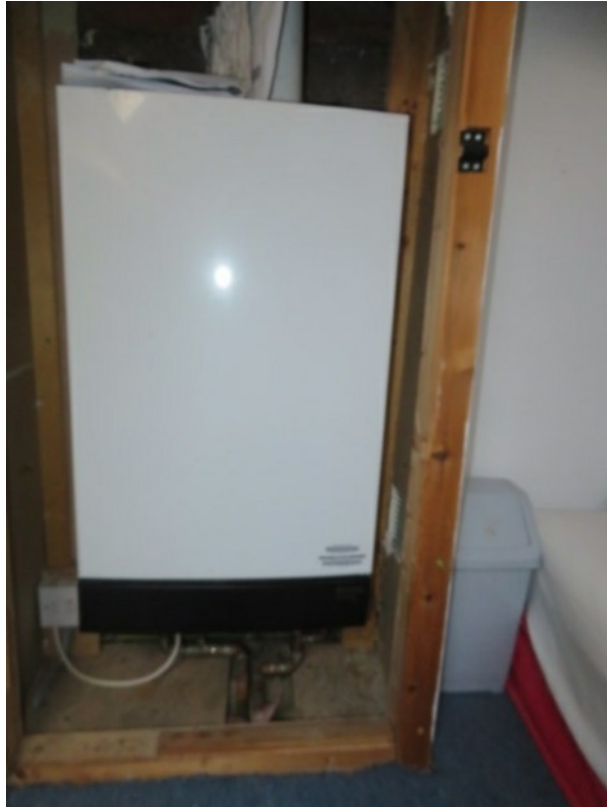
Boiler

Condition	<p>The radiator system was not in operation during the survey but the hot taps were tested, the boiler fired and hot water was delivered.</p> <p>No evidence was seen to suggest that an inhibitor has been added to the heating system recently to prevent a build-up of sludge in the pipework and radiators, and it is therefore recommended that the system be flushed through and an inhibitor added.</p> <p>Note: Combination boilers can only provide hot water to one appliance at a time (usually the appliance closest to the boiler.) Consequently if there is more than one demand for the boiler at a time the appliances further away can get reduced levels of hot water. It can also take longer to fill a bath than with a traditional system.</p> <p>This is a condensing boiler and as part of its function it discharges condensate (partially acidic water) which under building regulations has to be drained directly into a drain. In this property the condensate pipe drains to a gutter. The condensate pipe should be extended into a drain and clad against the possibility of freezing, which would stop the boiler working. The gutter it drains to does not belong to this property, therefore it is a form of trespass. This is also the section of leaking gutter mentioned in section 4.3, which will mean your neighbour will find out the condensate pipe is feeding into their gutter if you ask them to fix the leak.</p> <p>Finally, since April 2005 new boilers should be notified to the local Building Control Office. Since this boiler was only manufactured after 2008 there should be an installation certificate registered on the Local Authority Building Control register, we did not find one on the register.</p>

Action Required	<p>Flush through radiator system and add inhibitor</p> <p>No visible repairs were noted; normal maintenance servicing must be continually undertaken.</p> <p>Health and Safety –See also notes in 6.2 regarding the general safety and servicing of the complete Gas system.</p>
